Repair and Refurbishment Lessons Learned Using Cold Spray

Dr. Christian Widener, Director Repair, Refurbish, and Return-to-Service Center South Dakota School of Mines and Technology

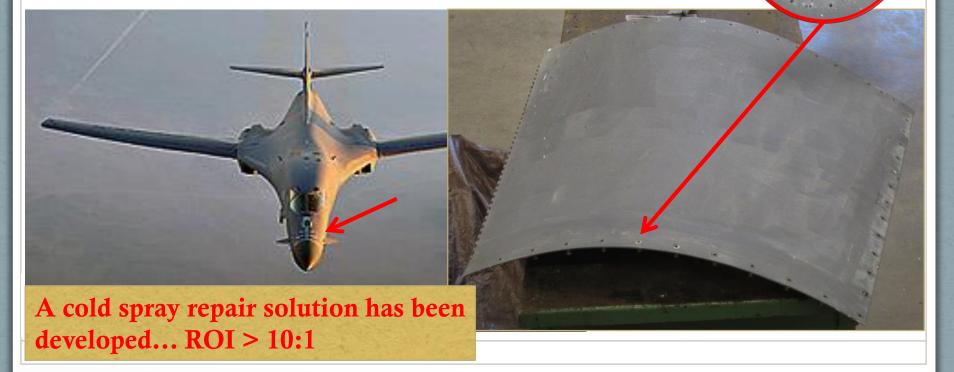
- B1 Bomber Skin Panel Repair
 - Wear at fastener holes
 - Replacement Cost >\$200K each (Fleet liability: \$50M)
 - Access panel not designed to be load carrying

- Approved Legacy Repair
 - External Doubler Repair

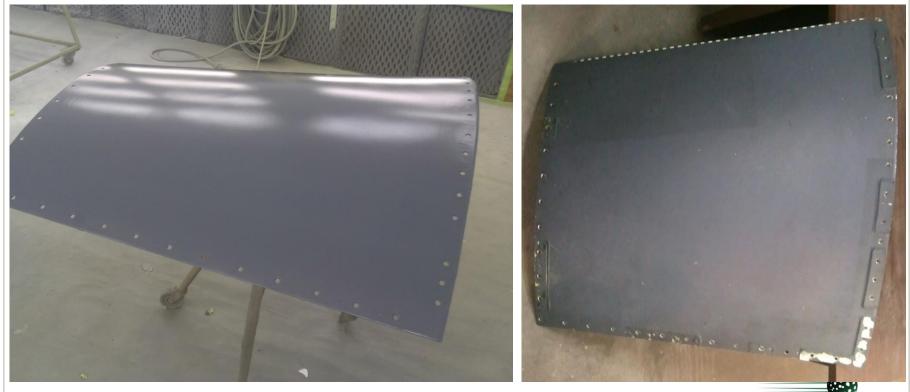
Fully Restored Panel vs. Legacy Repair Options

- The repair is currently flying on a B1 under an ETAR (since August 2012)
- Panels can be restored to their full form, fit, and function
- No sign of degradation or repair failure to date.
- Total development (with Tinker AFB support): 250 days
- Low risk and High return

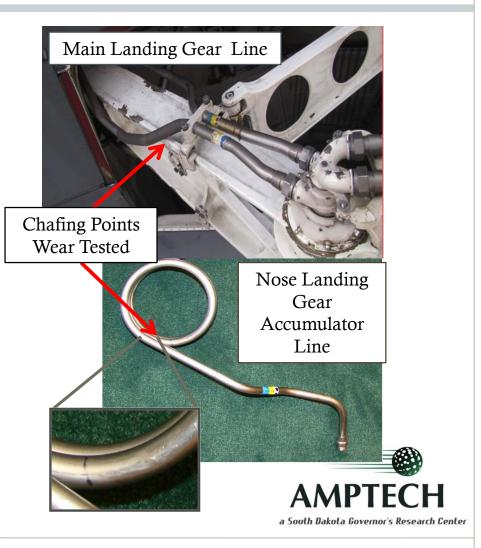
- B1 Hydraulic Lines
 - Chafing Prevention
 - CpTi on Ti-3-2.5
 - Flying since 2009...
- Lessons Learned
 - Hand spraying needed because of complexity and variability of tubing bends

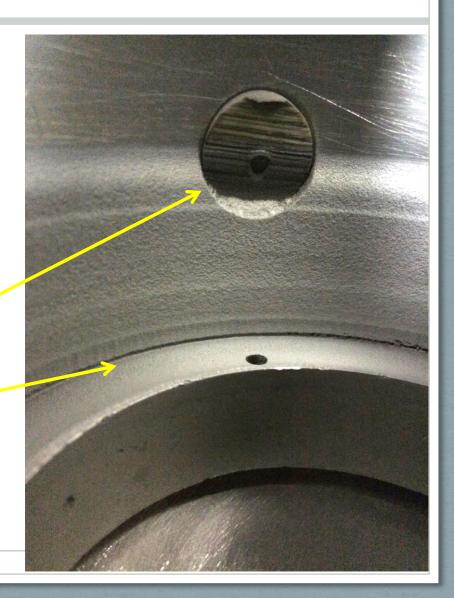
- TD-63 Valve Actuator Body – US Navy
 - Corrosion and sealing surface repair application
 - Path finder part
- Lessons Learned (Challenges)
 - Masking points
 - Inside corners

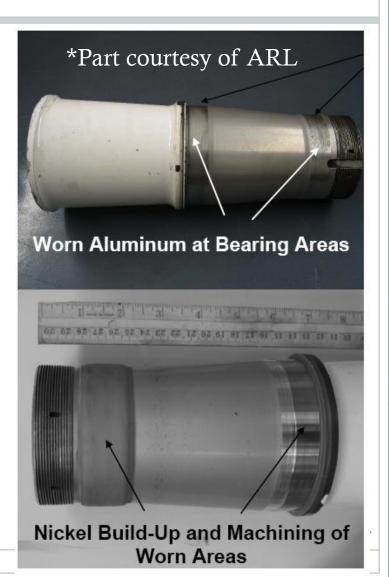
- B1 False Axle
 - Repair of worn bearing surfaces
- Lessons Learned
 - Must account for needed overspray to allow for machining
 - Layer thickness not always easy to predict on large build-ups
 - Must deal with blending issues
 at interfaces of overbuilt areas

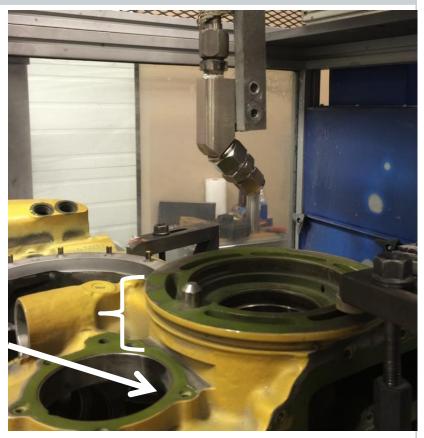
- F-15 AMAD Housing
 - Access to internal features can be restricted by other areas of the part.
 - Building up a full width on a surface generally requires access above and below.
