Cold Spray Repair Technology at Honeywell

CSAT 2016

Honeywell

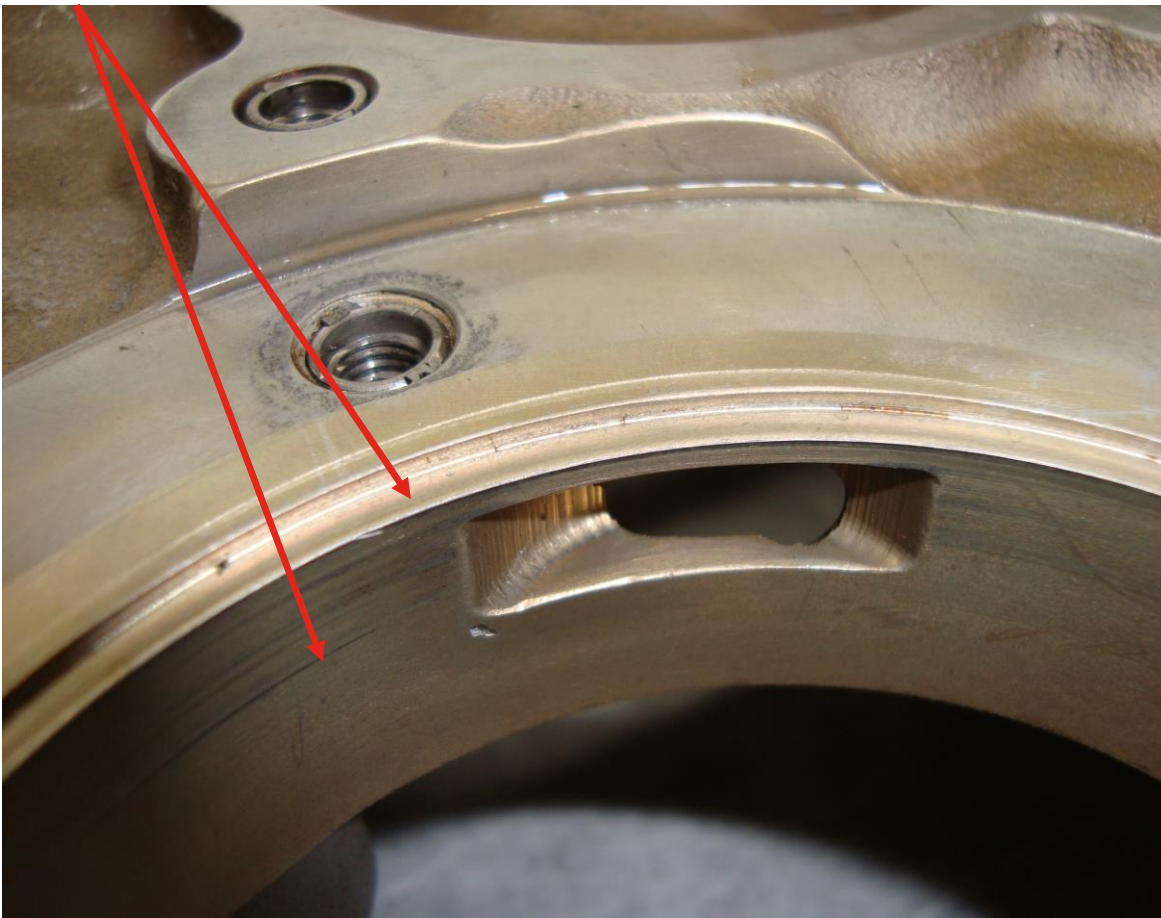
- First parts back from service that were cold spray repaired
- Every bore is repaired at first shop overhaul event

- After cold spray implementation, the bore did not require repair at next shop visit
- Tolerance for bore is .0005 inches
- Cold spray offers longer service life

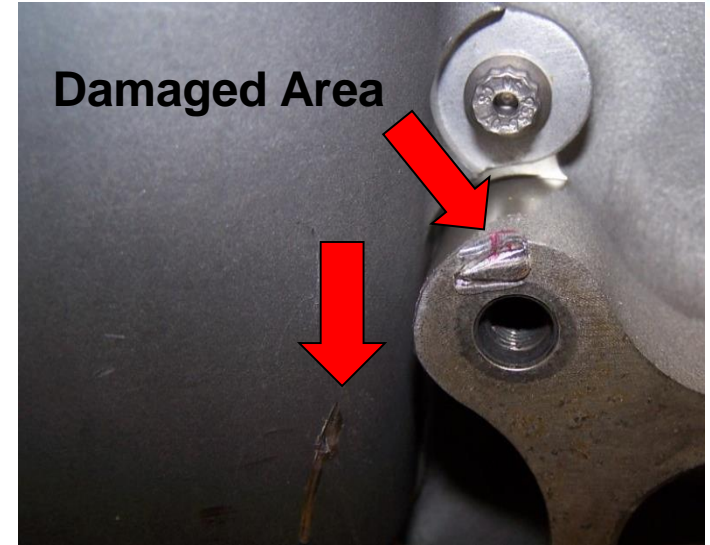
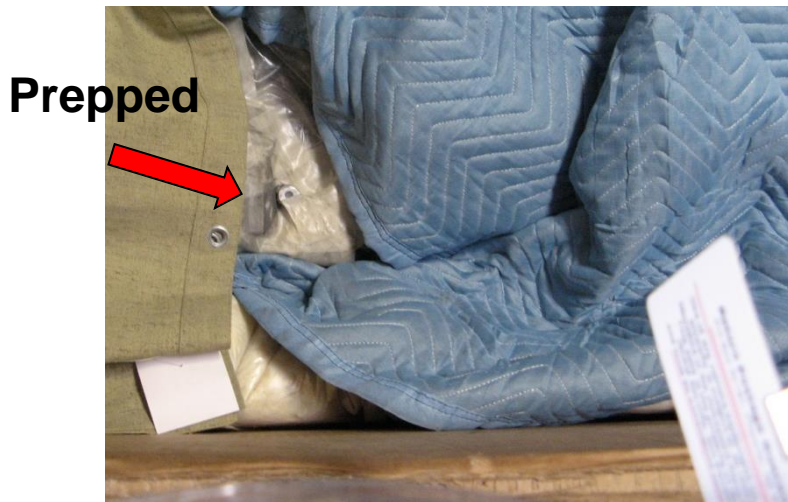
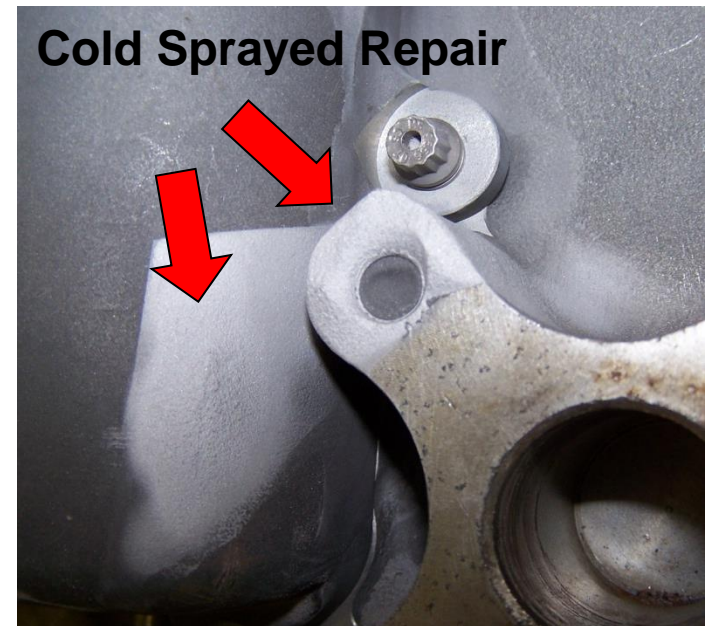
Engine in shipping box

- Customer returned engine that was damaged en route after overhaul
- Engine was masked/ protected in box
- Cold Spray repair process was performed with engine still in the shipping box

- Total repair time from start to finish 6 hours

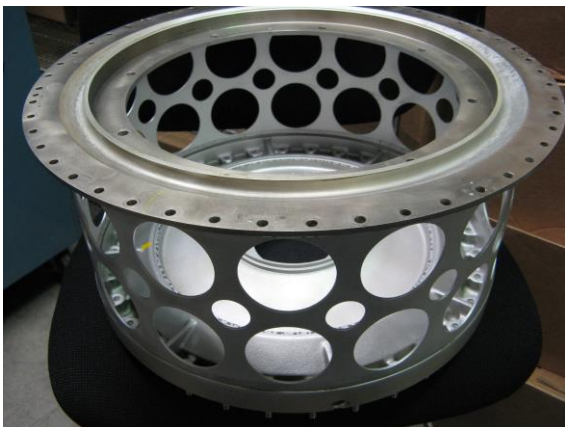
Inlet Housings

- Repair of previously un-repairable components due to distortion associated with weld repair and parent material cutback
 - Structural repair where the load bearing capability of the material deposit is required

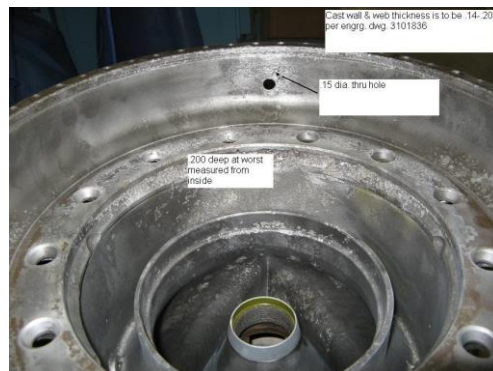
Engine Housing

Seal replacement and parent bore repairs
