# Cold Spray at PSNS & IMF

Tom Stamey, C/260M, 6/22/16

# Case study: MCWP

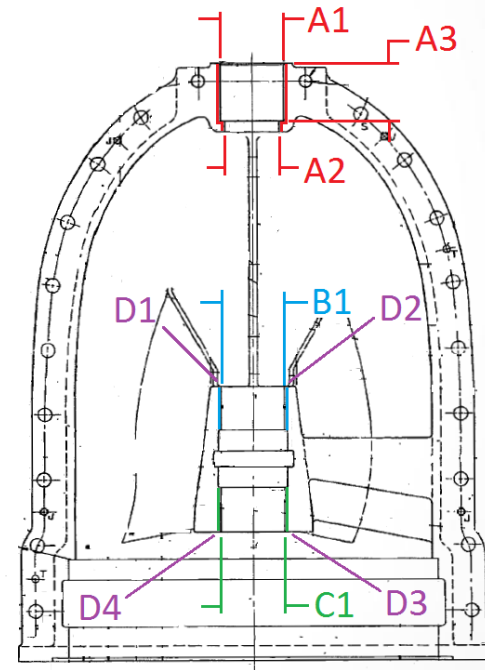
Cover

- The problem:
  - Surfaces A, B, and C were damaged in service.
  - Surface A can be epoxy repaired.
  - Surfaces B and C are commonly epoxy repaired, but the effective life of the repair is shorter than the maintenance periodicity of the pump.
  - The gun metal (tin bronze) base material of the pump is not readily weld repairable. It builds up poorly and is prone to cracking.
  - Replacement pumps are extremely expensive ( $\approx$ \$500,000).
- The solution:
  - Cold spray repair.

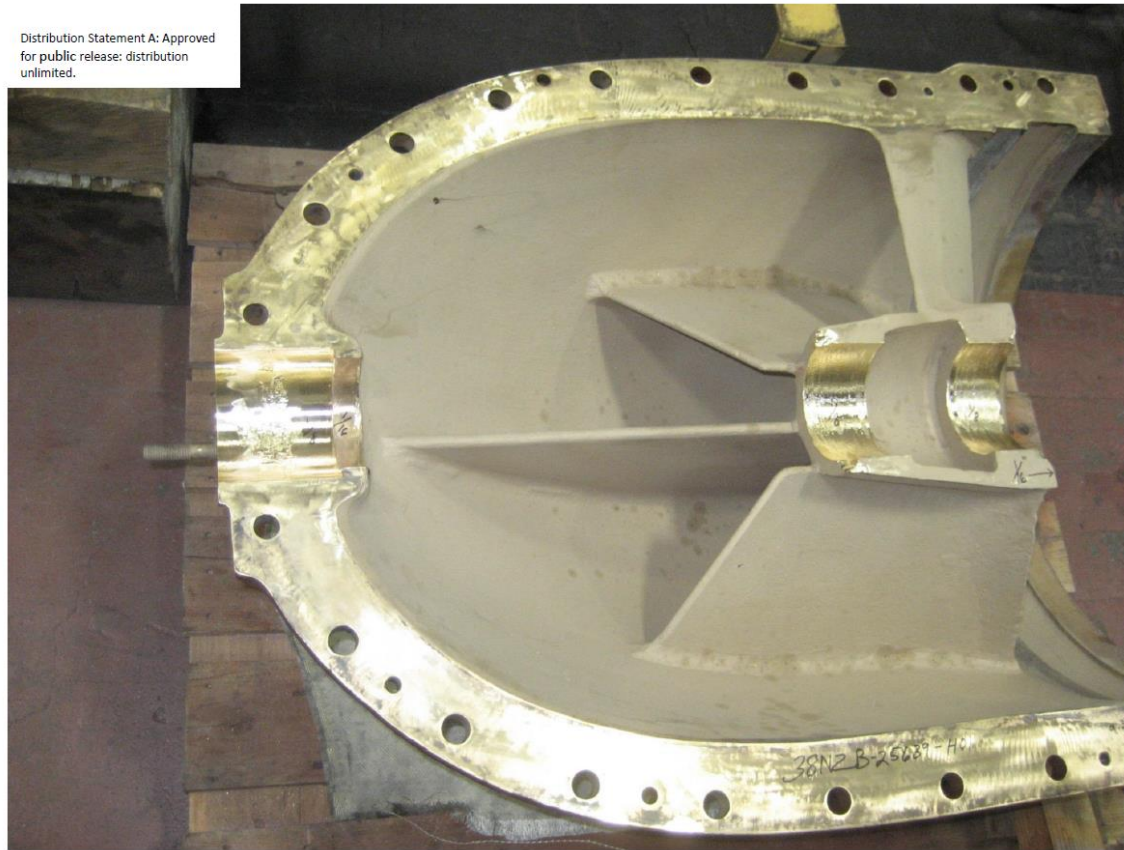
Cover: As prepped

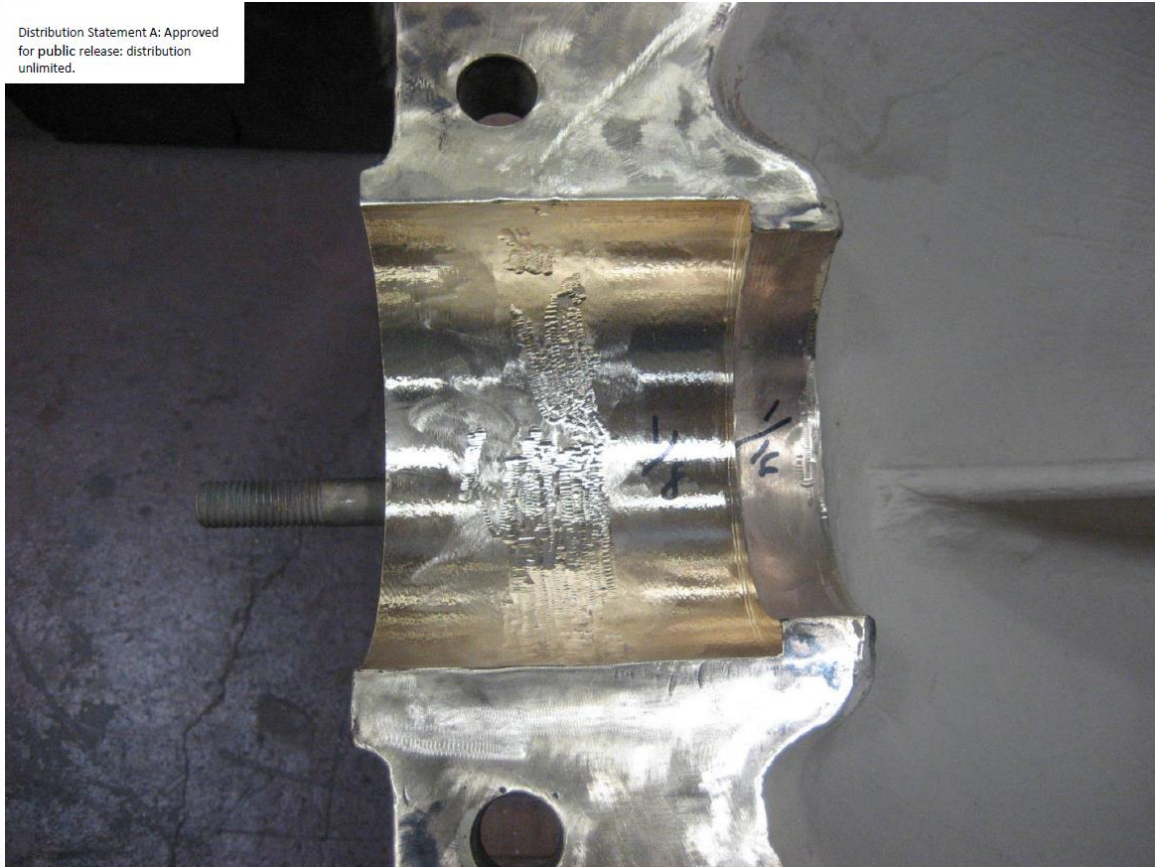
Cover: As prepped  
Area A detail

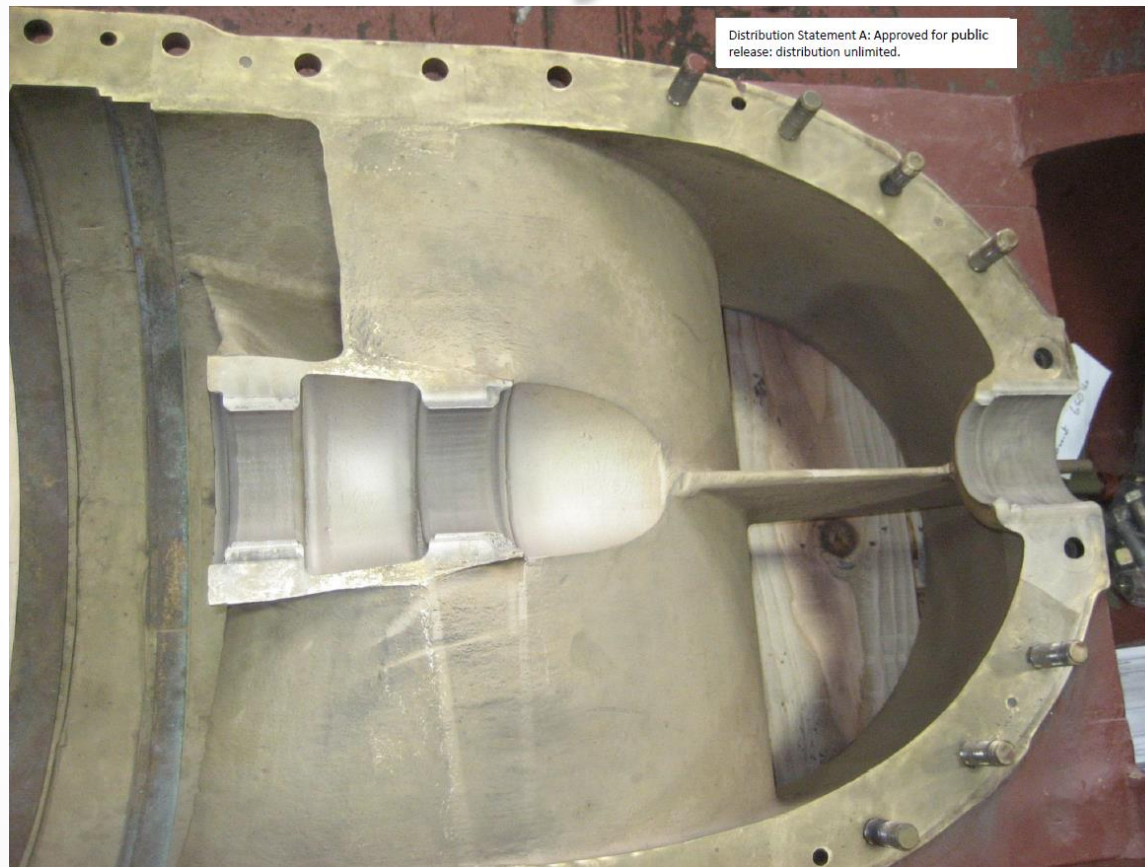
Case: As sprayed

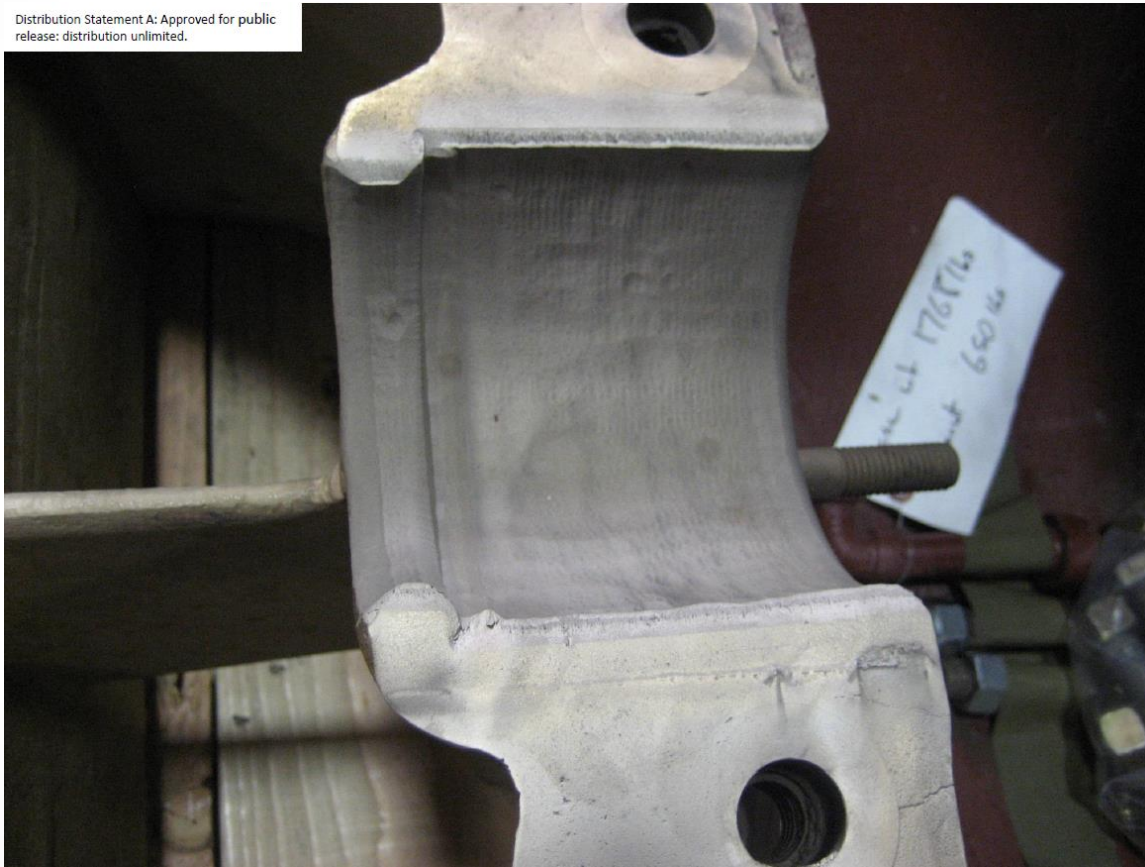
Case: As sprayed  
Area A detail

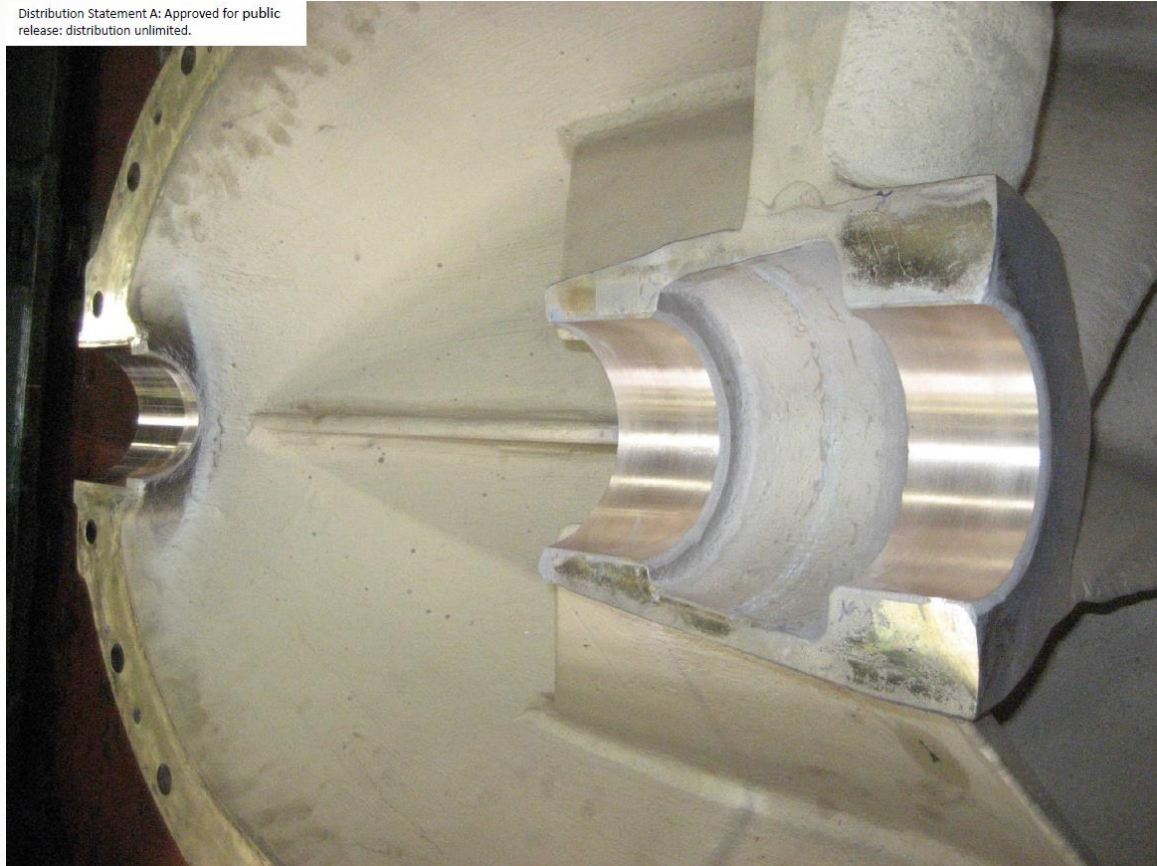
Cover: Finish machined

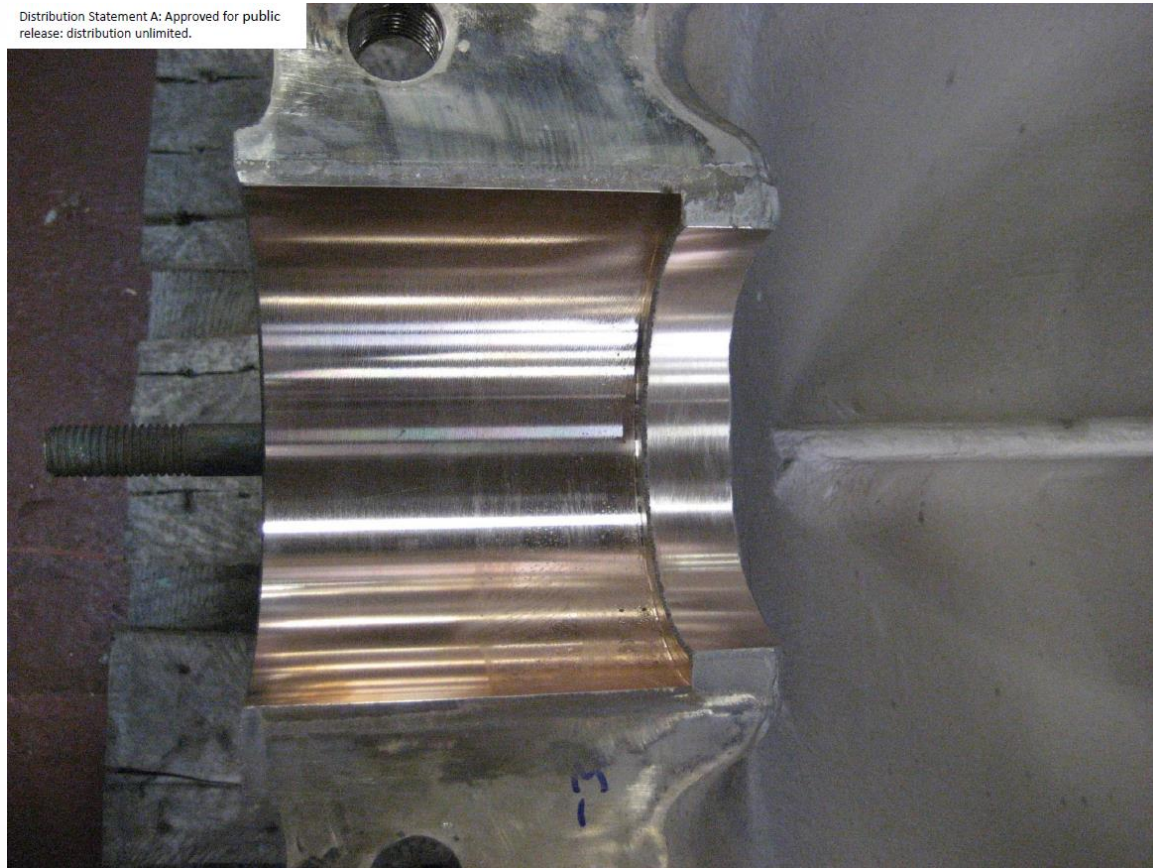
Cover: Finish machined  
Area A detail

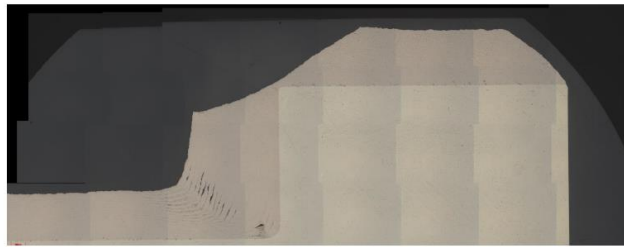
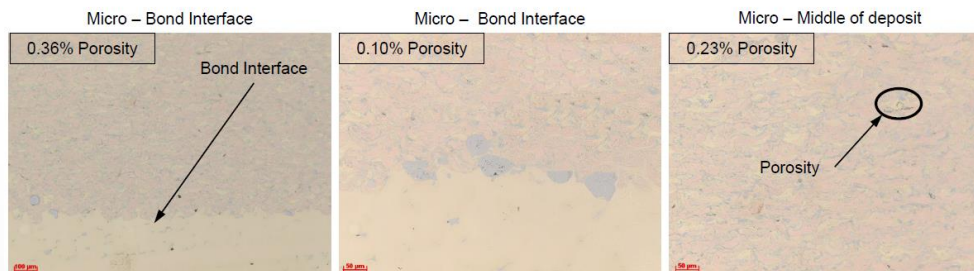
Mosaic Images of Cross Section

- Metallurgical examination:
  - Examination of test coupons and mock-up showed less than 1% porosity.
  - The reentrant corner porosity was not measurable.

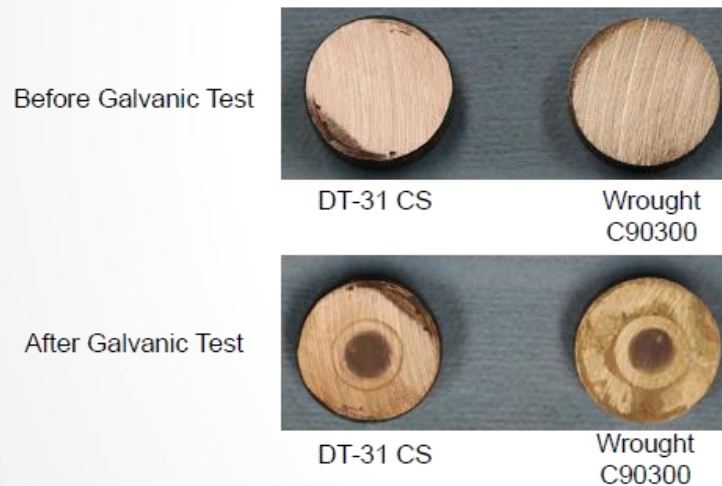
ASTM G71 testing

- Corrosion:
  - General corrosion testing per ASTM G71
  - Crevice corrosion testing per ASTM G78
