Cold Spray Development for Apache Mast Support

Materials and Processes Technologies

- To develop a structural, cold-spray repair solution for corroded nickel plated main rotor support mast

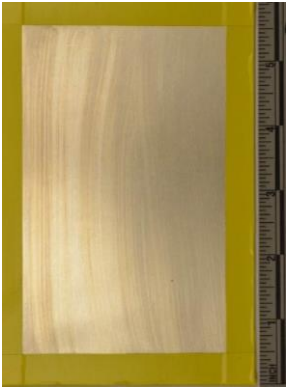
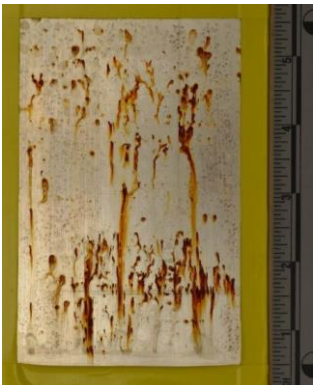
EL Ni + Ag

24 Hours

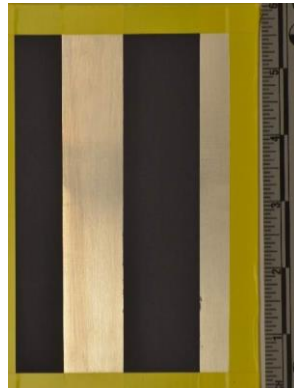
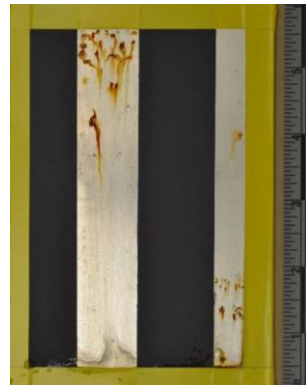
Combo

24 Hours

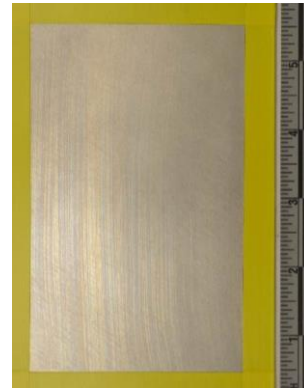
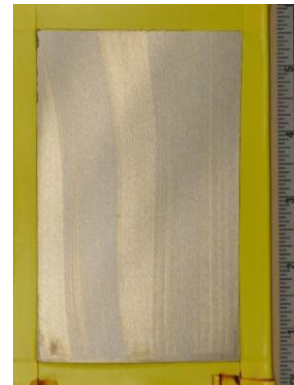
CS Ni

360 Hours

- **Two reasons for improved corrosion performance**
 1. Cold spray coating much more uniform than electroless nickel plating
 2. Removing silver reduces some galvanic potential from the system
 1. Silver
 2. Electroless Nickel
 3. 4340 Steel

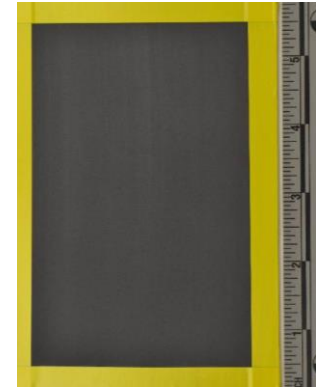
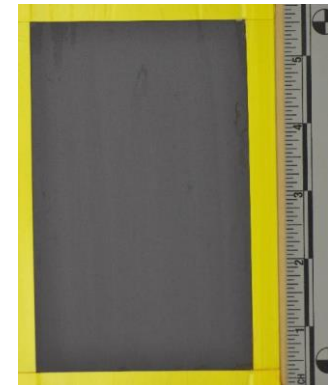
CS Ni + Dry Film

360 Hours
