Cold Spray Repair of Magnesium

ARL Center for Cold Spray
17 May 2011

UH-60 Sump Assembly Main Module-Main Gearbox Repair

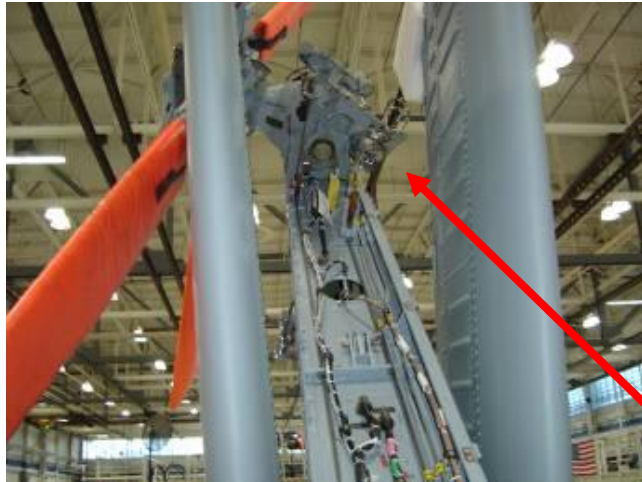
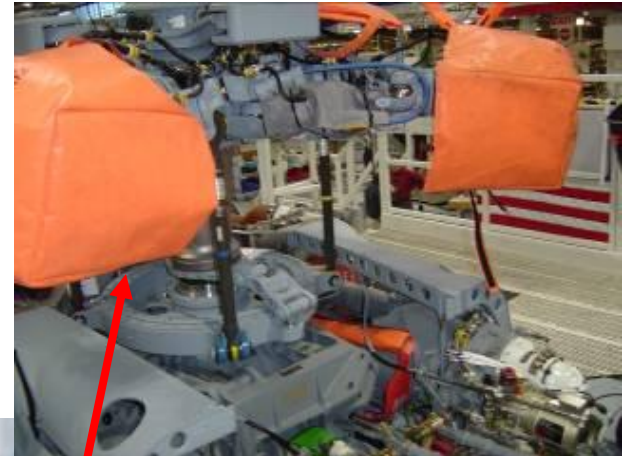
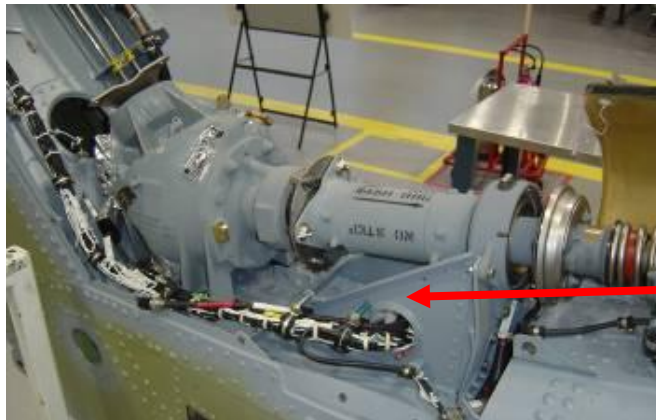
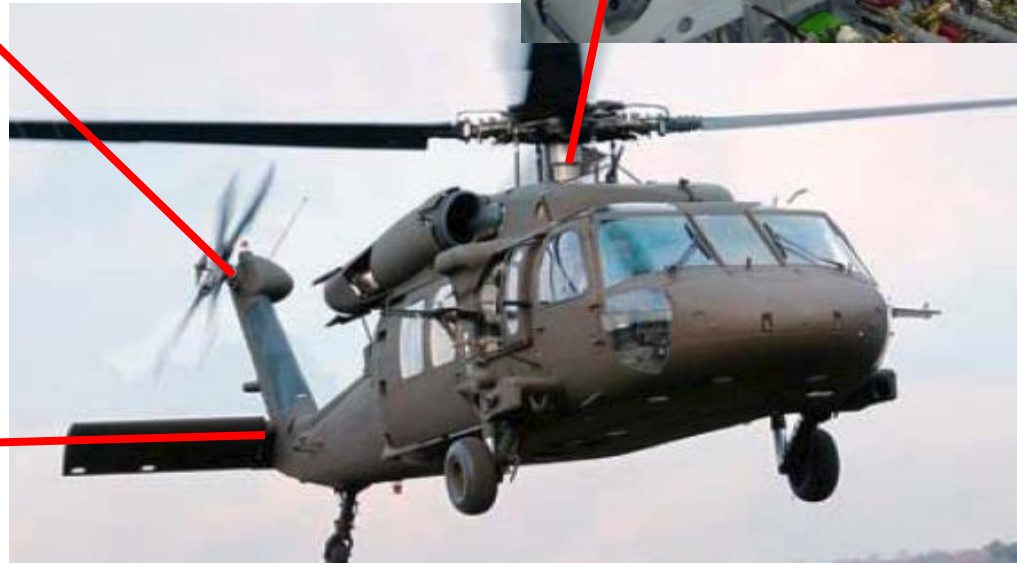
Examples of corrosion damage from service

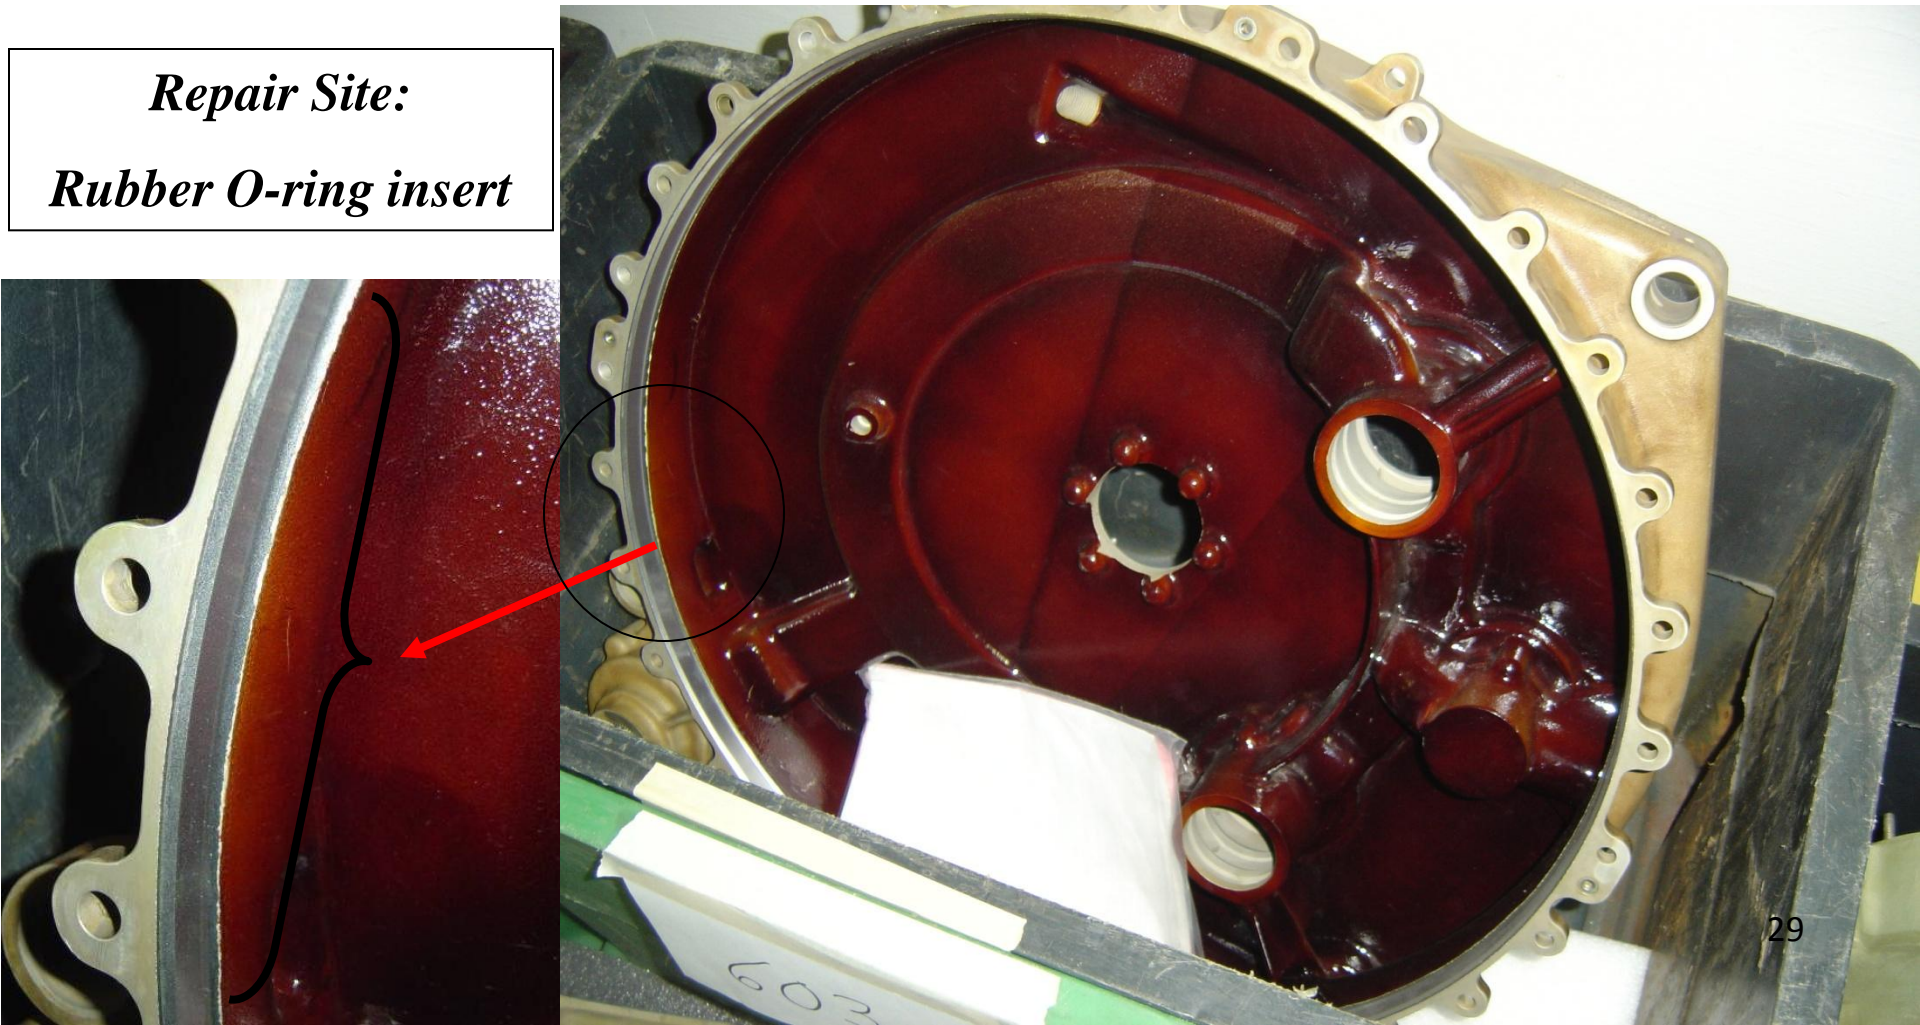
Repair Site:
Rubber O-ring insert

Sump Assembly Main Module

-Main Gearbox Repair

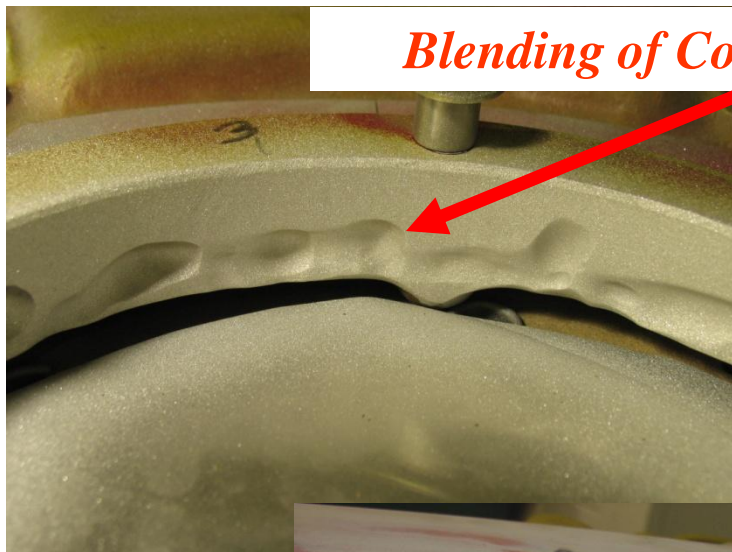
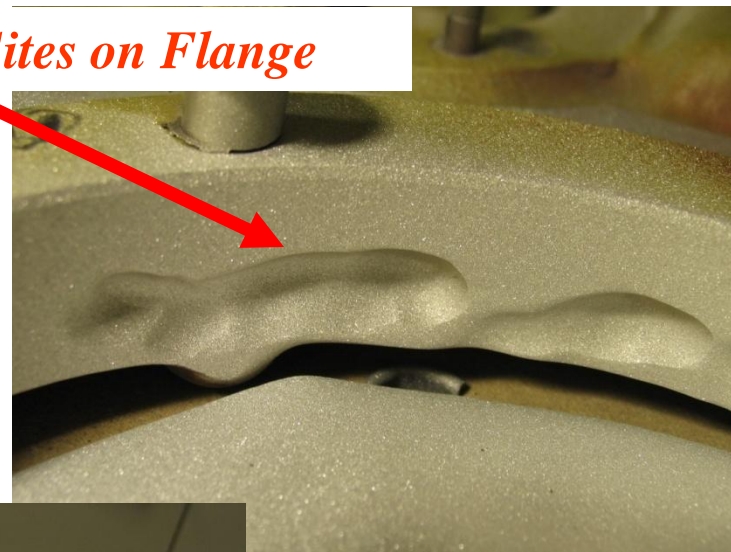
Blending of Corroded Sites on Flange

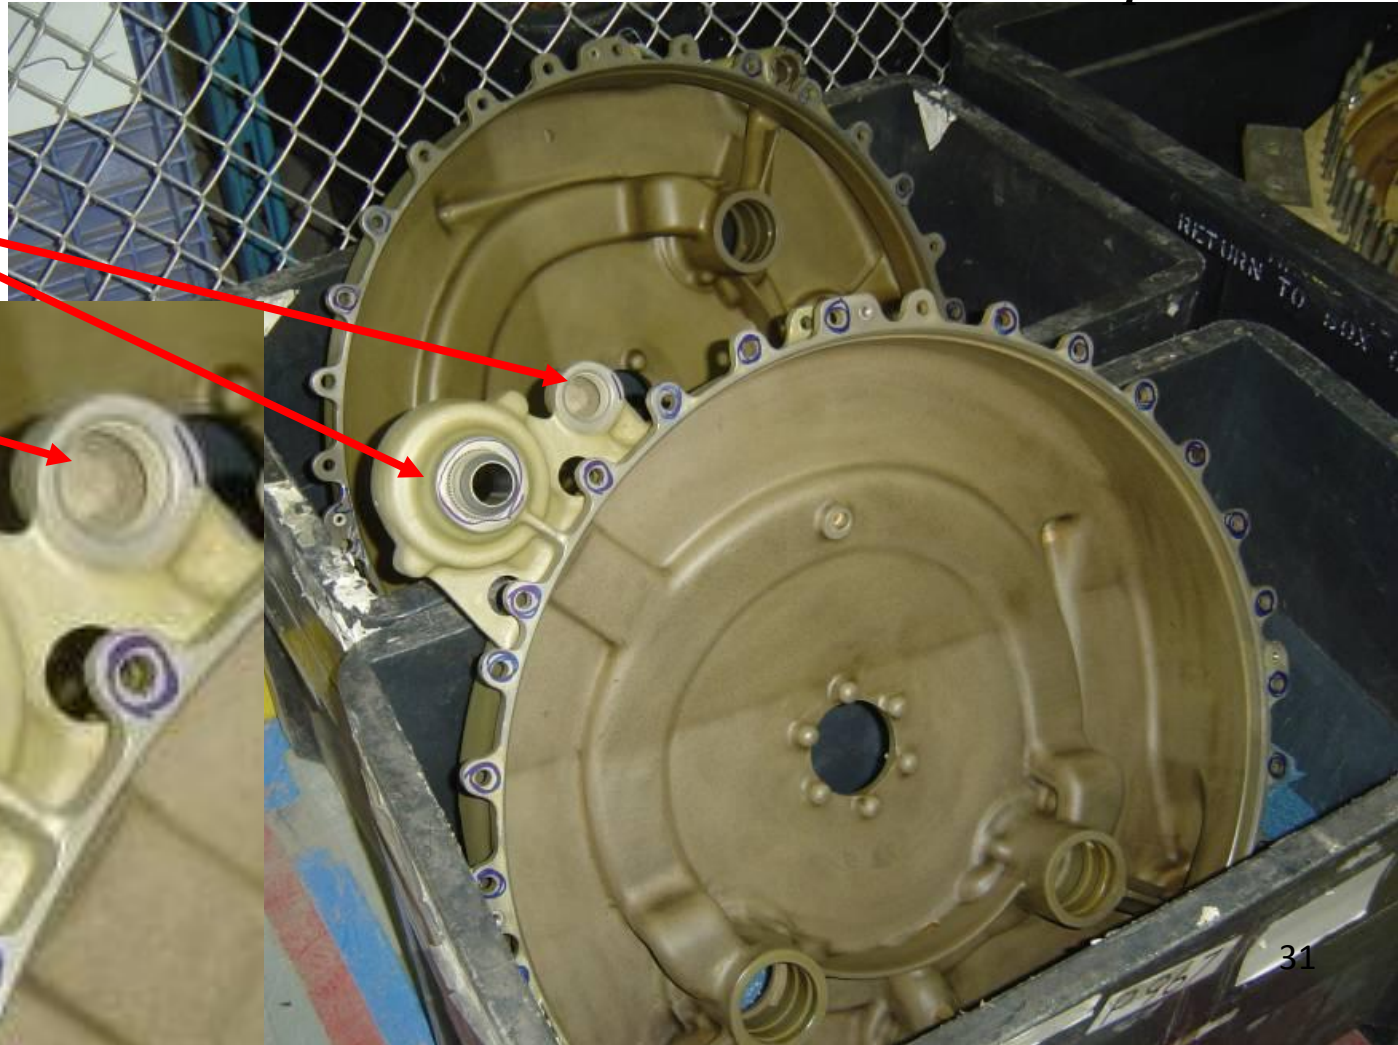
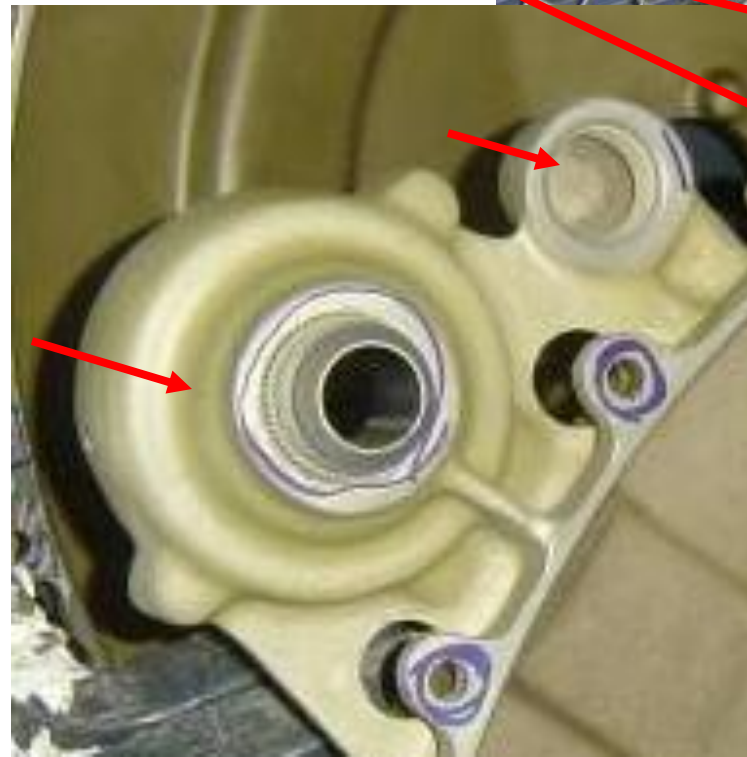
Filter Bowl Mount

Cavities collect water

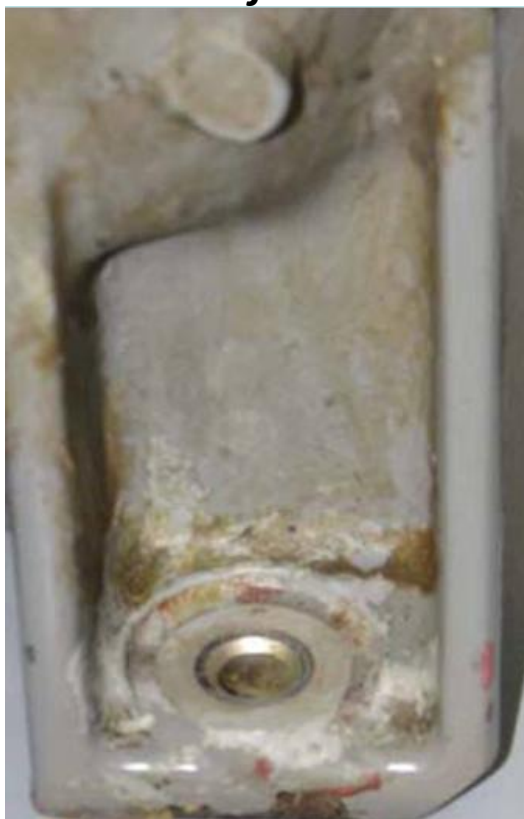
Before

Corrosion damage on the H-60 IGB is the leading cause of component removal

- Specifically, the corrosion occurs around the mounting pads. Inside areas as well as the bottom of the feet
- FY2009: Navy removed 23 corroded IGB from Service (82% of all removals)
- Component cost is \$45k
- 88 hours to remove, replace, and perform flight checks. Labor rate is \$36.95 hour
