# Qualification of the UH-60 Main Gearbox Sump – Progress to Date

**Robert Guillemette, M&P Engineering**  
**Jason Wu, M&P Engineering**  
**Wayne Petroskey, O&R Engineering**

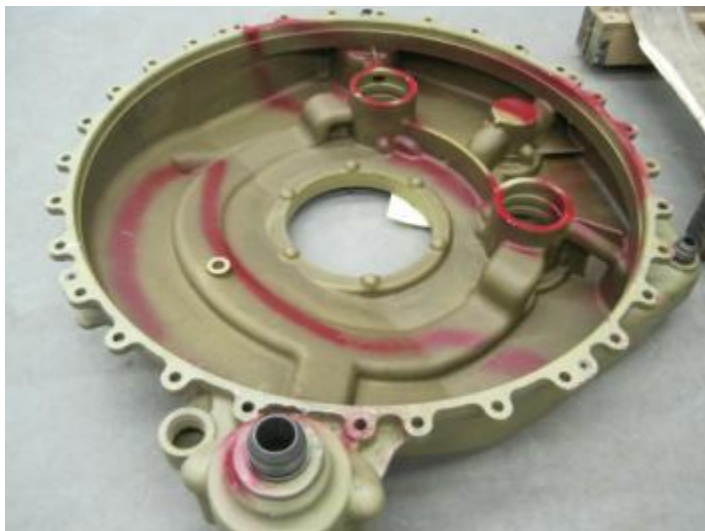
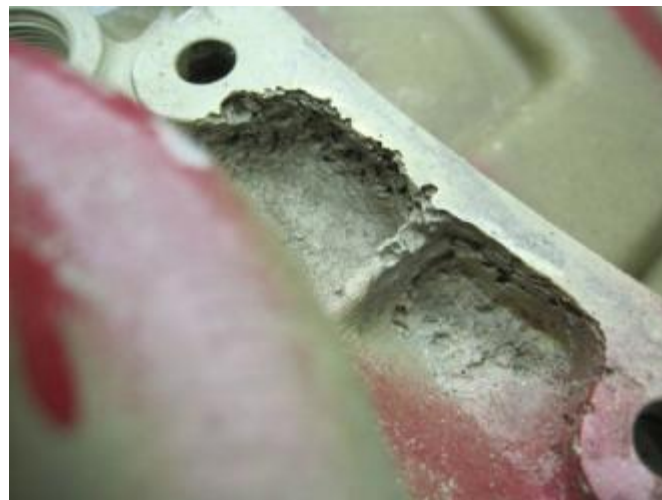
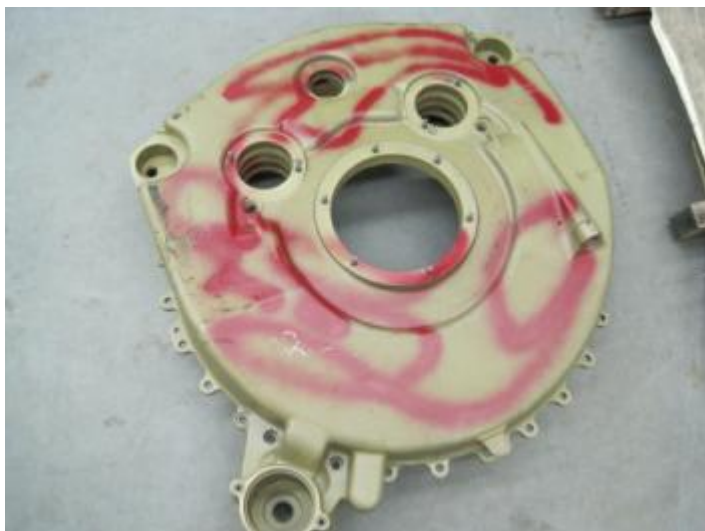
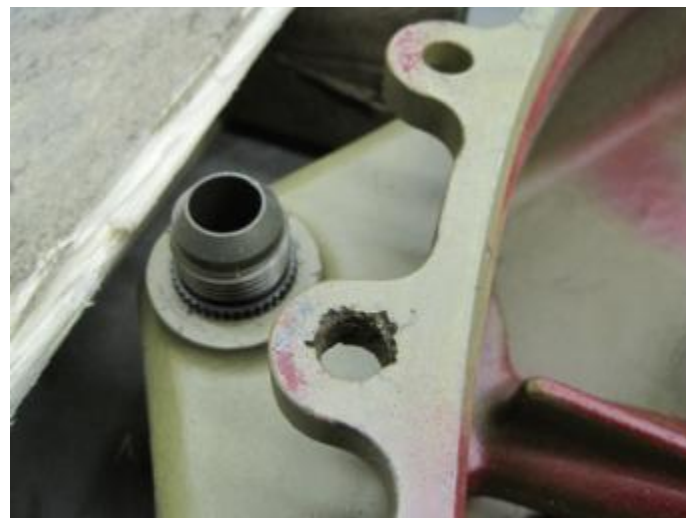
# Corrosion of Main Gearbox Sump

- Advantages over current HVOF repair of magnesium
  - No preheat of part
  - No post sealing of coating
- Limitations of HVOF
  - No exterior application
  - No feathering of coating
  - No coating of split lines
  - No bearing/shear loads
  - No recovery of strength from coating

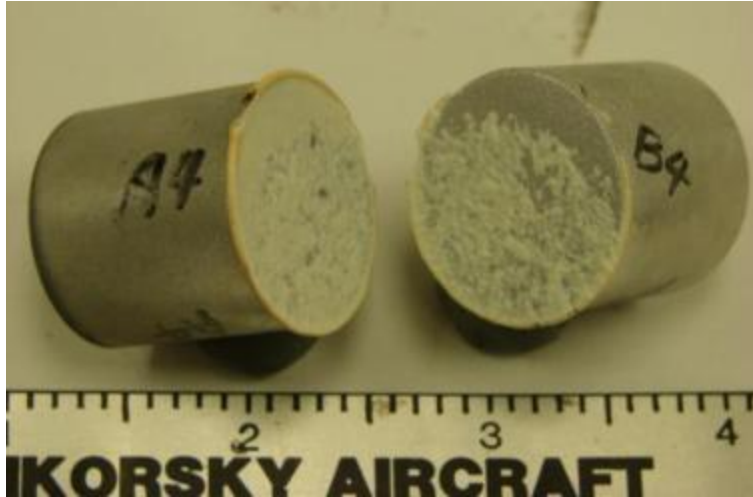
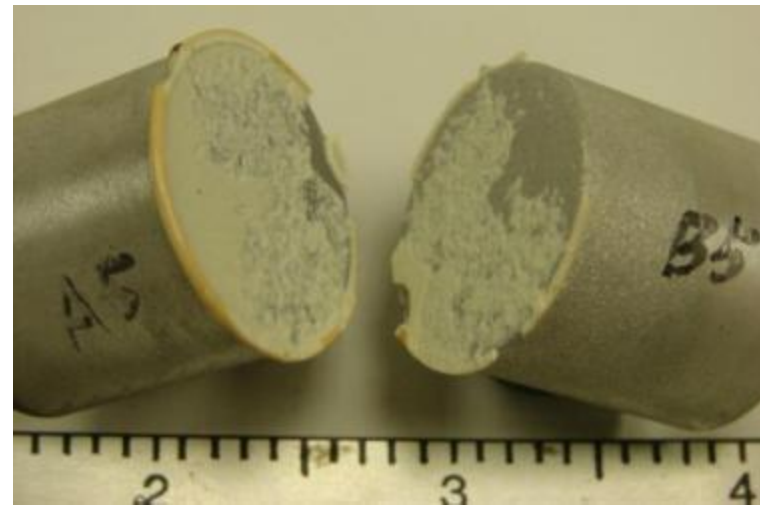
# Fracture Surfaces of Adhesion Test Coupons

Specimen #	Diameter (in)	Max load(lbs)	Adhesion Strength (ksi)	Failure Mode
A1-B1	1	6908	8.8	Fixture thread failure. Coating intact
A2-B2	1	7299	10.1	Fixture thread failure. Coating intact
A3-B3	1	6288	8.01	Fixture thread failure. Coating intact
A4-B4	1	8293	10.56	Glue failure (85% mode 2+15% mode 1)
A5-B5	1	9306	11.85	Glue failure (75% mode 2+25% mode 1)
A6-B6	1	9118	11.61	Glue failure+ partially coating failure (30% mode 5+25% mode 1+45% mode 2)

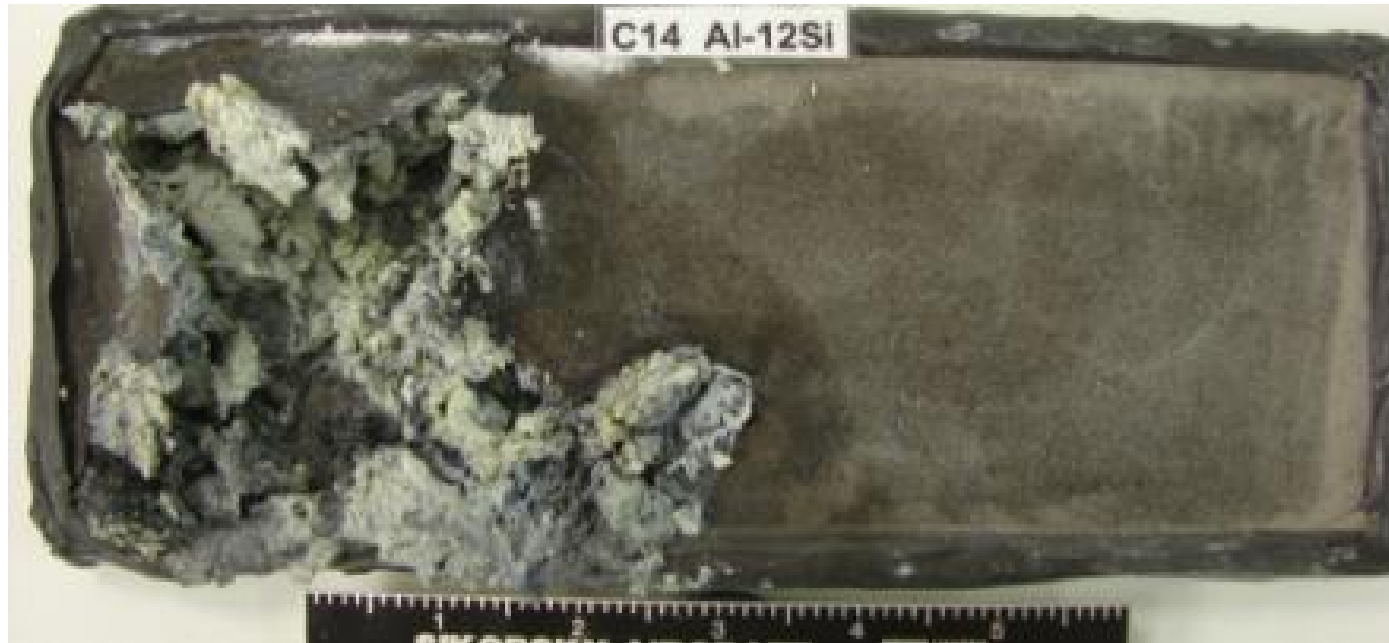
# HVOF Al-12Si after 500hrs ASTM B 117

HVOF Al-12Si coating specimens at 500 hours. Coating cracking at 320 hours at C14 panel and peel-off at 365 hours

Coating	Panel ID	Corrosion Migration rating per ASTM D1654*	Maximum Corrosion Damage Depth (inch)	The Percentage of Original Scribe Lines Corroded	Weight Loss after 500 Hours (g)***
HVOF Al-12Si	C13	1	0.57	100%	27.13
	C14	0	0.42	100%	30.12
	C16	2	0.36	100%	**
Cold Spray CP-Al	C18	5	0.31	27%	**
	C21	6	0.27	35%	2.38
	C22	6	0.3	31%	3.45

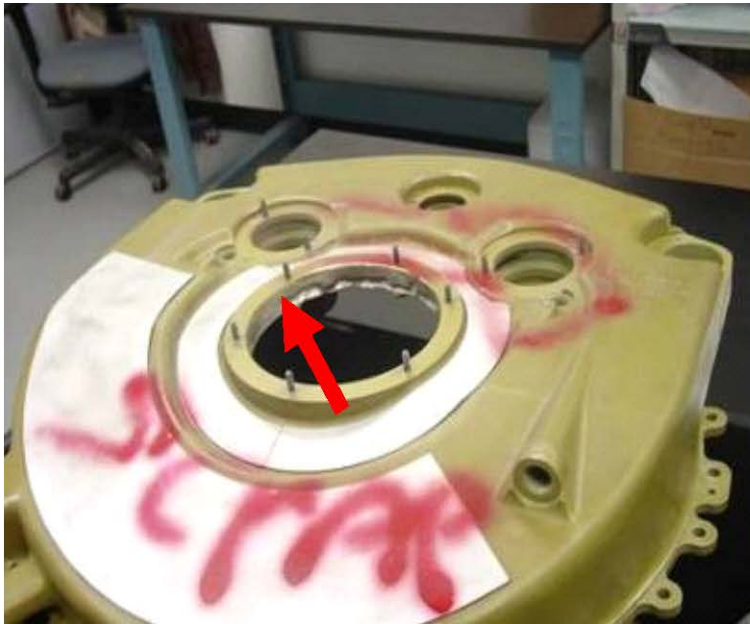
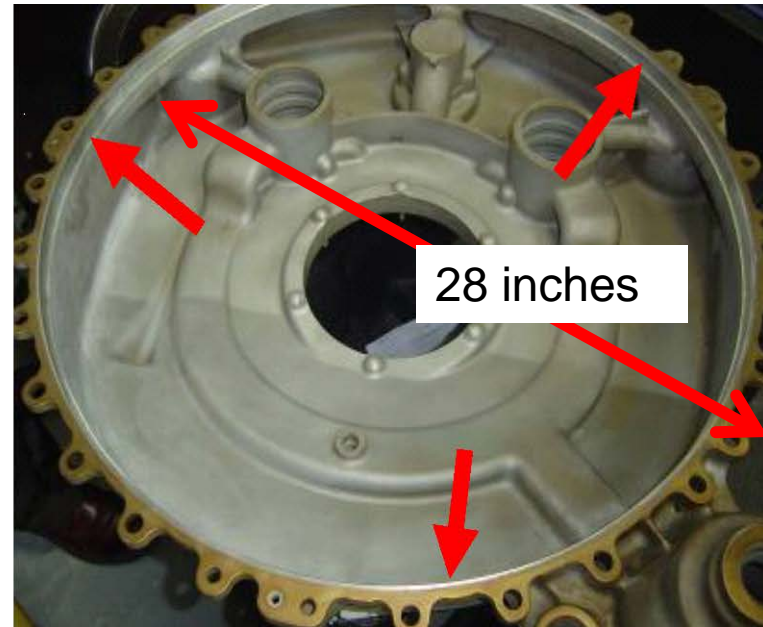
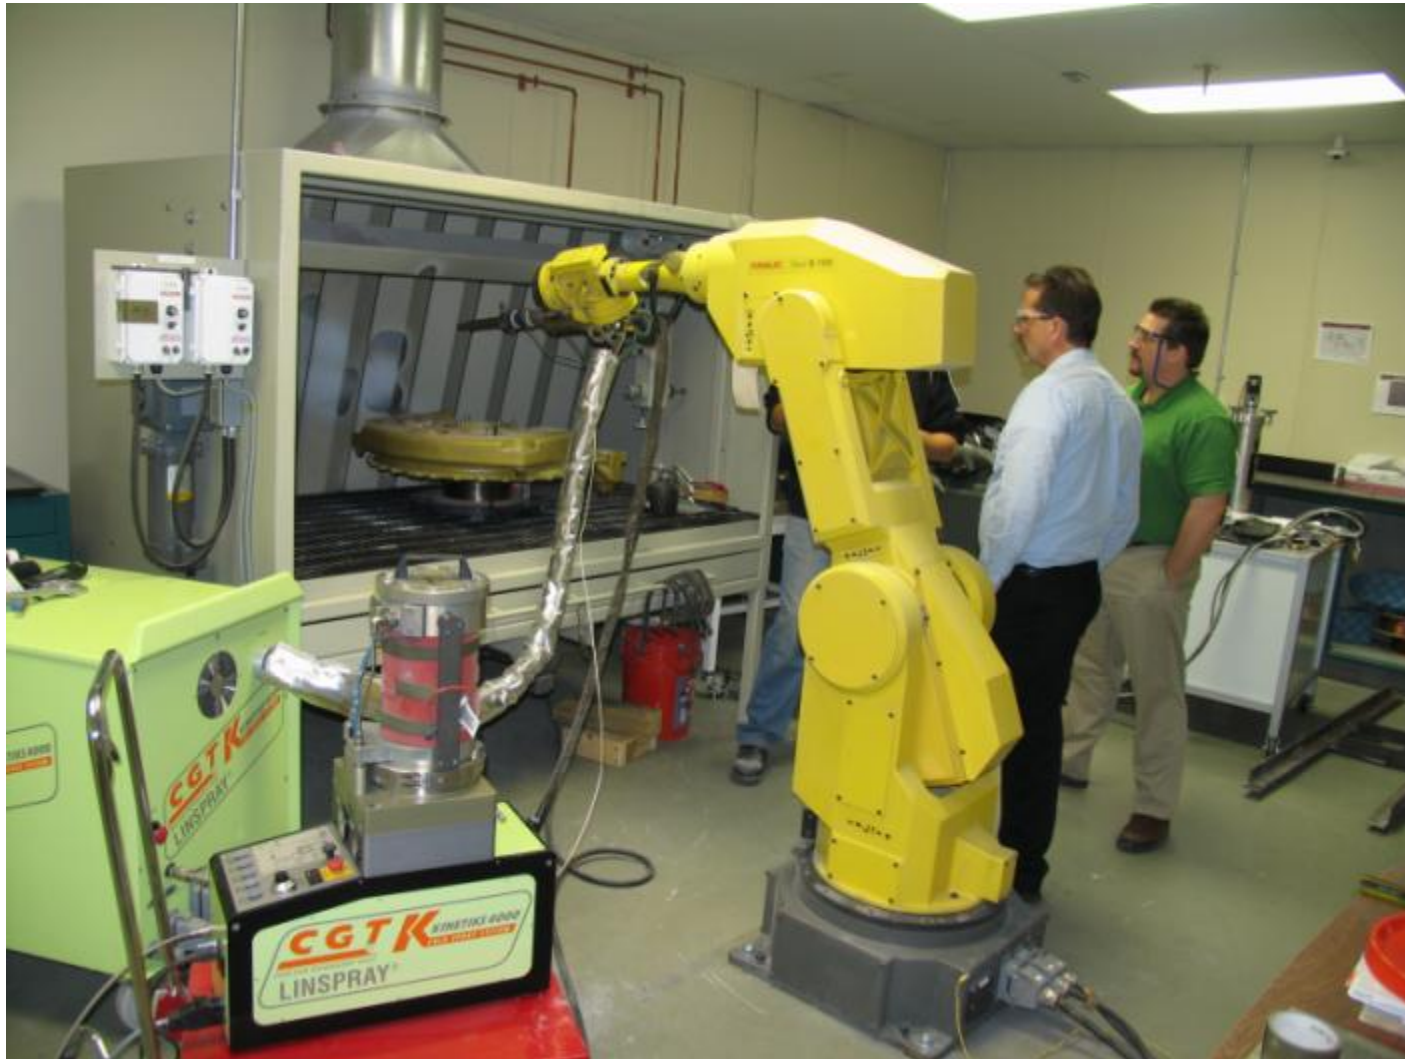
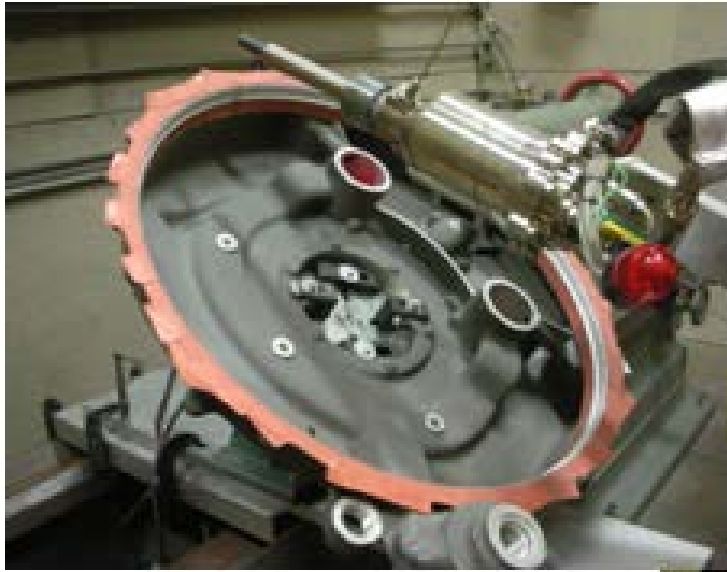
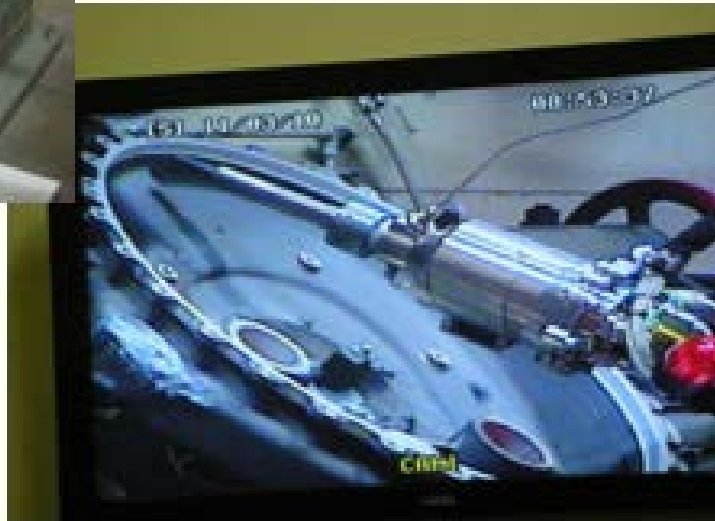
# Cold Spray of H-60 MGB Sump

- Visual examination showed a uniform coating with no cracking, pitting or chipping
- Metallurgical evaluation showed same coating microstructure and bond line integrity as test coupons (ARL sump)

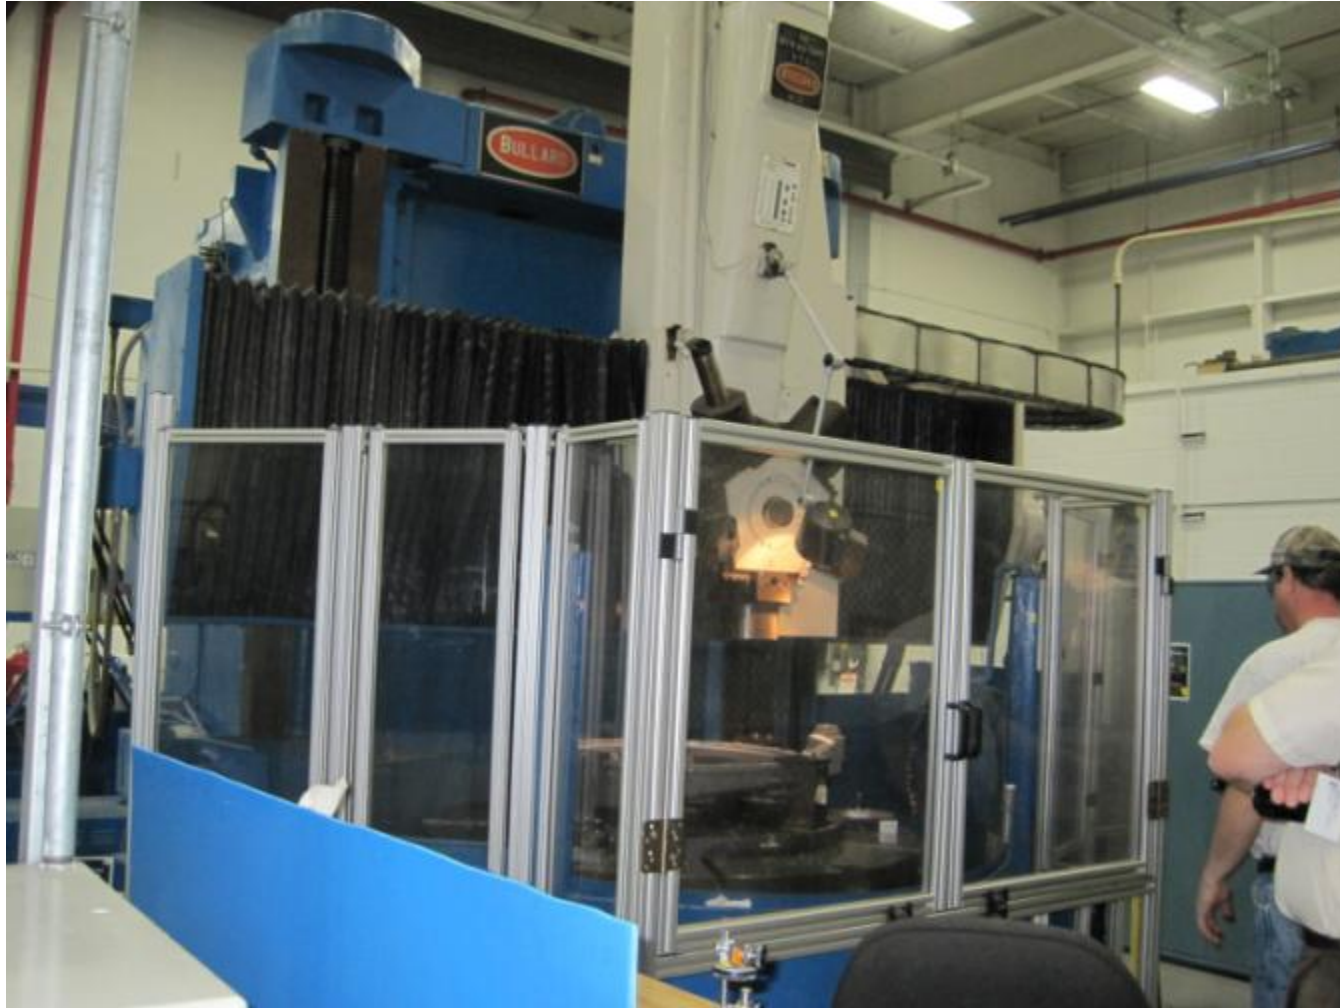
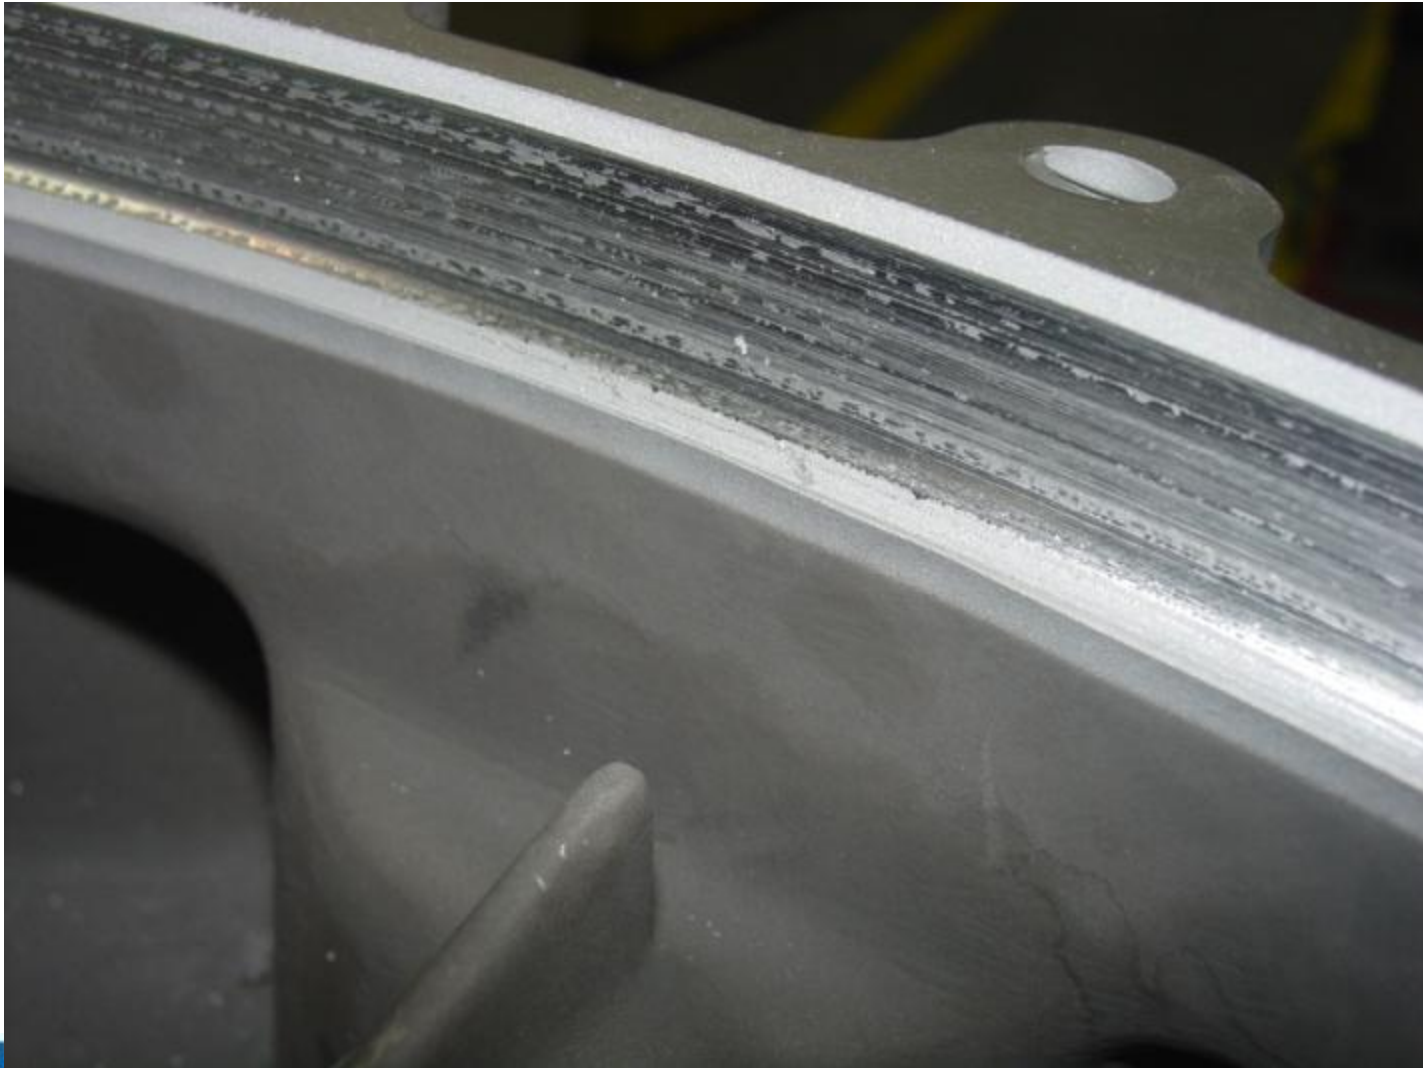
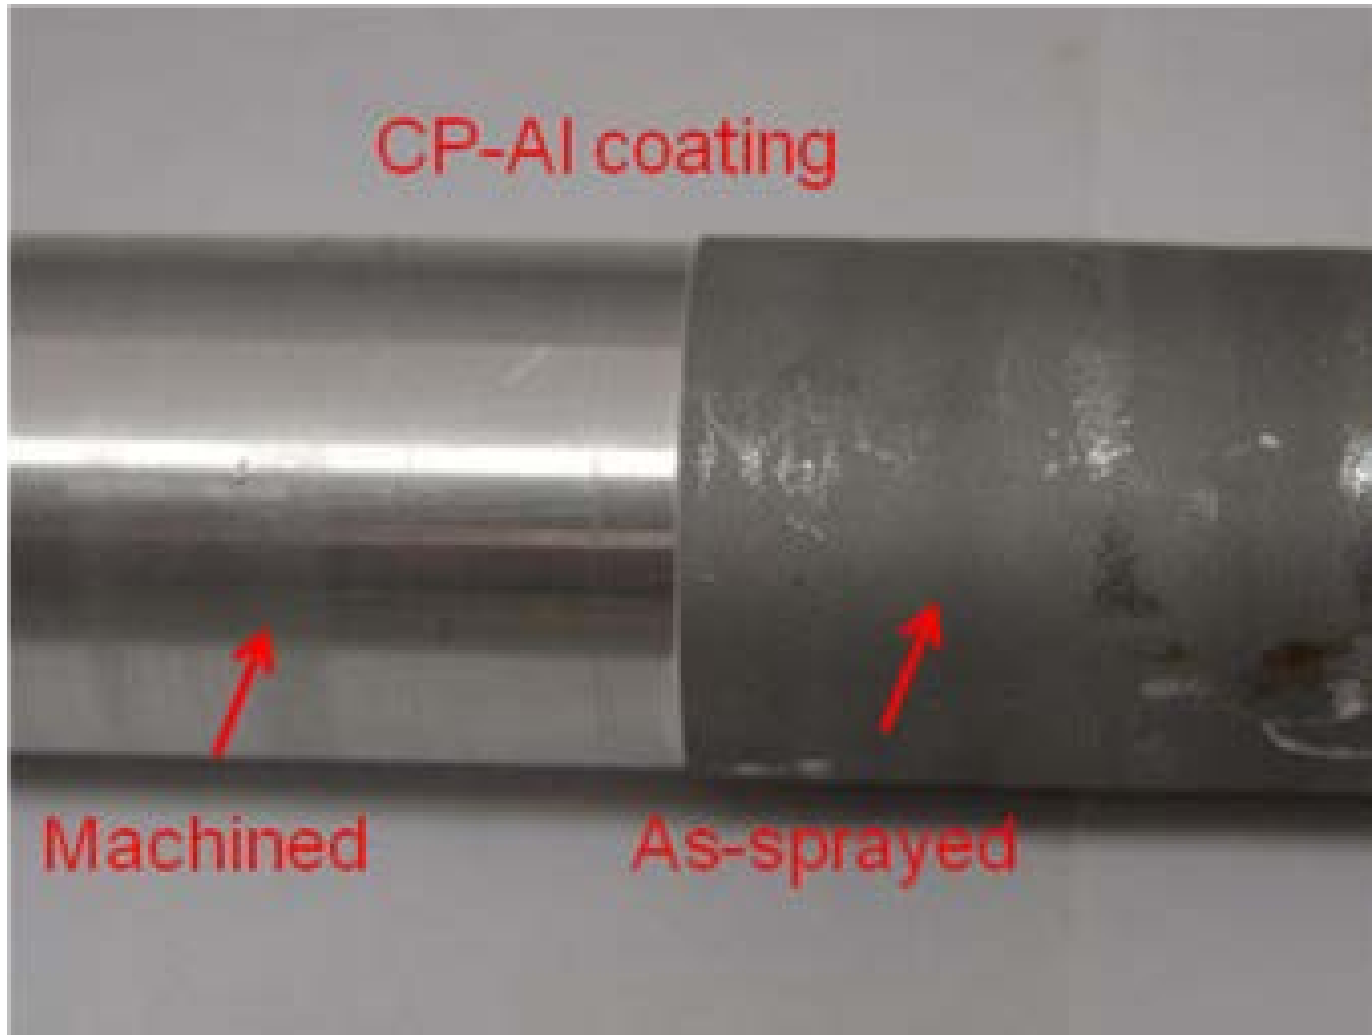
# Machining of CS CP AI MGB Sump

- Witnessed no peeling, flaking or chipping during machining
- Not a drop in for current HVOF coating
- Machining parameters optimization in progress
