Fleet Readiness Center Southwest

Production Cold Spray Repairs for NAVAIR

Cold Spray Action Team (CSAT) Event

Date: June 19, 2018

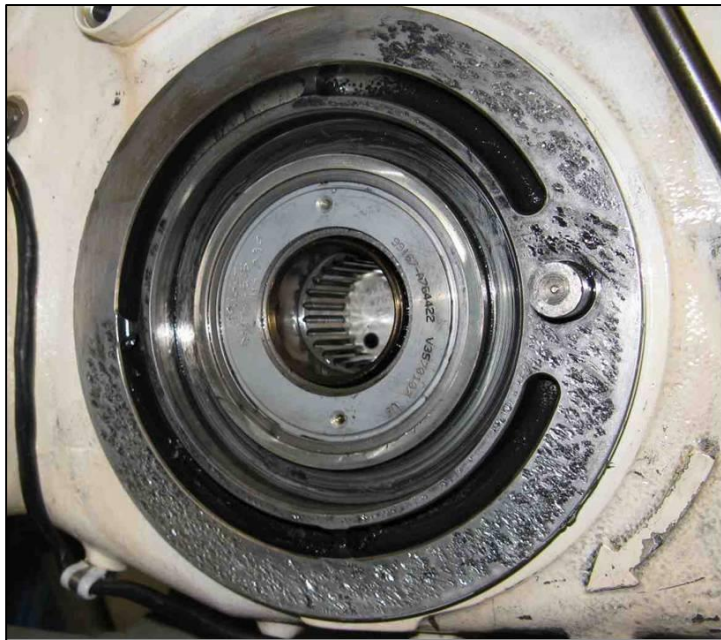
Repair: Fretting damage to sealing surface

Fretting Damage

Repair Type: Dimensional restoration

Powder: 7075 Aluminum with Nickel

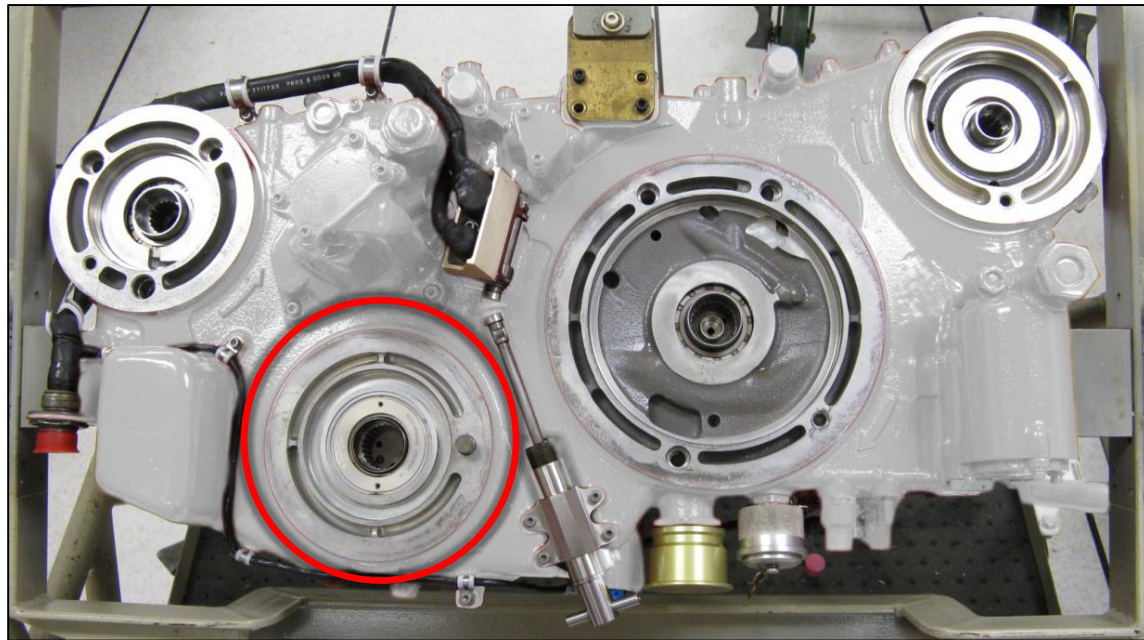
After Repair

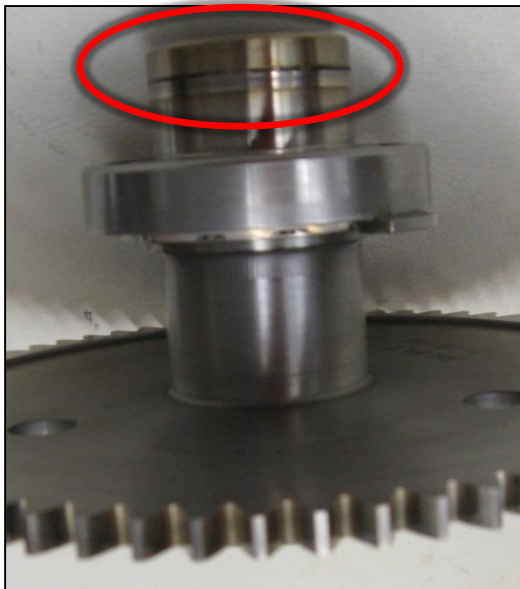
Repair: Wear damage to sealing surface

Damaged Seal Surface

Repair Type: Dimensional restoration

Powder: Tungsten Carbide Cobalt

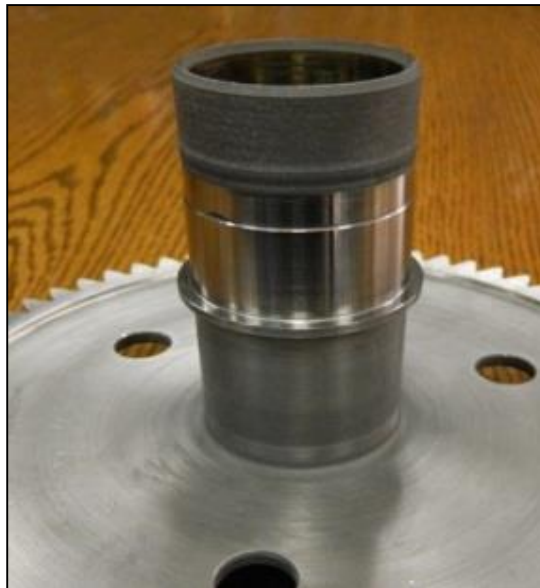
After Cold Spray

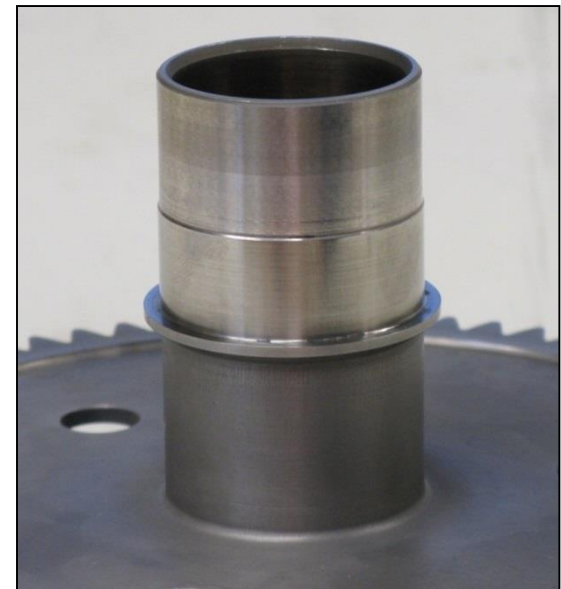
Restored Seal Surface

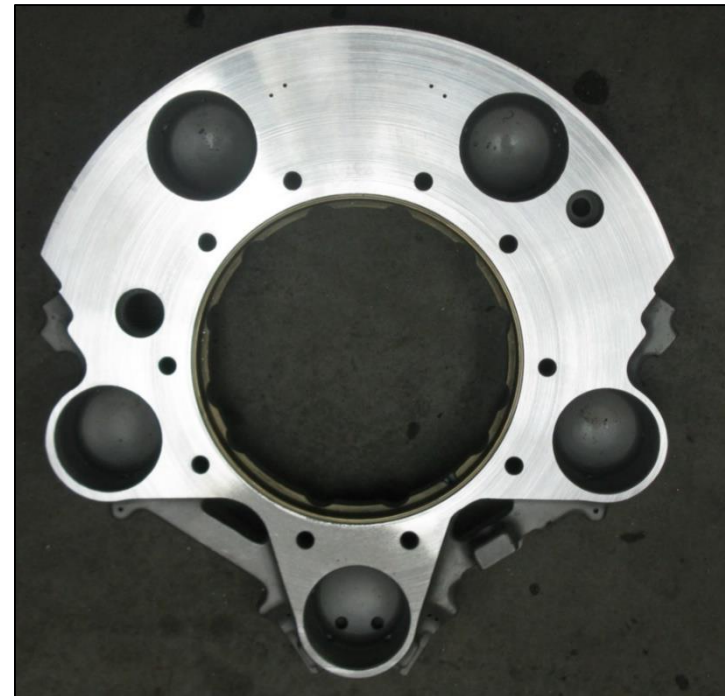
After Repair

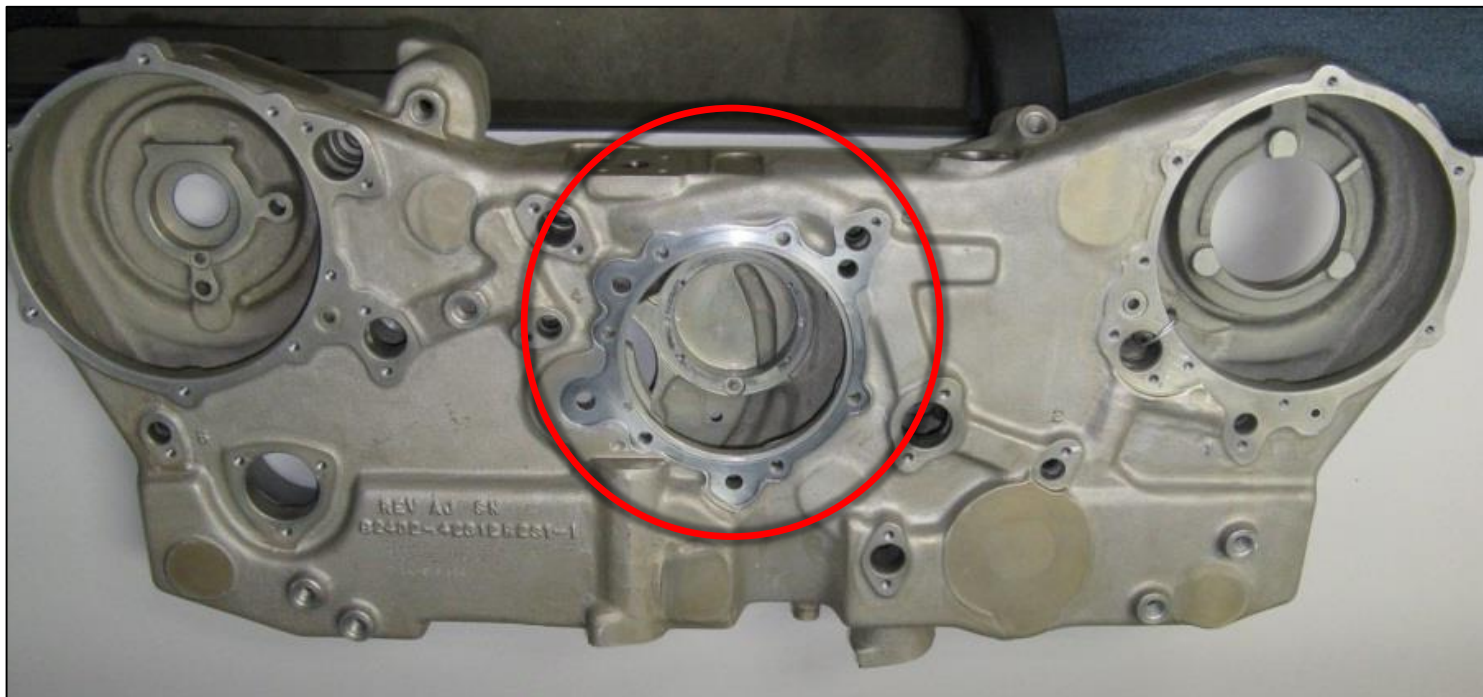
Repair: Fretting damage

After Repair

Repair Type: Dimensional restoration

Powder: 7075 Aluminum with Nickel

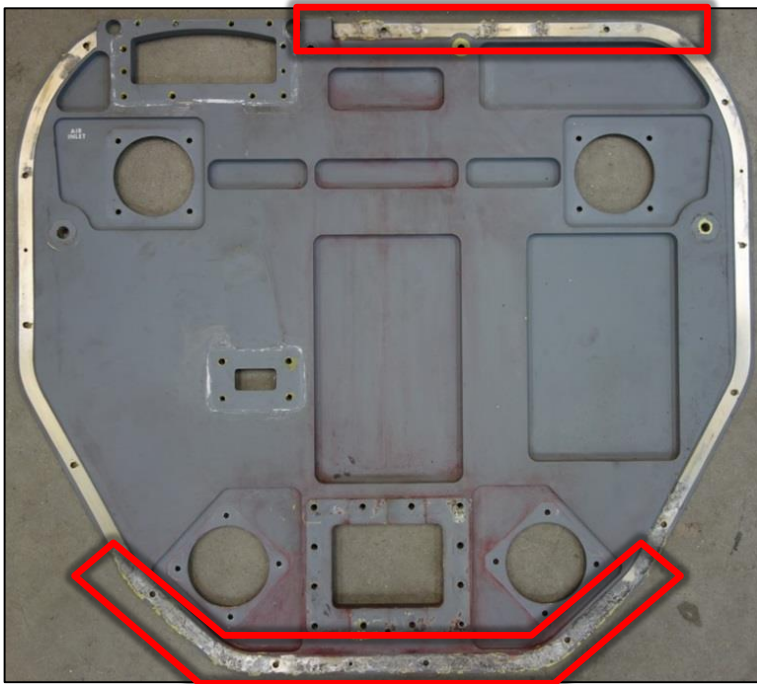
Repair: Corrosion damage

Corrosion Damage

Repair Type: Dimensional restoration

Powder: Aluminum with Chrome

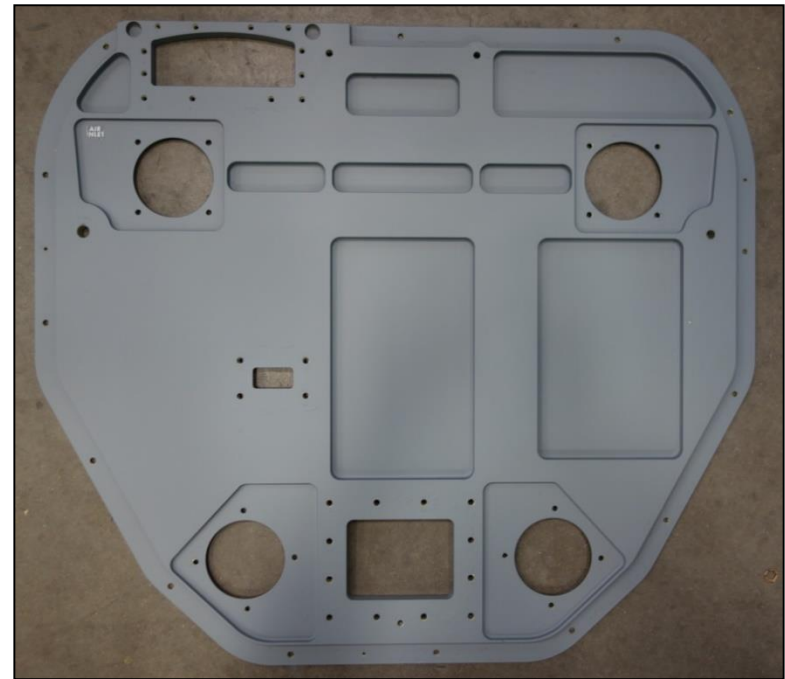
After Repair

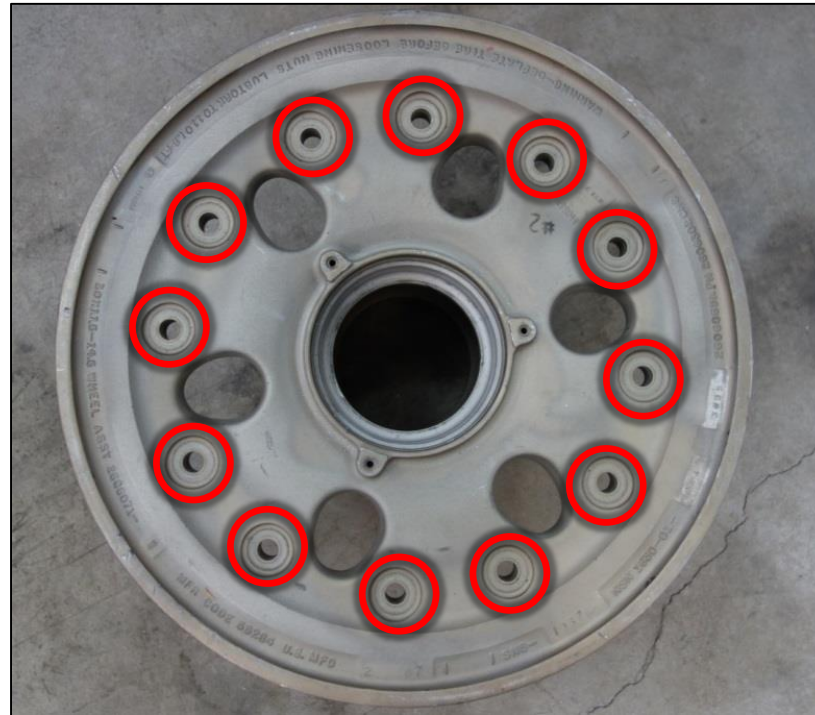
Repair: Mechanical/corrosion damage

Before Repair

Repair Type: Dimensional restoration

Powder: Aluminum with Chrome

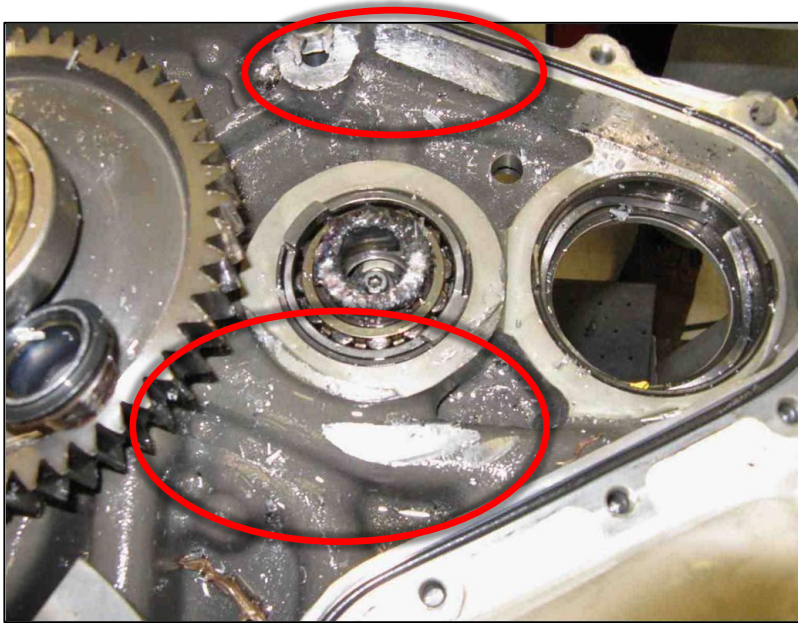
Repair: Mechanical damage

Mechanical Damage

Repair Type: Dimensional restoration

Powder: Aluminum with Chrome

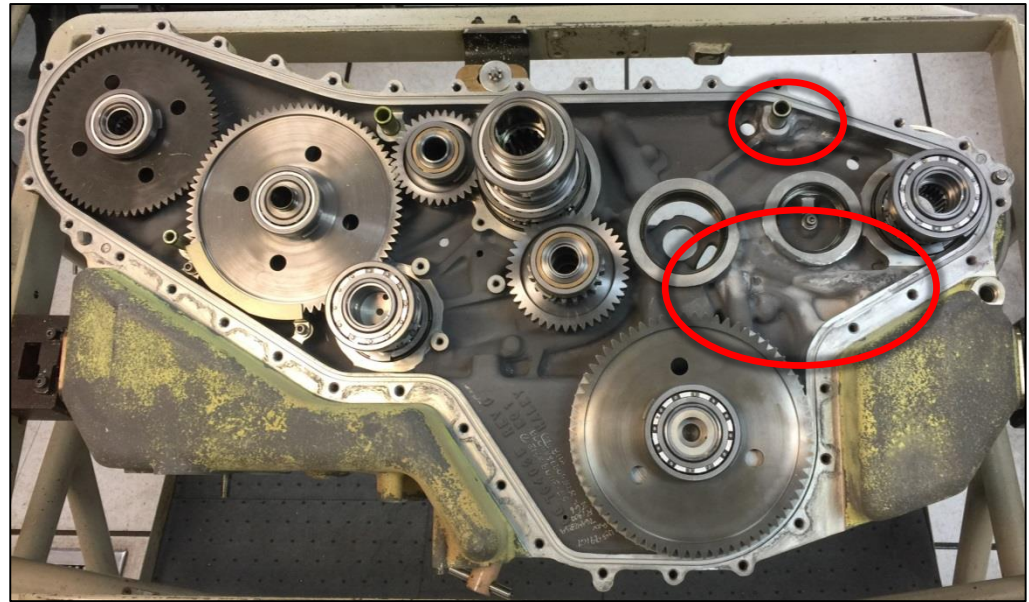
After Repair
