Cold Spray Repairs of Aircraft, Engine and Rotorcraft Components Using a Proven NOT Novel Technology

June 25, 26, 2019

Walter Mroch, President and FAA Consultant DER

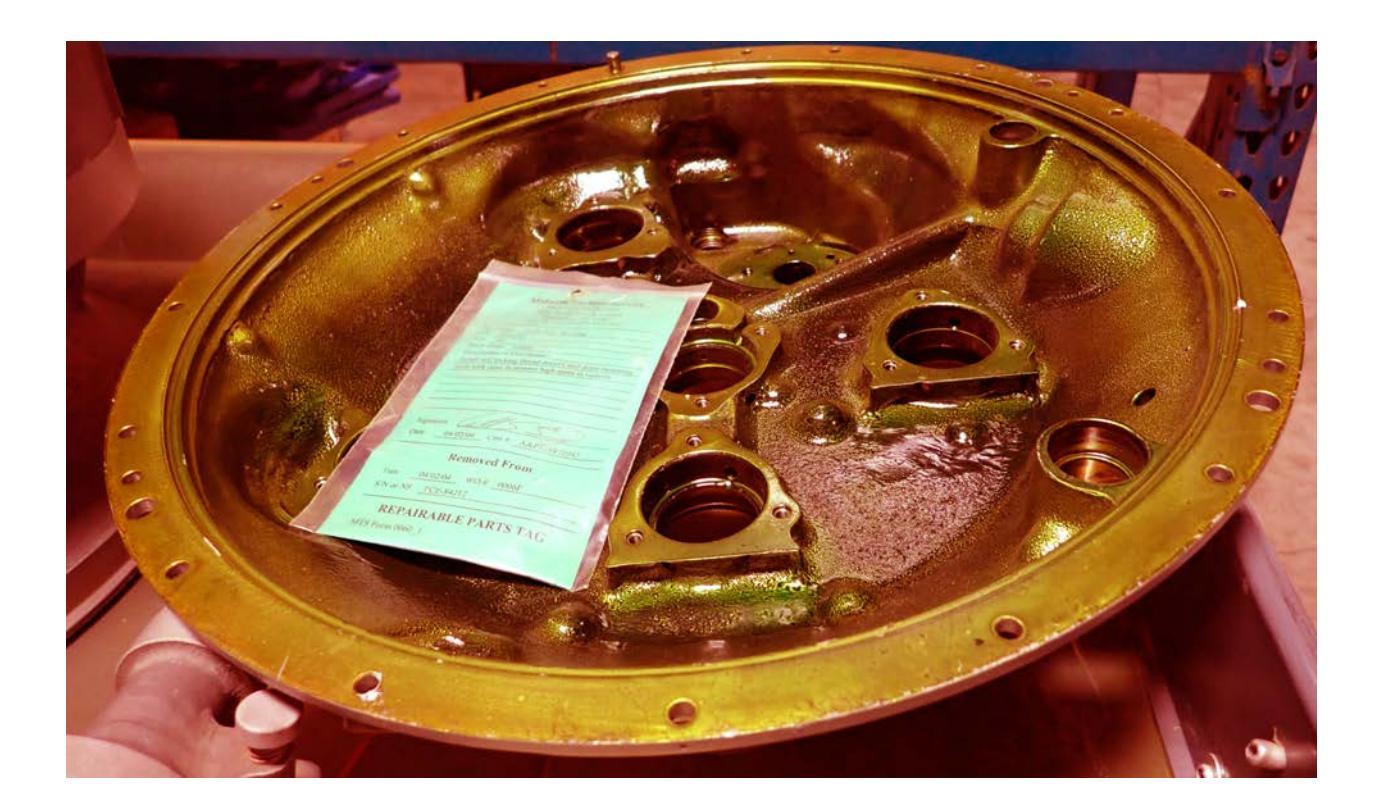
BUT FORTUNATELY MANY ARE GOOD DUE TO POORLY DESIGNED REPAIRS.... WHILE THIS SIDE OF THIS DIAPHRAGM LOOKS PERFECTLY GOOD AFTER REPAIR IT COULDN'T HANDLE EVEN A SIMPLE BAKE TO CURE TO THE PAINT

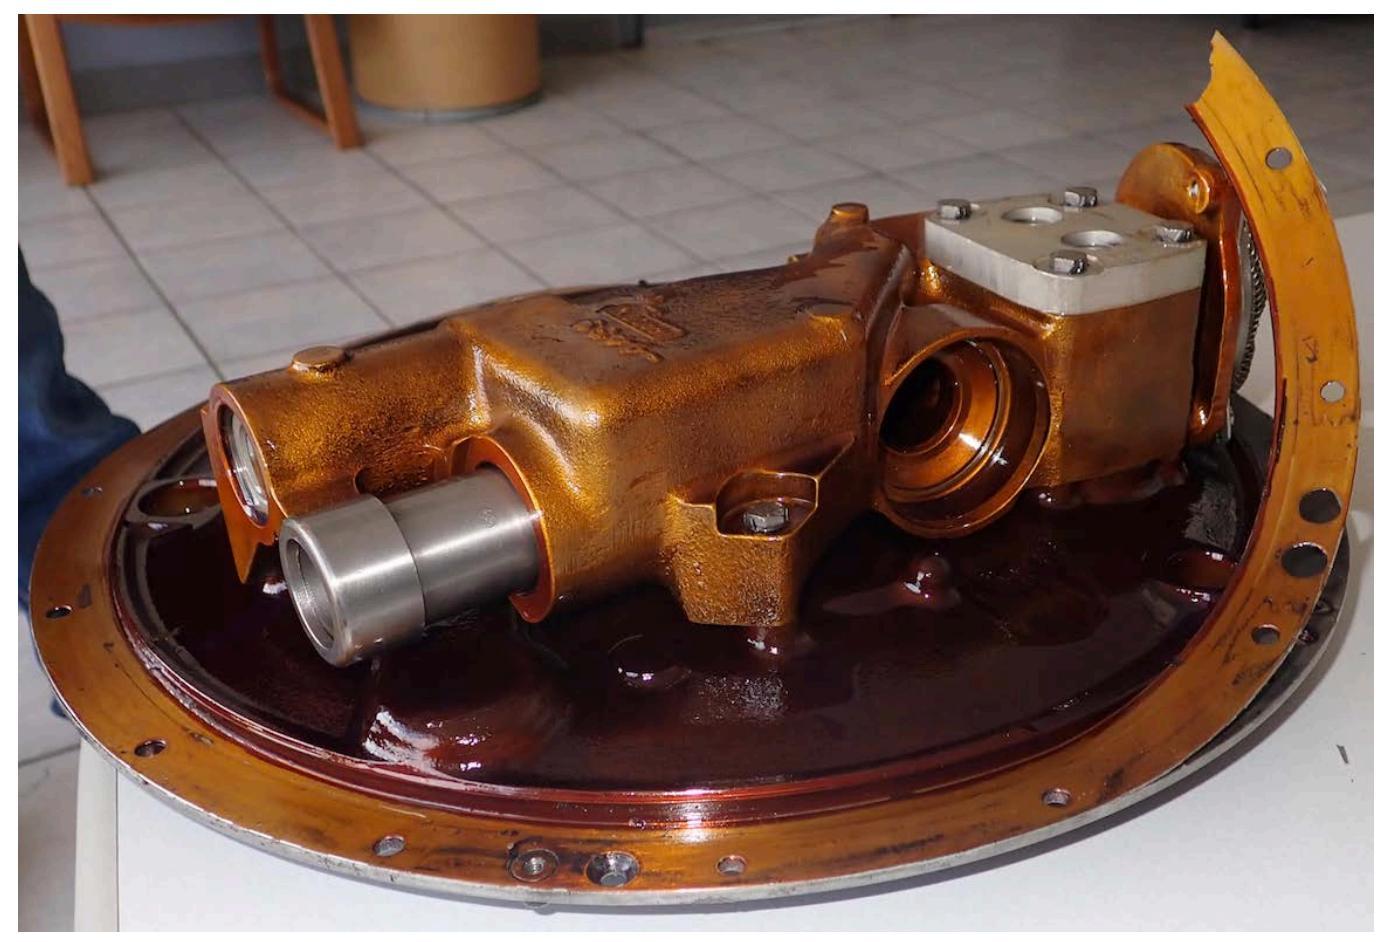
THE OPPOSITE SIDE OF THE DIAPHRAGM. PLASMA SPRAY ALREADY LIFTING BEFORE IT WAS EVEN IN SERVICE - INSTALLED ON AN ENGINE

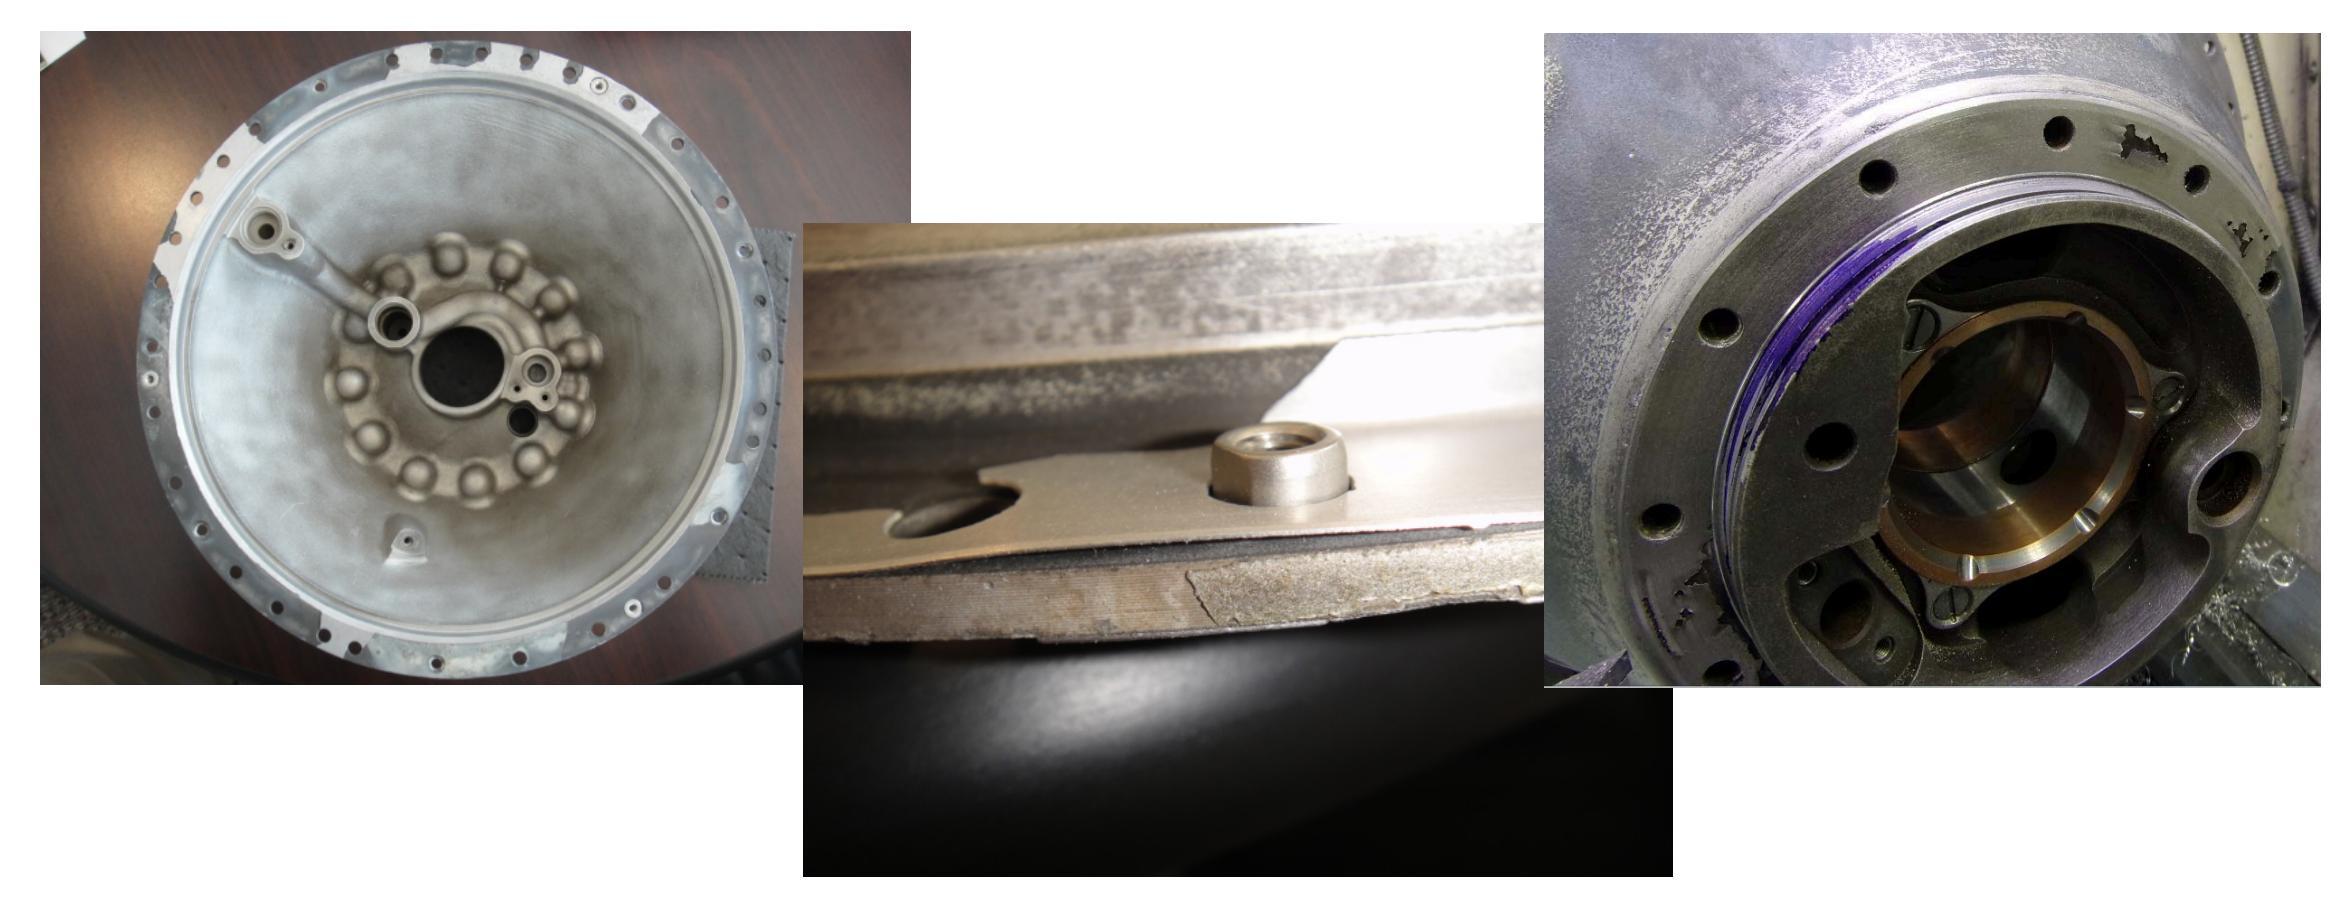
ANOTHER EXAMPLE OF PLASMA SPRAY FAILURE

THIS REPAIR WAS HALTED BY PWC DUE TO ITS INHERENT PERFORMANCE PROBLEMS

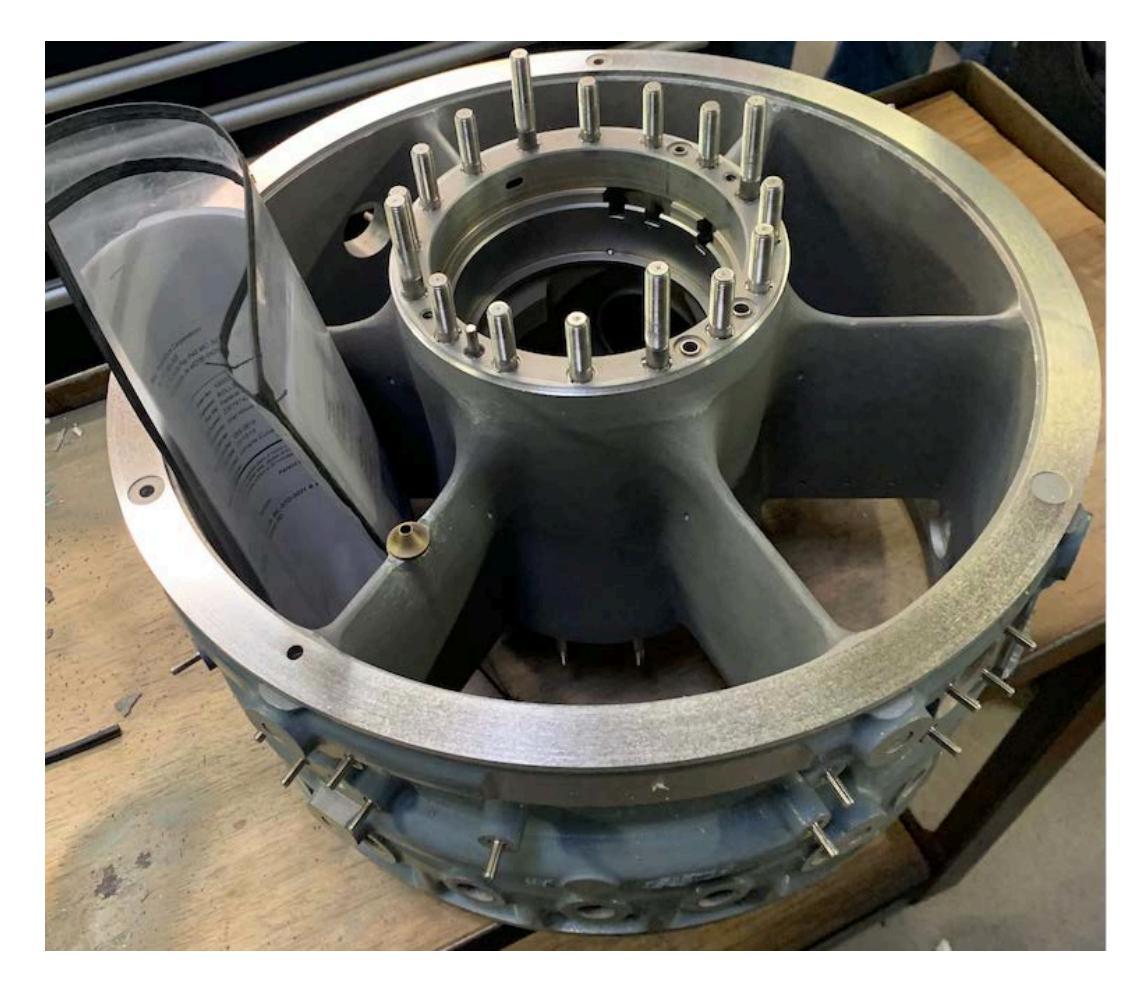
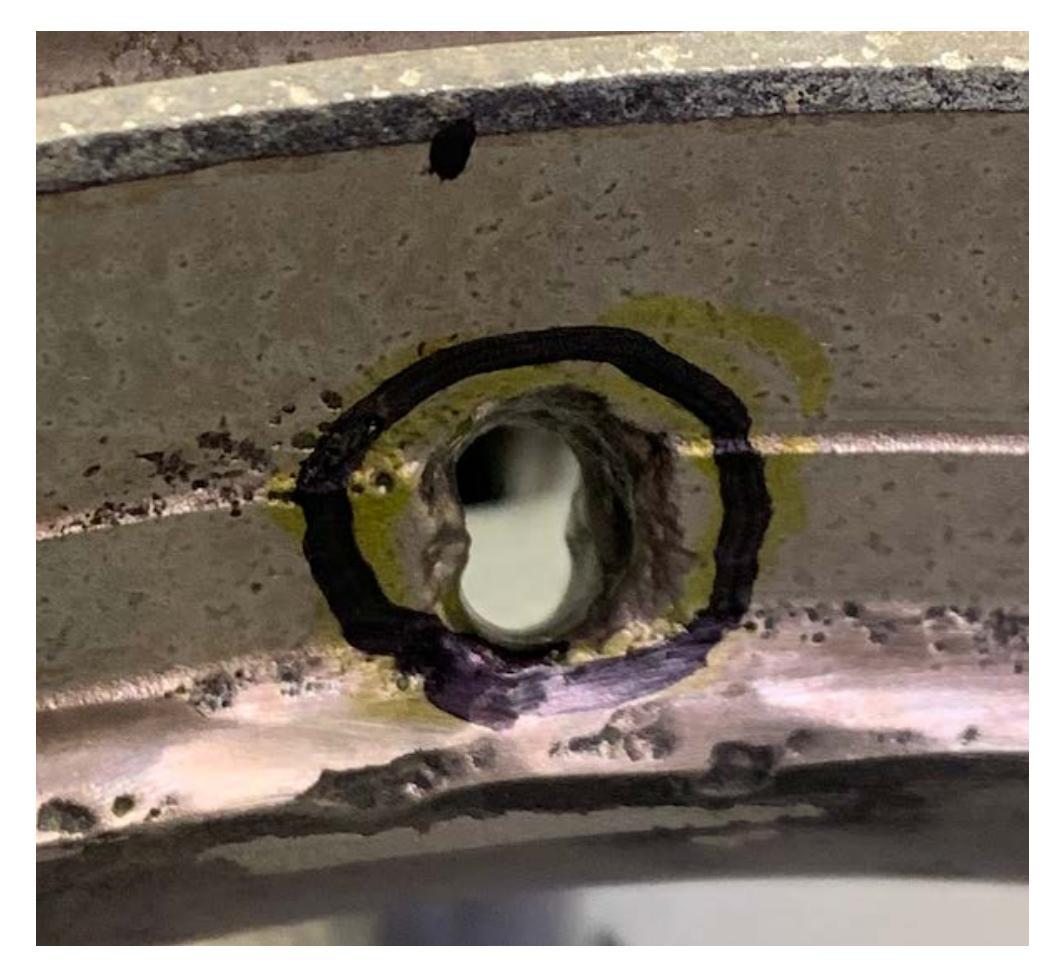
Cold Spray Action Team **2019 INCOMPACTOR ANOTHER EXAMPLE OF PLASMA SPRAY MISAPPLICATION**

AFTER PLASMA REMOVAL A FILLER WAS FOUND AND REMOVED REVEALING A CASE DRAIN WHICH HAD BEEN COMPLETELY COVERED

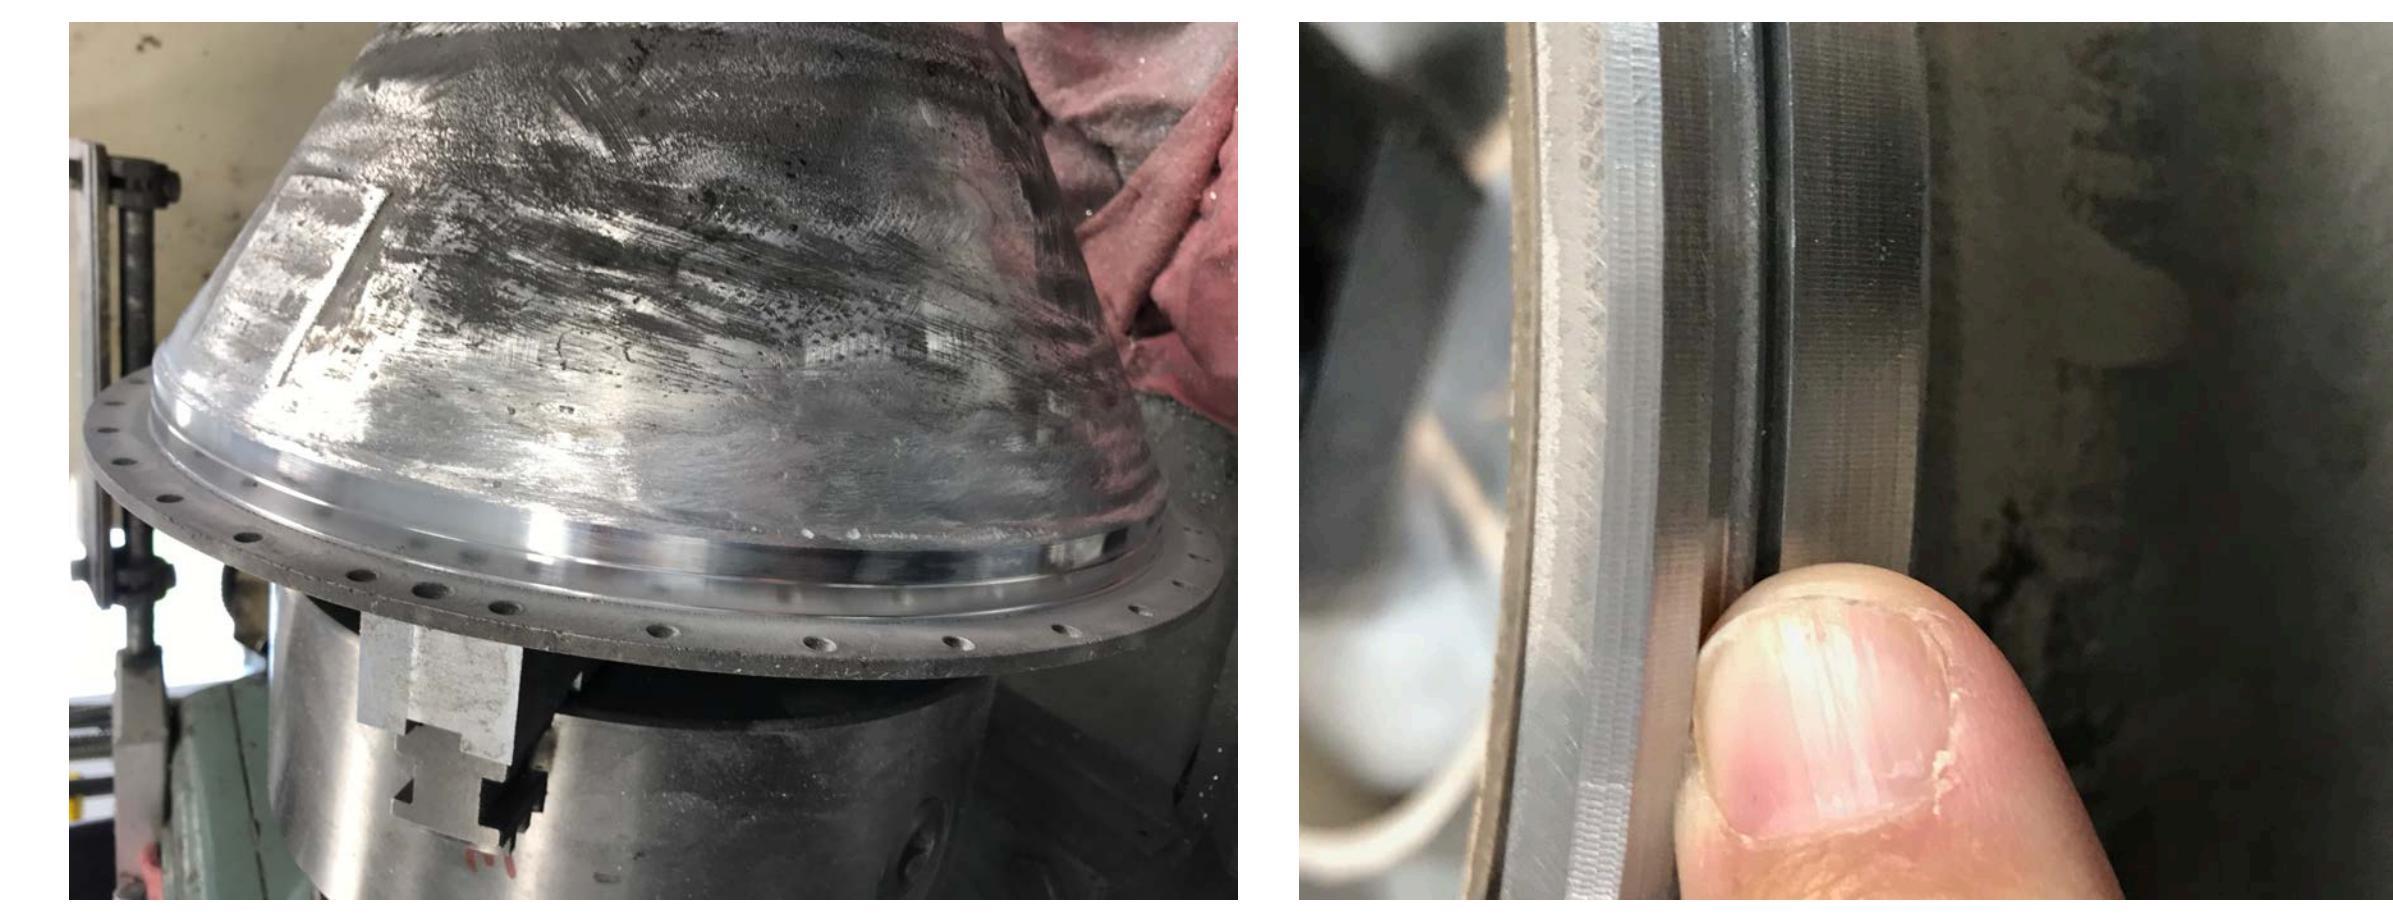
FINISHED FEATURES AFTER COLD SPRAY AND MACHINING OPERATIONS

FINISH MACHINED RGB FLANGE AND SIDE

FINISHED OD AND SEAL GROOVE ON AIH

DER APPROVED REPAIRS

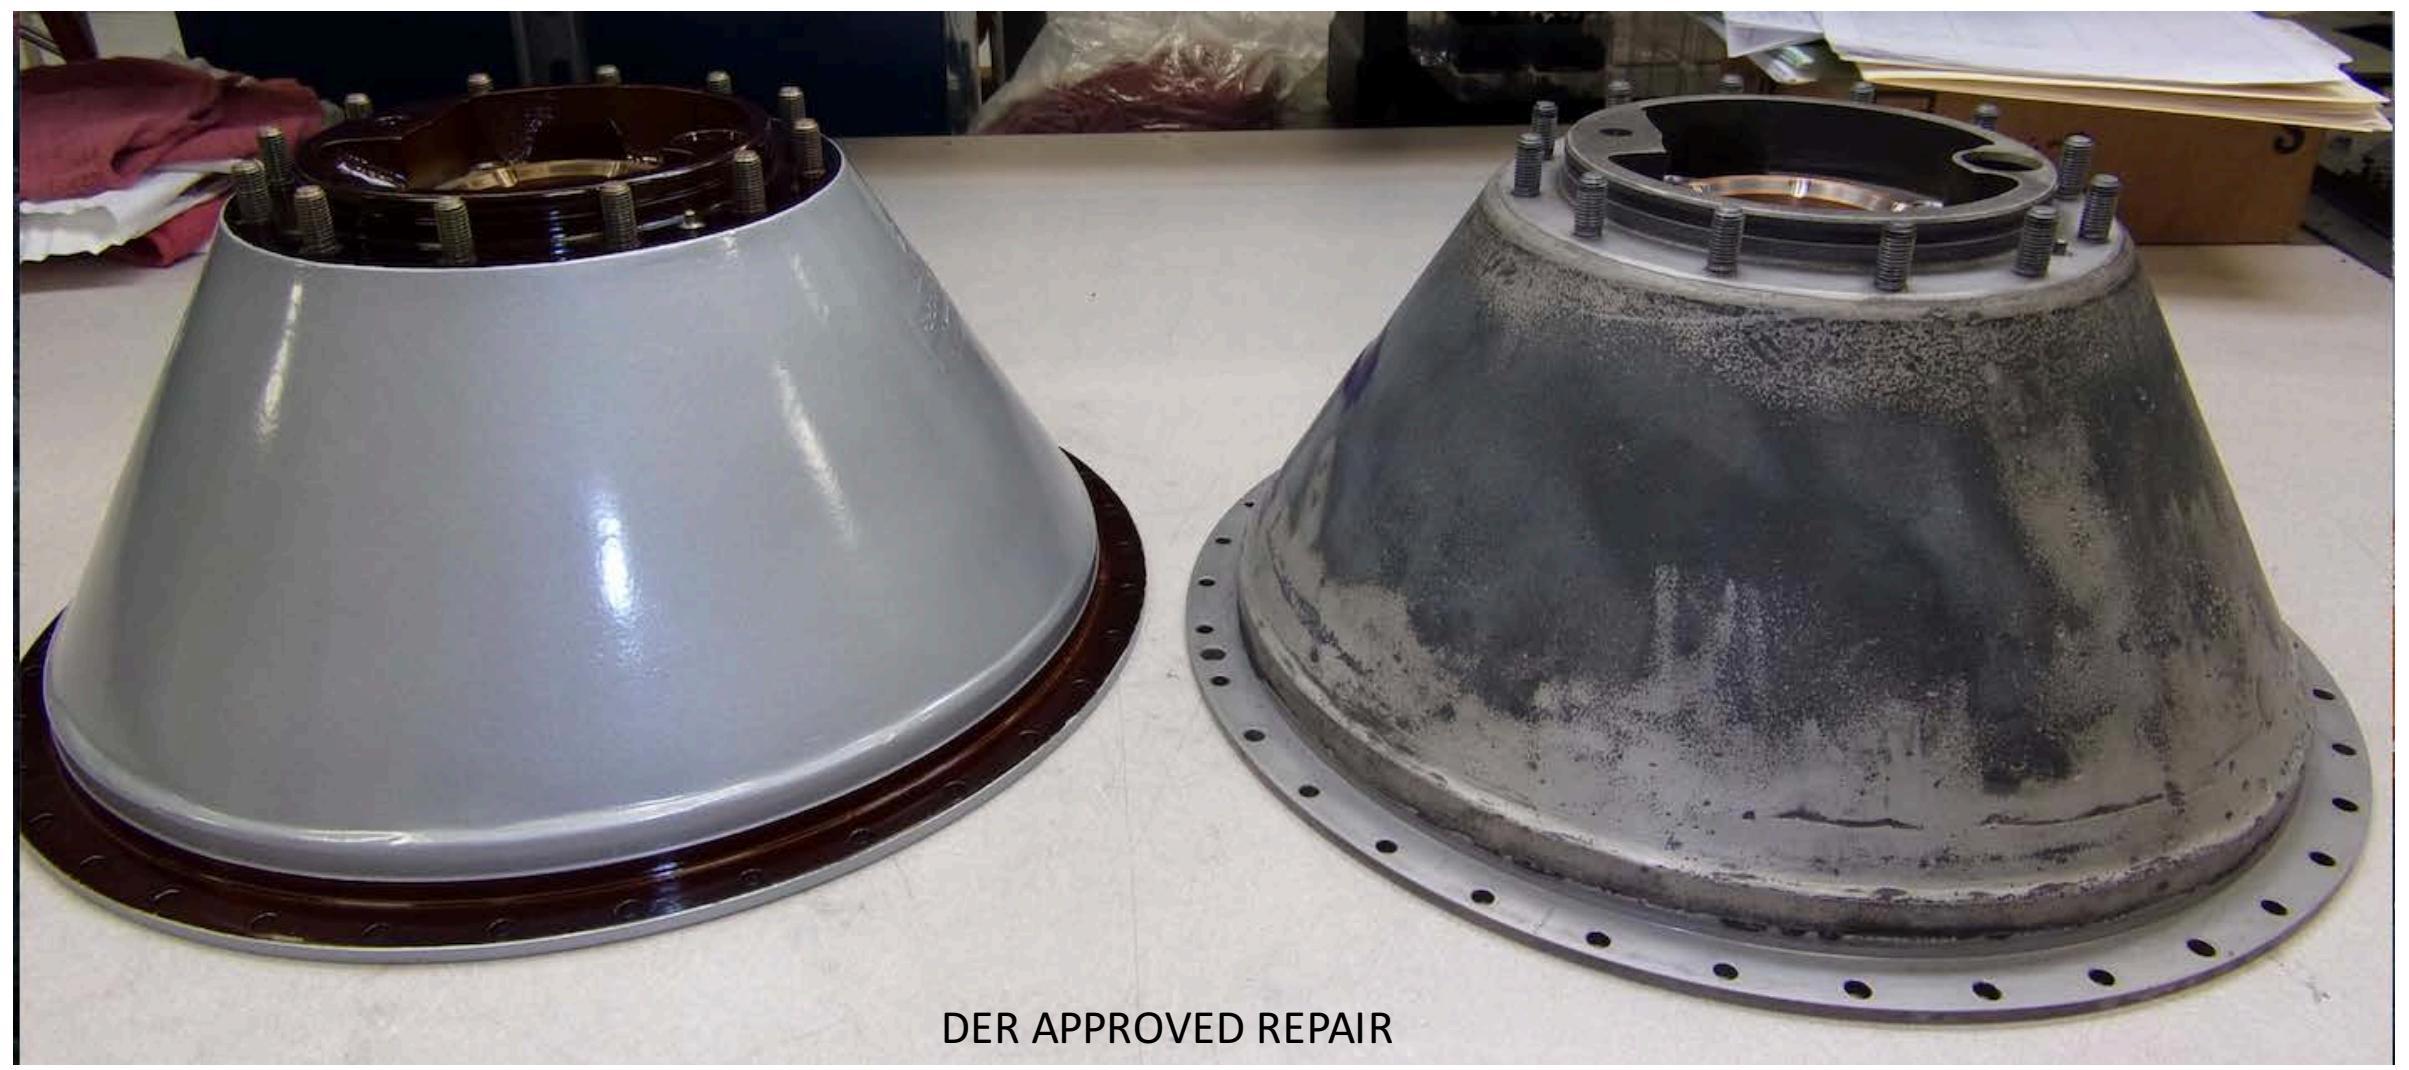
FINISHED RGB HOUSING AND TYPICAL ORIGINAL PLASMA DELAMINATED VERSION
