Cold Spray Case Studies and Implementation

Tom Stamey
PSNS & IMF, C/260M

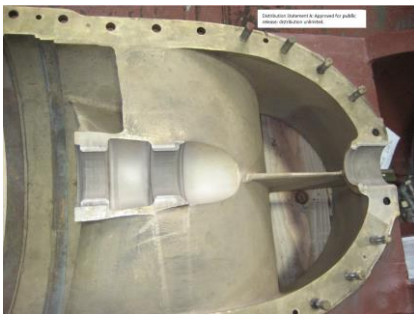
Cover: As sprayed

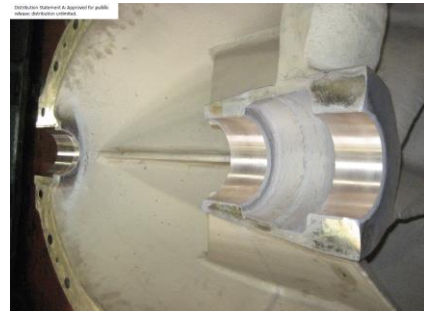
Cover: Finish machined

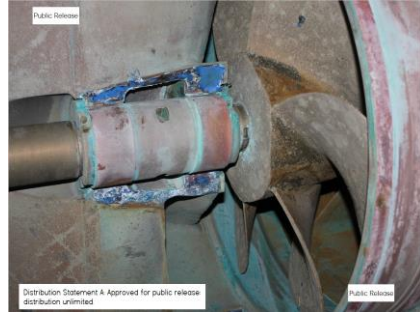
Case: With Water Bearing

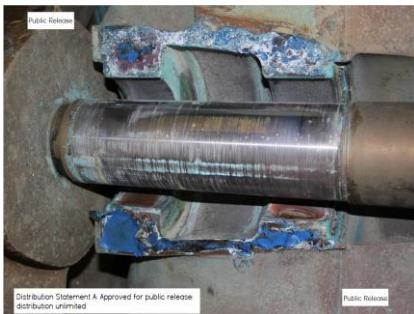
Case: Without Water Bearing

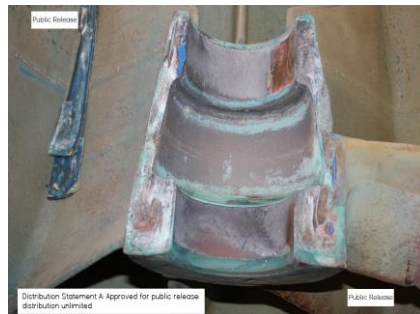
Cover
