Development of Cold-Sprayed Titanium/Baghdadite Composite Coating for Bio-implant Applications*

Avneesh Kumar, Harpreet Singh, Ravi Kant
Indian Institute of Technology Ropar, Punjab, India

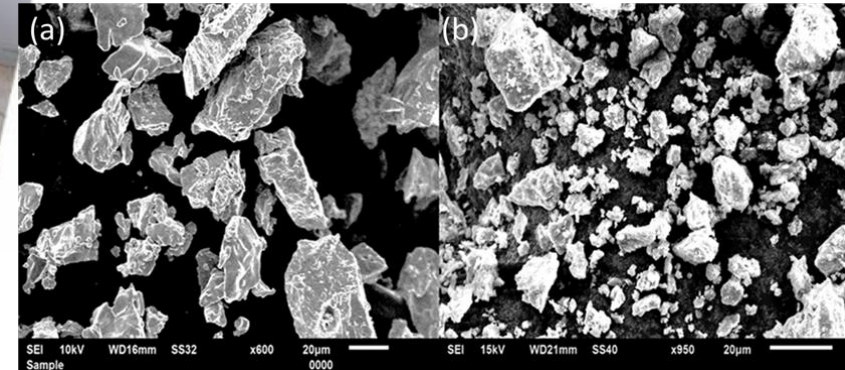
Mixing

Titanium (Ti)

Baghdadite (BAG)

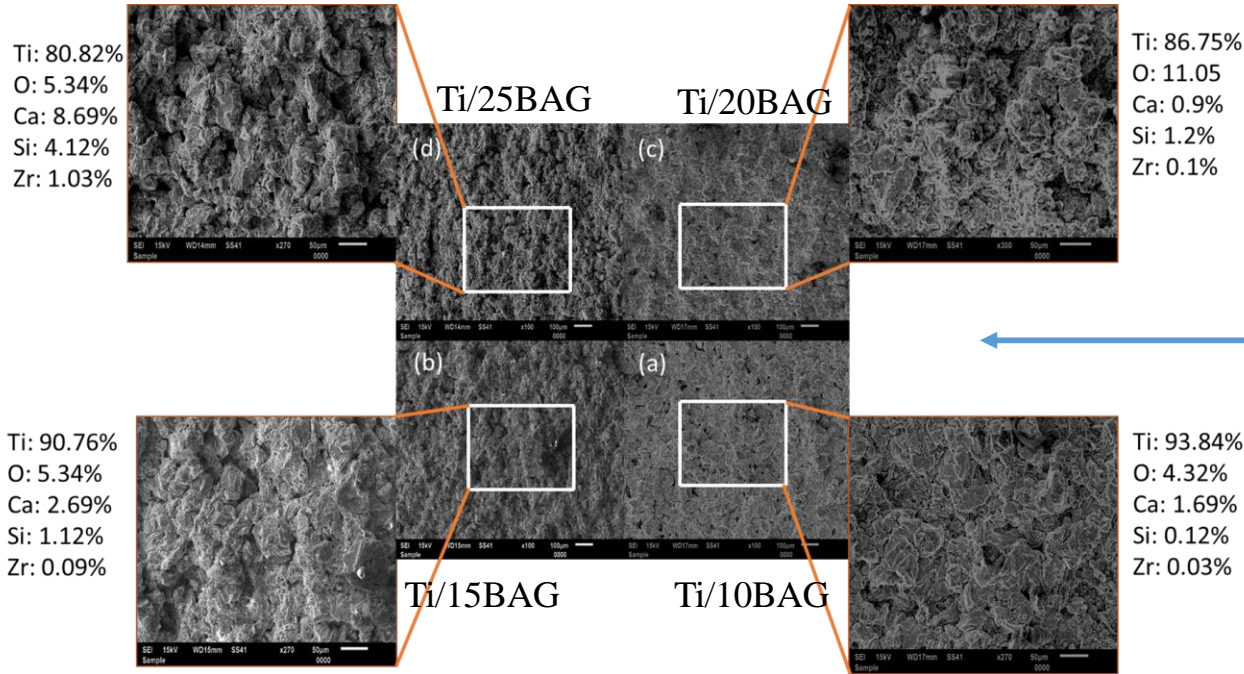
Surface SEM/EDS analysis

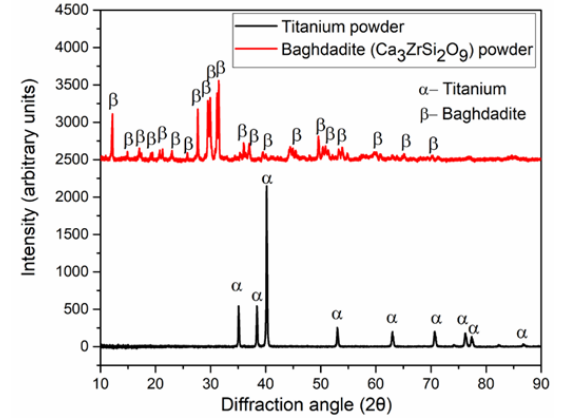
XRD analysis
