Cold Spray Case Studies and Implementation

PSNS & IMF, C/260M

Case Study: Swing Check Valve

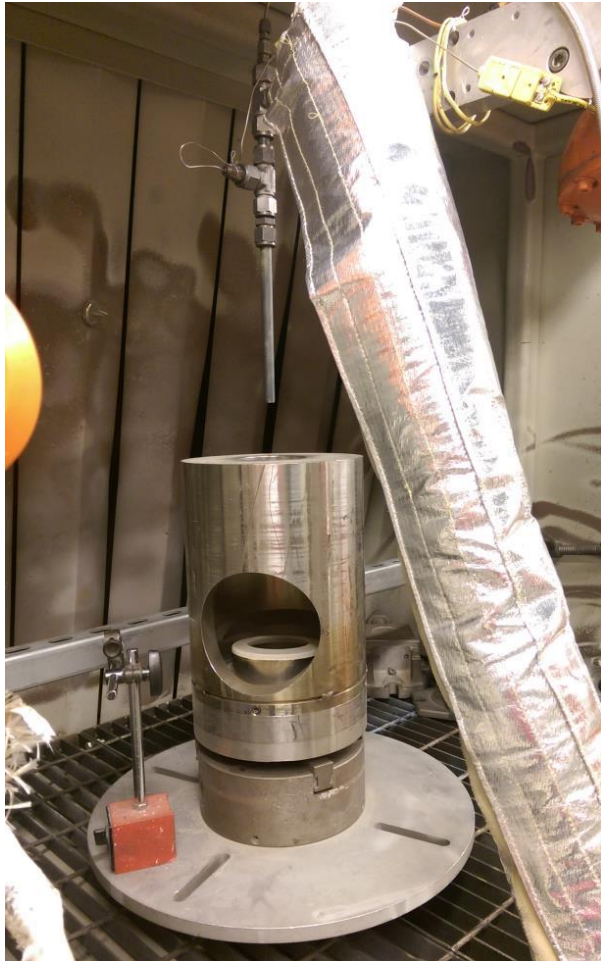
Spraying the Mockup

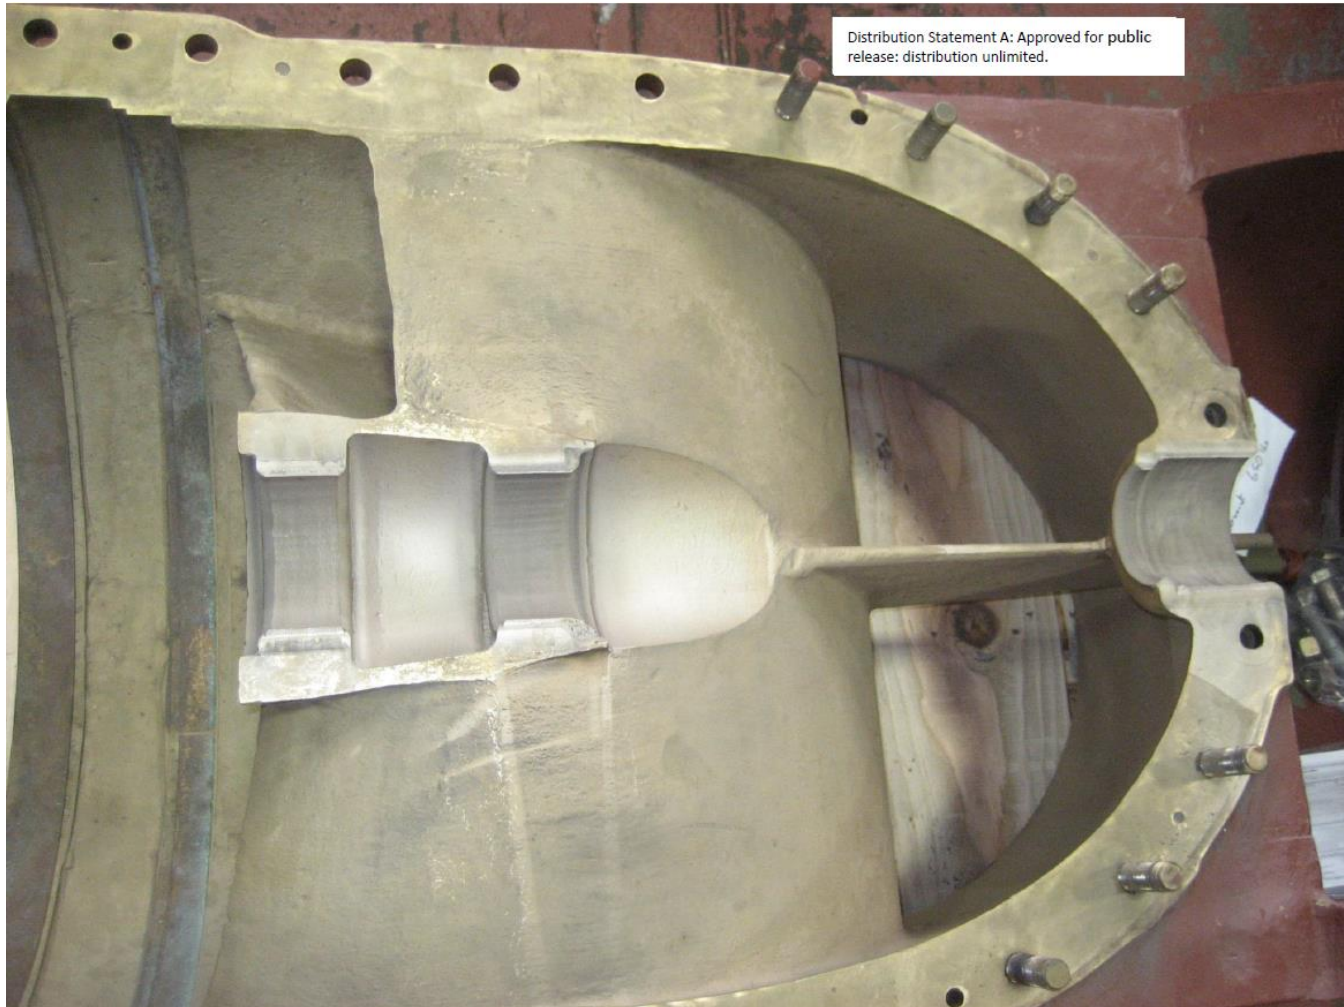
Case: As sprayed

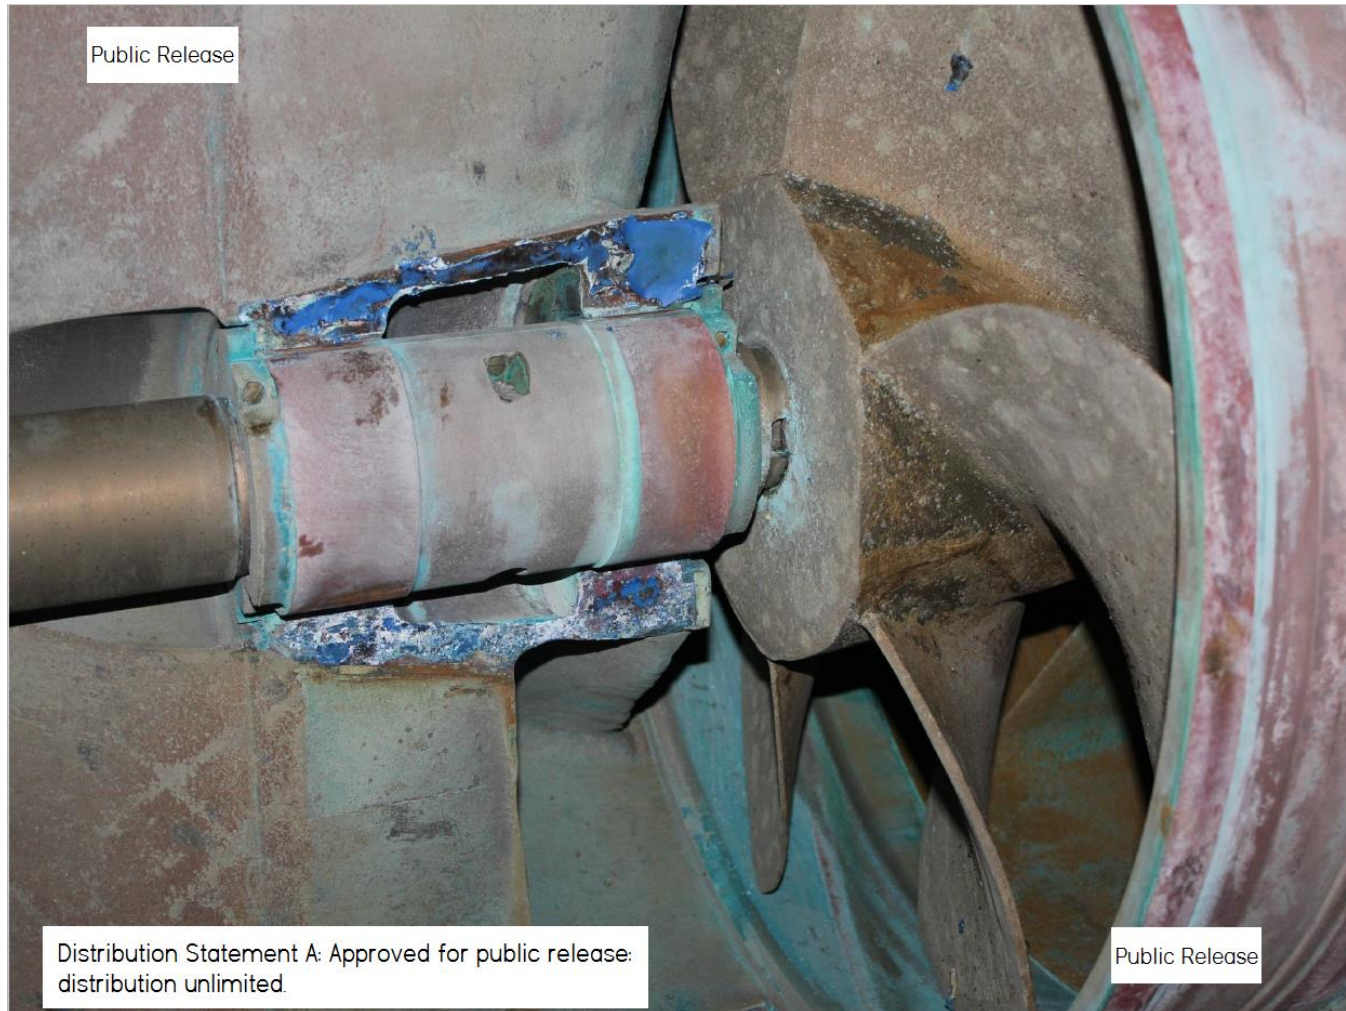
Case: With Water Bearing
