Progress Report: Adhesive-free Bond Strength Test for Cold Spray Coatings

**CSAT 2017
June 15, 2017**

Materials Joining and Engineering Technologies

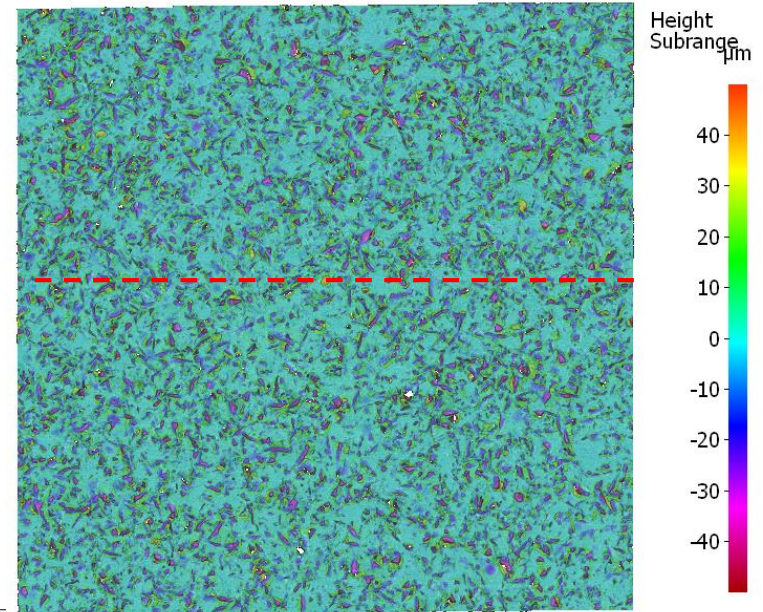
After grit blasting

- Grit blasted substrate assembly (pin & collar)
 - If present, defects are smaller than the surface roughness.

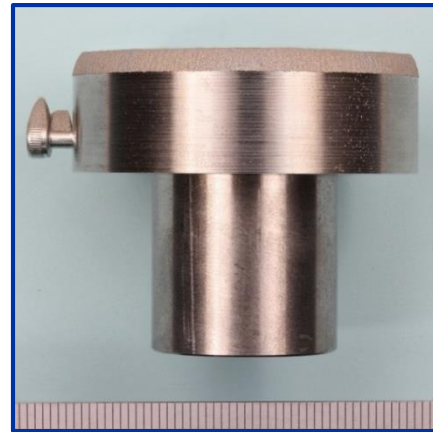
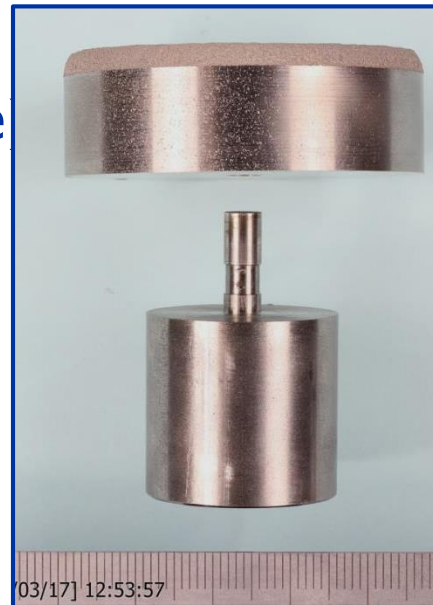
TWI Test – Initial Assessment

- 3mm AISI 316 SS coating deposited onto grit blasted mild steel.
- Coating pulled until failure.
 - Failure mode: Adhesive (bond line failure)
 - Failure load: 1.179kN
 - Adhesion strength: **60 MPa**

- No significant defects found at the pin-collar interface
 - ▣ Checked following a number of surface operations, including coating.
- Coated assembly successfully coated and pulled.
- Coating failed adhesively with an adhesion strength value that seems “not unreasonable” for such a coating.
- Basic design is therefore appropriate for further development.
