Repair of Boeing747 Integrated Drive Generators

Repair Procedure Development and Specification

Optimized Repair Procedure

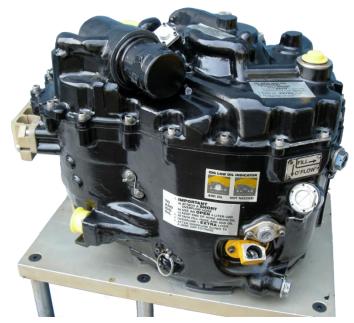
(IDG)

• In-flight power generation device that converts engine variable input speed into constant output speed to drive an AC generator for supply of constant frequency AC electrical power for aircraft

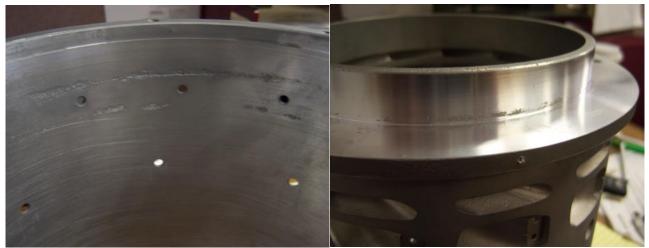
APU Generator Stator Housing-Boeing 747

- ✓ Pitting Corrosion
- ✓ Failures are located at tight tolerance heat-sensitive areas such as stator bores, exciter bores, pilots, mounting pads and mating faces...

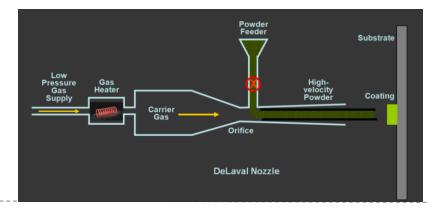
Downstream Injection Cold Spray (SST)

Gas: Air, Nitrogen / Helium

Gas Pressure: 60 -500 psi (4-34 bar)

Gas Temperature: 20 – 550°C (68 - 1022 °F)

Particle Velocities: 300 - 900 m/s

Handheld SST Manual Gun with Thumb and Forefinger controls

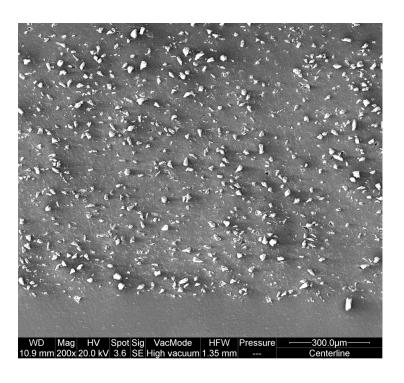
Metallographic Inspection

- **✓**Porosity less than 2%
- **✓** No cracking
- **✓** No lack of bonding

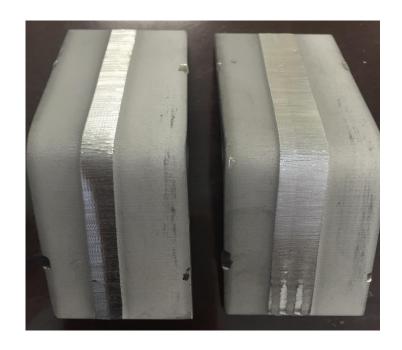
Hamilton Sundstrand SPR52 Bending

90-Degree bend tests with the coating in tension bent around a 0.25" radius showed no spalling or chipping

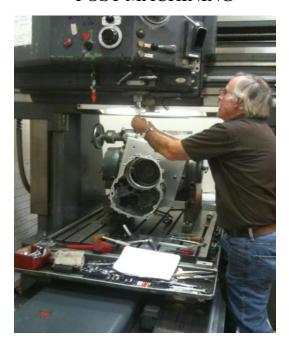
ROBOTIC COLD SPRAYING

POST MACHINING

- ✓ Removal of existing corroded and/or damaged surfaces
- ✓ Pre-machining as necessary to facilitate spray deposition
- ✓ Surface preparation
- ✓ Cold spraying using manual or robotic gun
- ✓ Post machining of the repair per OEM/LJW approved engineering specifications
- ✓ Visual and dimensional inspection
- ✓ Non destructive examination per ASTM-1417
- ✓ Corrosion protection of repaired areas using applicable solutions

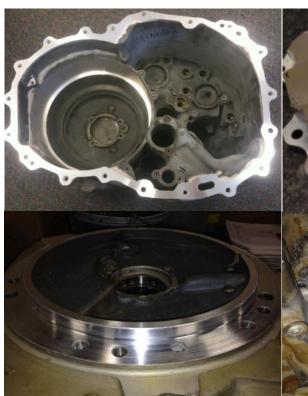
Finished Products

IDG Stator Housing-747/757/767

APU Generator Endcap-Boeing 777

IDG Stator Housing-MD11/777

IDG Stator Housing-A320 classic
