SST™ Cold Spray Technology Keeping Historical Aircraft Airworthy

Problem Description

DeHallivand DHC-1 # 054 RCAF Aircraft Gypsy DH Major 10MK1-3A engine

Canadian Historical Aircraft Association

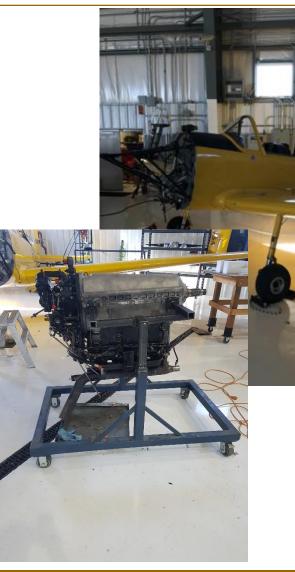
Liquid Penetrant Inspection

- Crack present at a flange in the upper cover eradicating fastening point to the lower crankcase
- Crack present at the bolt region in the lower crankcase
- Both Magnesium and Aluminum cast alloys would not tolerate elevated temperature repair processes, such as welding

Due to the already weakened material condition, SST recommended that both the cracked flange at the cover as well as the cracked region at the lower crankcase be completely removed. The missing feature would be rebuilt using the SST cold spray process

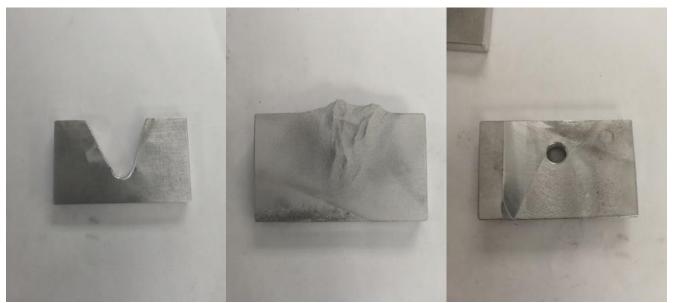
- Worked with Transport Canada and Fliteline to Design the NEW Repair Procedure
- New Repair Procedure based on MIL-STD-3021 for non-structural repair (2008-2015)
- Required simulation samples for hand free-form spraying
 - ✓ ¼" hole, same distance to edge as in block, cut through at 25 Degree
 - ✓ Hand free-form spray & machine

- SST Series P machine with Manual Spray gun 2.0mm orifice UltiLife[™] Nozzle
- Remove damaged sections
- Surface prepare with SST-G0002 to roughen surfaces
- Hand spray damaged areas with SST-A0082 using:
 - Nitrogen
 - 180 psi (12.5 bar) / 425C
- Conventional machining to dimensional tolerances
- CMM dimensional verification
- Assembly and release

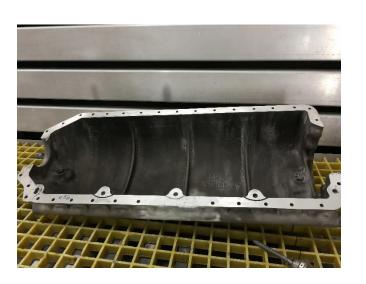
Upper Cover

- Masking was not necessary
- Gasket thickness was quite small so distortion was not allowed

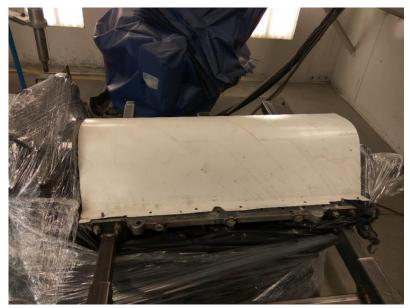
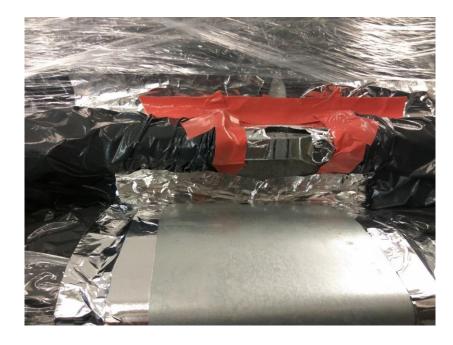
Lower Crankcase

In this case masking was necessary to

- ✓ Avoid tear down/disassembly of the engine
- ✓ Protect engine components during spraying and post machining
- ✓ did not have to drain the oil

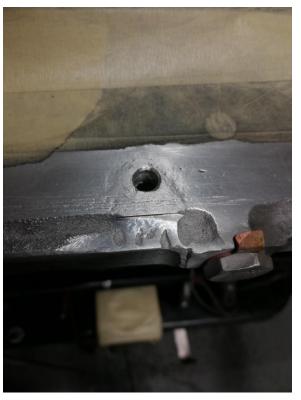
before

As sprayed

Machined

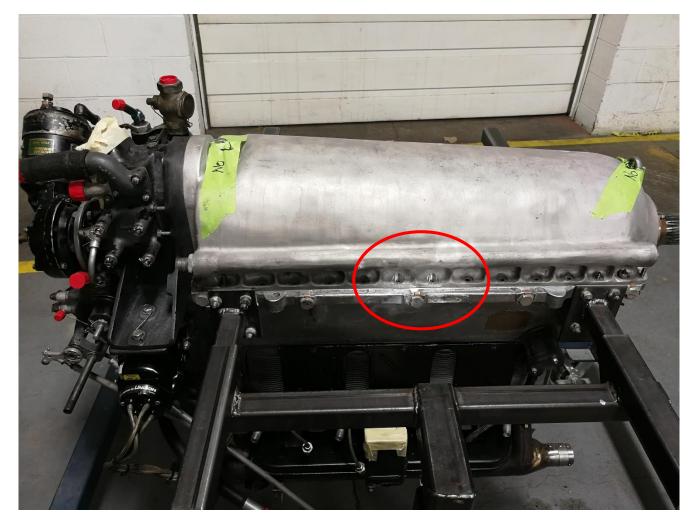
Engine ready

- Engine cover flange repair Approval Summary
- TC Process Design Repair Document 1701 rev 1. 29/11/17
- TC Maintenance Manual Supplement 1701M rev 1. 5/12/17
- TC-Canadian Aviation Regulation Approval O-RA17-139 dated 8/12/17
- Once the repair was done the subsequent installation on the engine into the aircraft and return to service of the aircraft was certified by AME/AMO in accordance with the Canadian Aviation Regulations PART V- Standard 571 – Maintenance
- After 50-flight hour the aircraft was re-inspected without any issues
