**CSAT Meeting: WPI, Worcester, MA**

# **B1 Bomber-FEB Panel Repair by Cold Spray**

**South Dakota School of Mines and Technology**

**October 30, 2012**

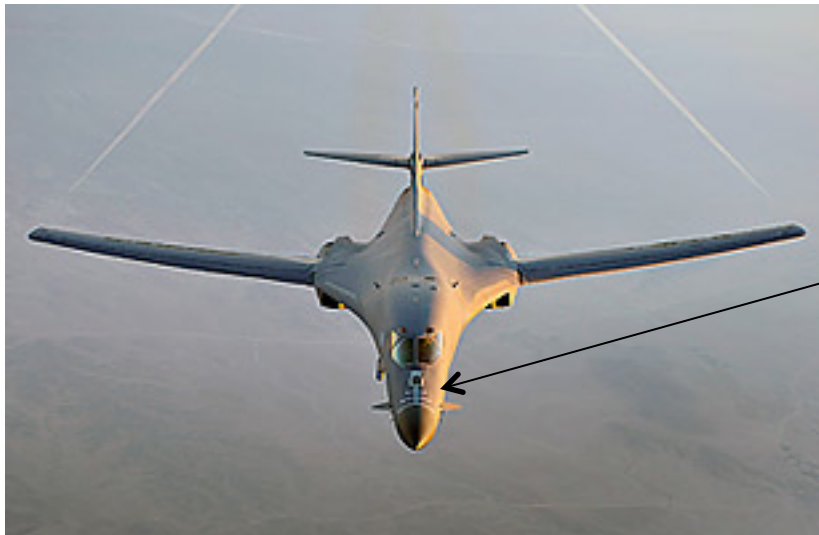
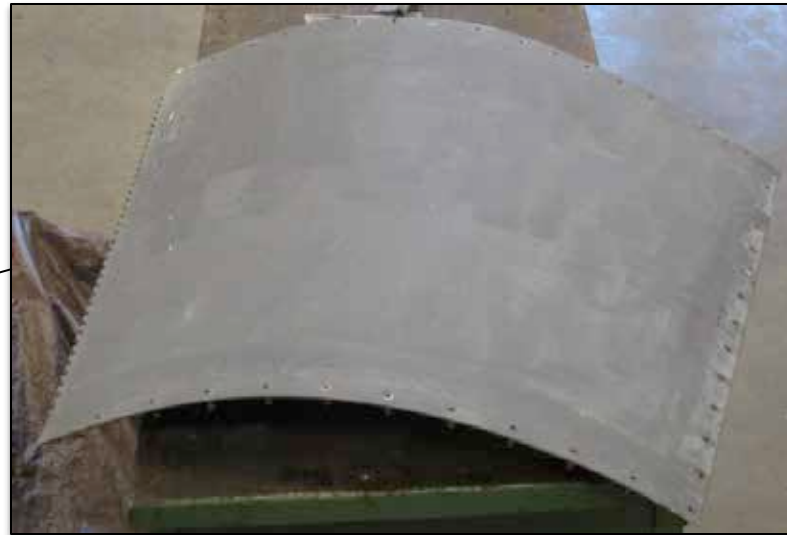
- Aluminum aircraft external access panels are typically secured to the airframe with steel TRIDAIR fasteners.
- The fasteners are designed to sit flush with the panel to enable laminar airflow over the fastener head.
- Repeated access to these panels wears and enlarges the holes in the panel.
- As wear increases, the fastener sits further and further below the surface of the panel, resulting in turbulent airflow, vibration of the panel, and eventual pull through and loss of the fastener in flight...

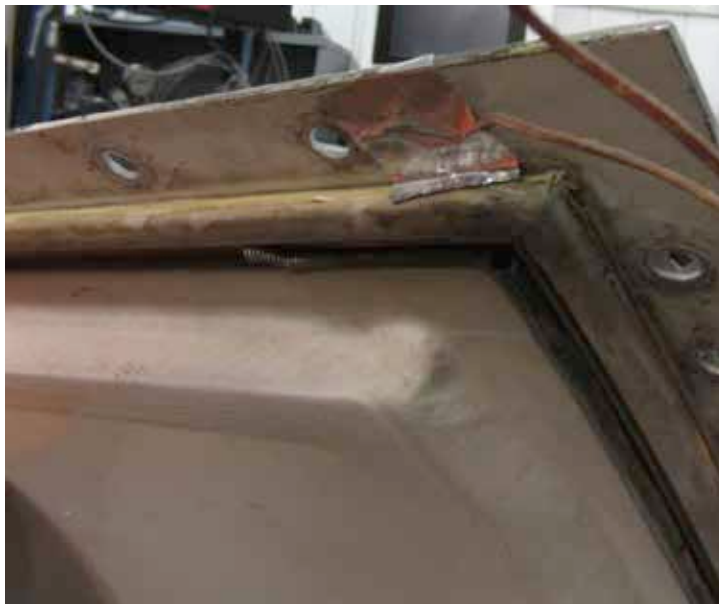
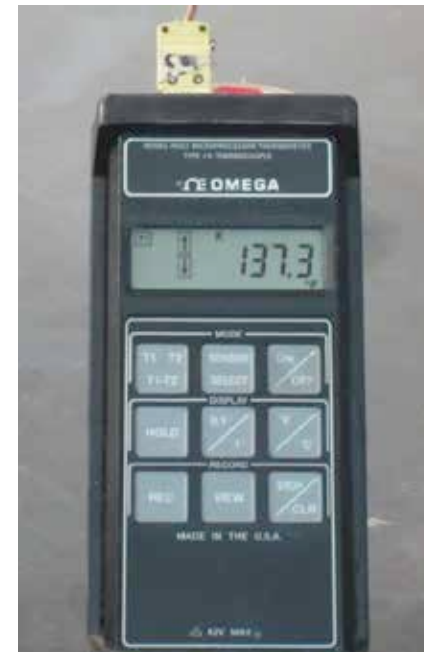
# Thermocouple Data

- Temperatures on the back side of the panel were monitored by thermocouple and did not exceed 100°C.
- Max. observed transient temp during repair was 153°F, but 137°F shown here was typical (<63°C).

There is no detrimental effect to the 2024 or composite material substrate at these temperatures.

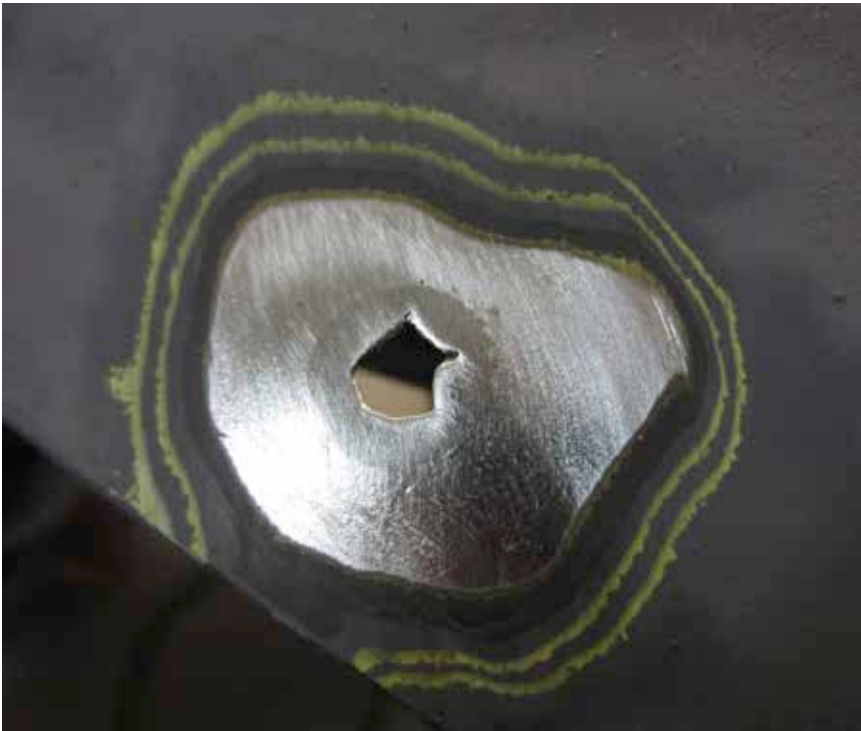
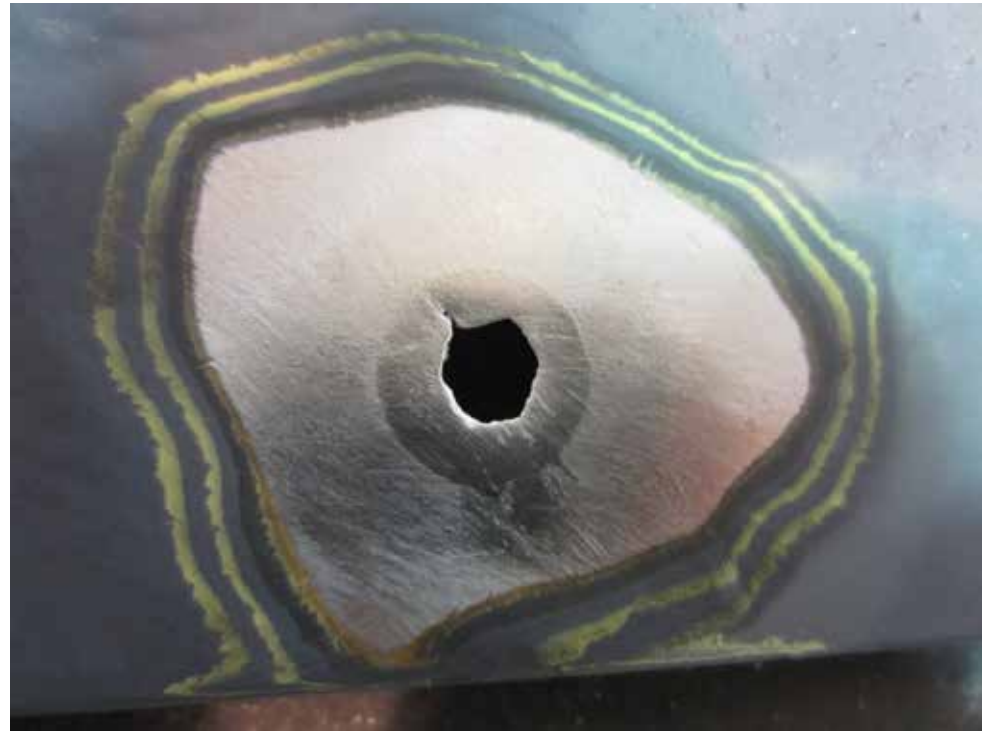
# Fine Polish

- After grinding, the holes were polished with fine scotch brite discs.

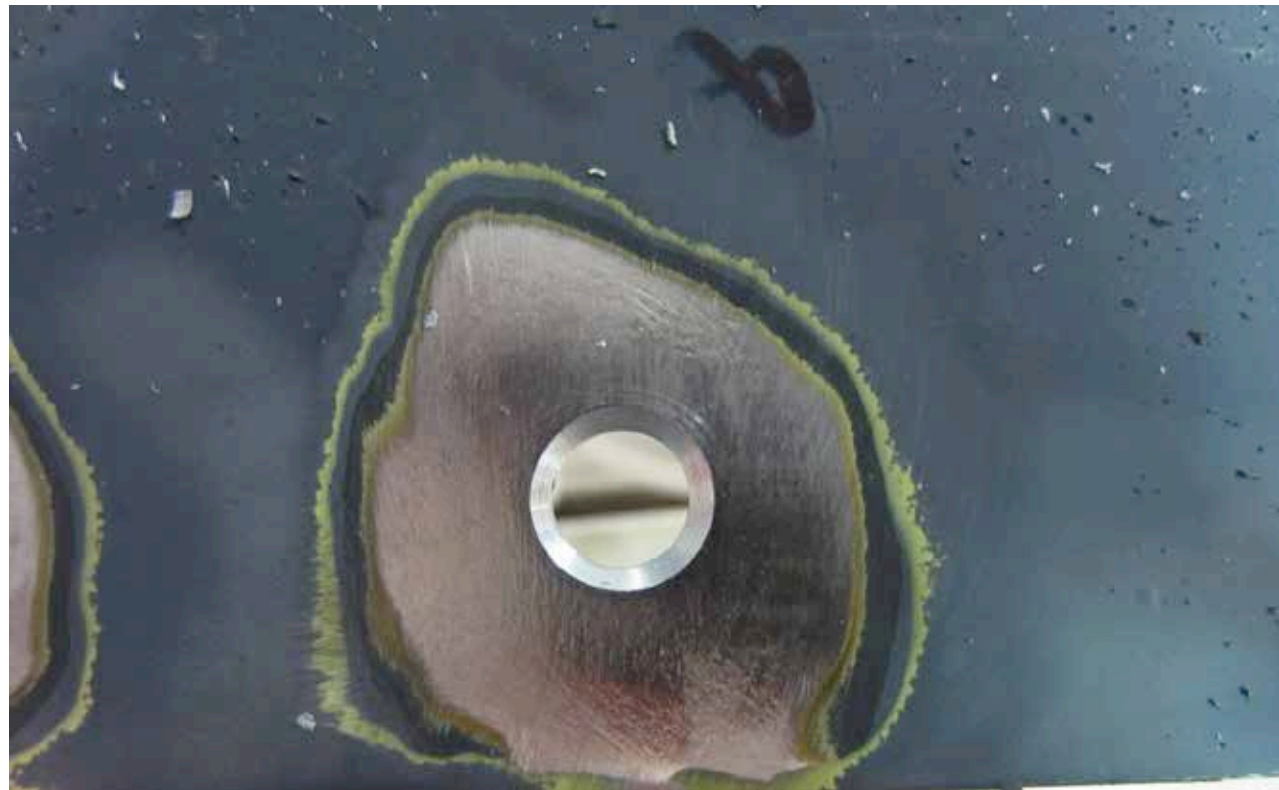
# Hole after Micro-Stop

- Final machining was performed using a micro-stop tool to cut the proper chamfer for the Tridair fastener.

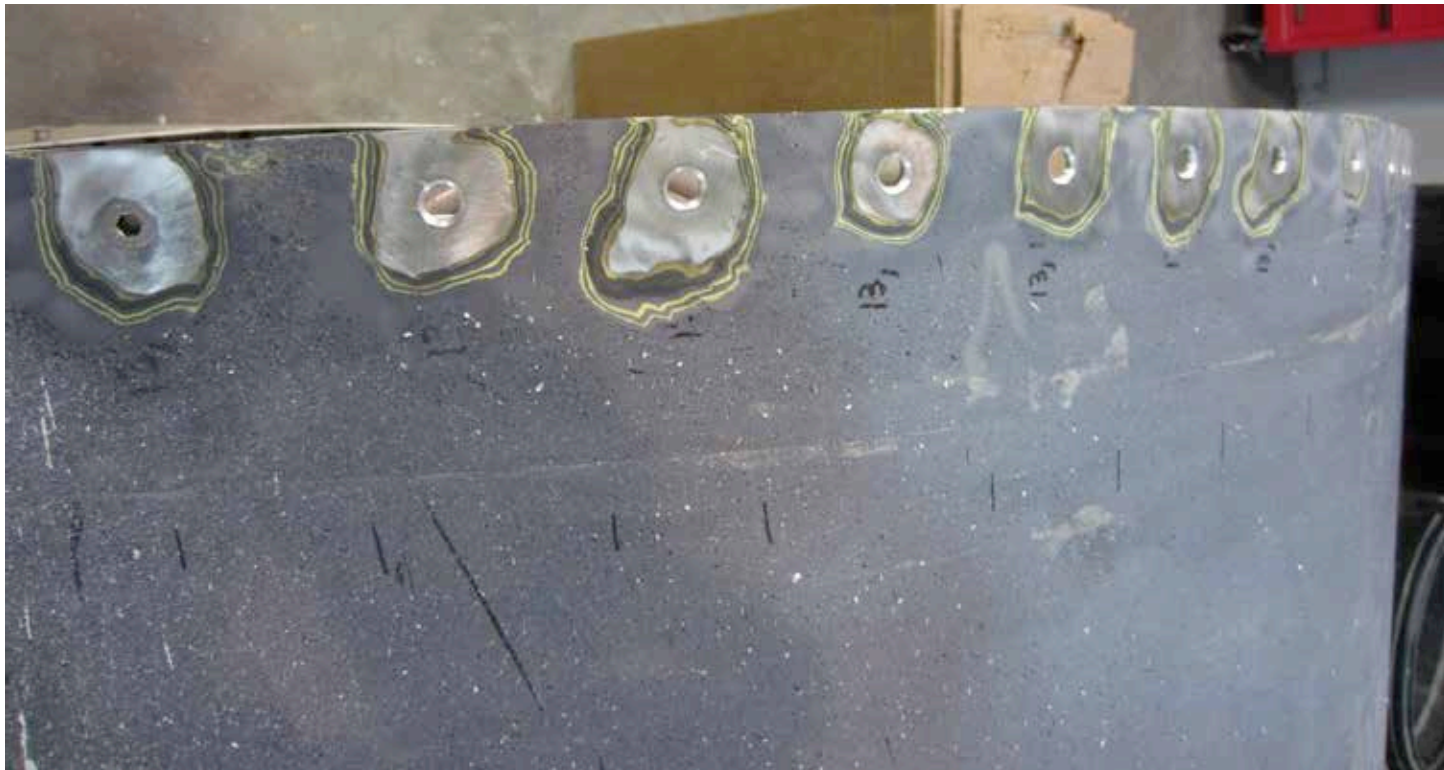
# After Micro-Stop

- Final repair before painting.

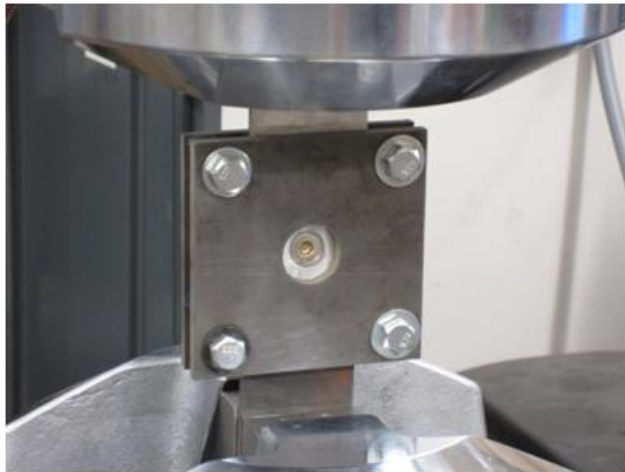
# Testing Procedure

- Guided lap shear
- Fastener torque applied = 40 in-lbs
- Carried full Mil-HDBK fastener bearing yield load of 3400lbs.
- Tested up to failure at 5600 lbs – **no delamination at failure**

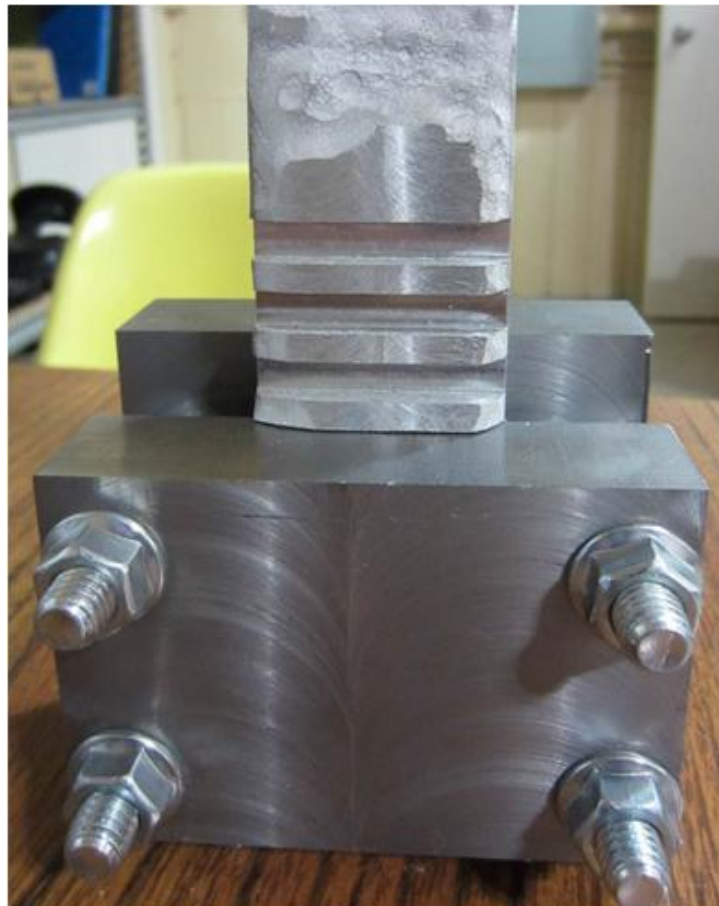
## Cold Spray Adhesion

- Three lug shear testing
- >5000 psi avg. interface strength (Avg. 5681 psi  $\pm$  729)

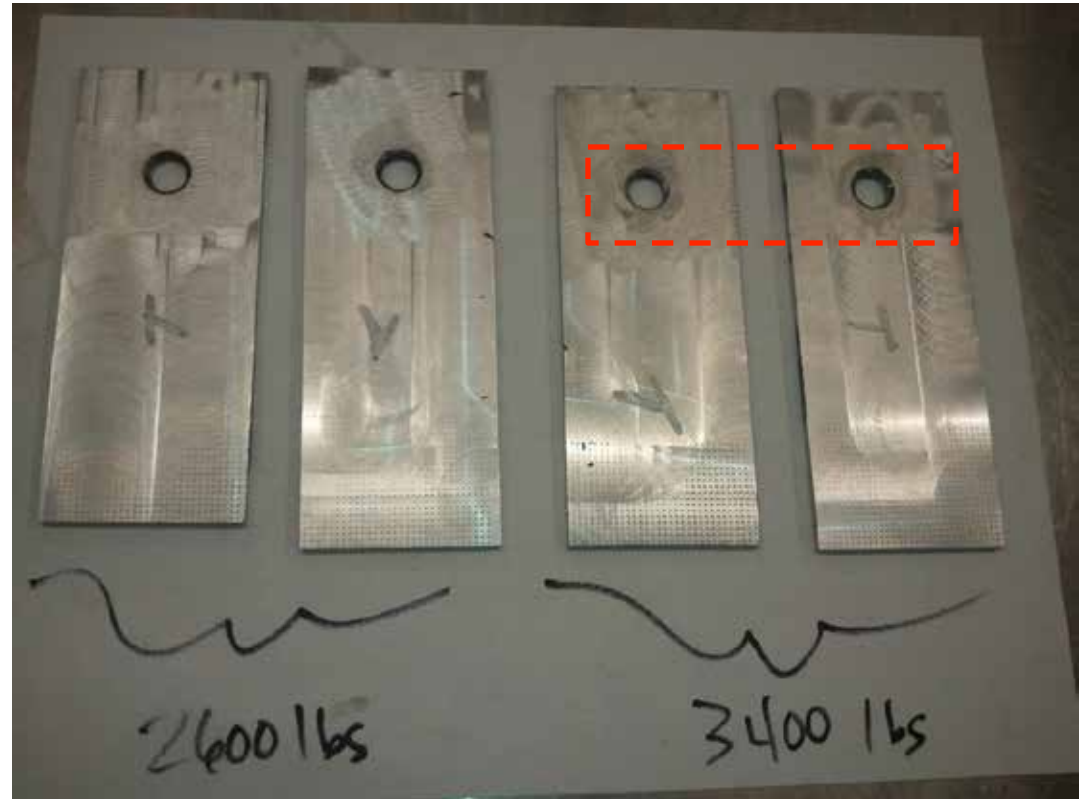
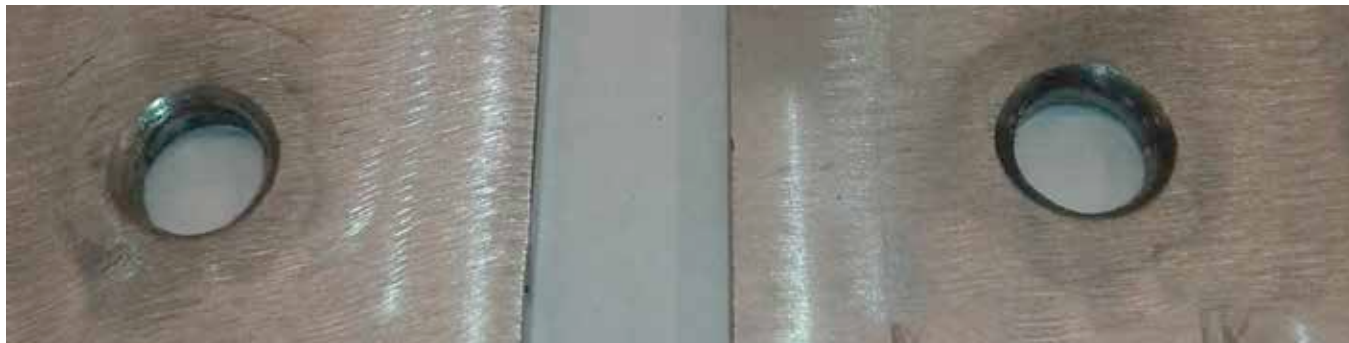
# Testing Results

No evidence of cold spray material failure observed up to full bearing yield.
