# CS Repair and Refurbishment Developments at SDSM&T

Christian Widener, Ph.D.

**South Dakota School of Mines and Technology  
& VRC Metal Systems**

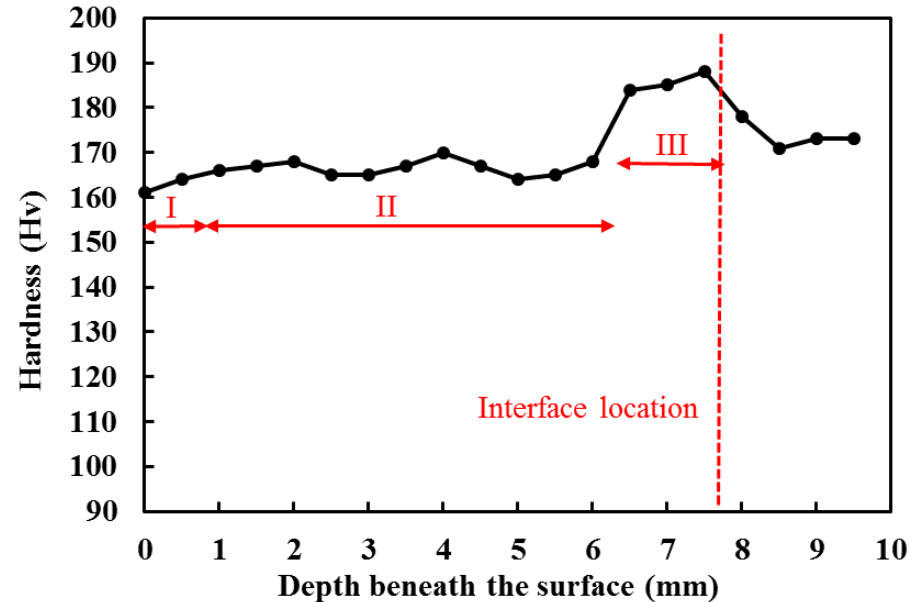
# Al 7075 Cold Spray with PWAA

- Vickers microhardness distribution from the top of the CSP 7075 layer to the substrate: before T-73 heat treatment (left) and after T-73 heat treatment (right).
- The dashed red line represents the location of the deposit/substrate interface.

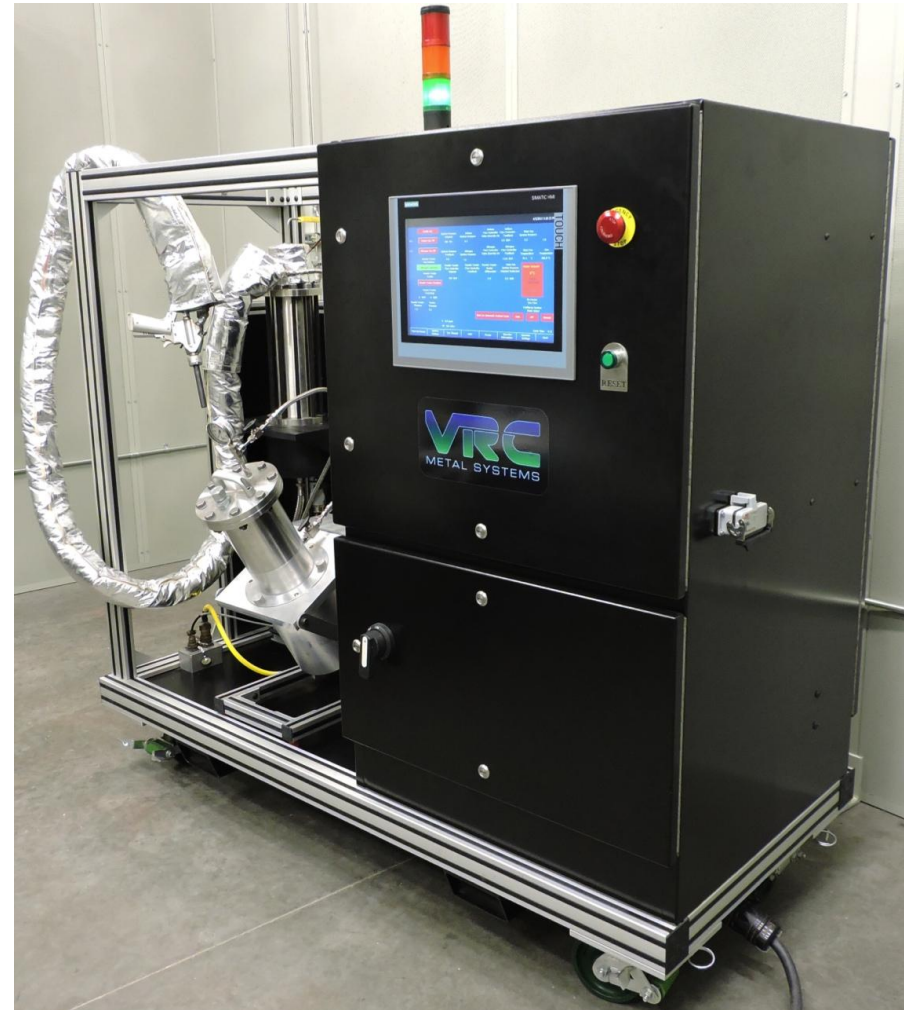
# VRC Gen III Cold Spray System

## Hand-Held Capable

- Working with VRC Metal Systems to develop cold spray equipment solutions
- The Goal is to support and accelerate cold spray implementation for suitable applications.
- Operates at 1000 psi to enable more with N<sub>2</sub>.

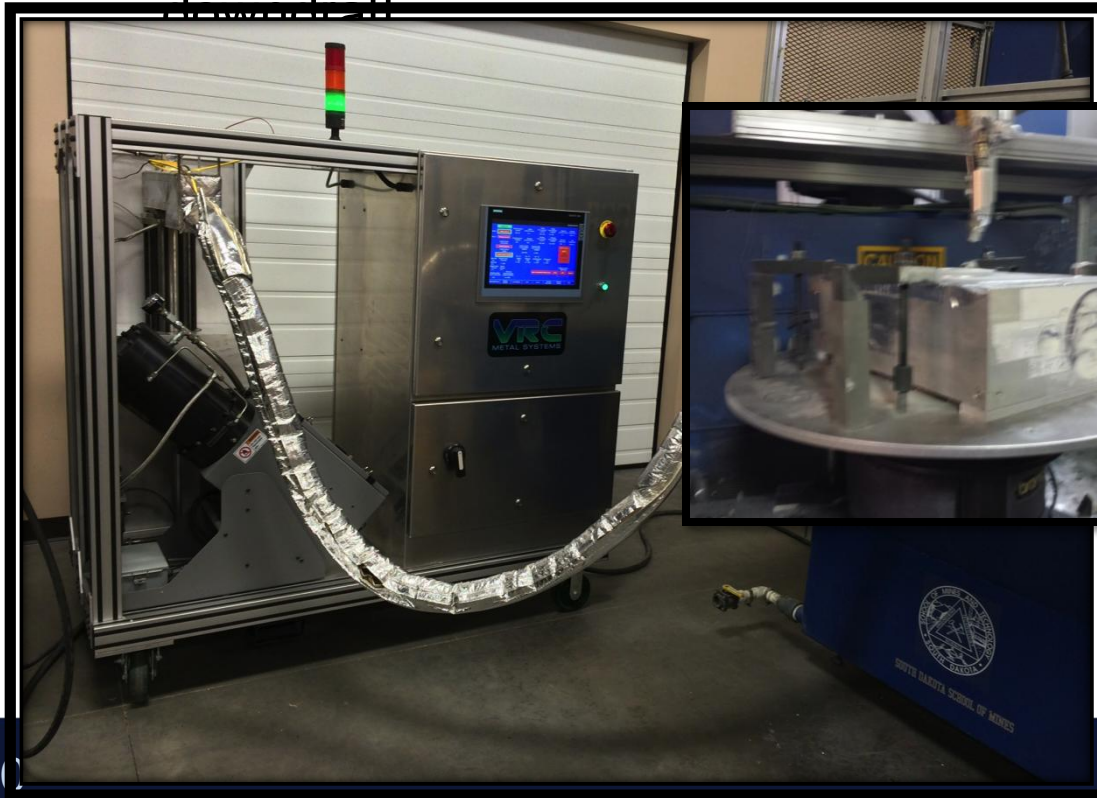
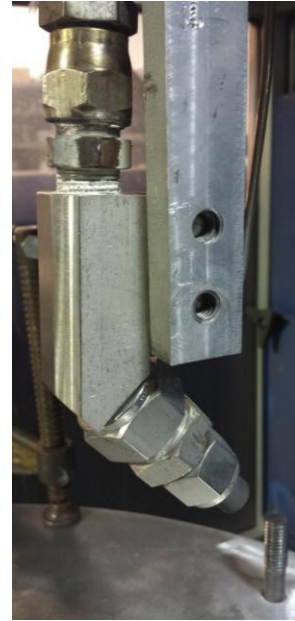
# Development for Internal Bores

- Worked with ARL and MOOG to develop a repair process for a valve body internal bore.
  - Made a shortened nozzle (75 mm) with internal bore 45° gun
  - Turn table rotating at 60 rpm with 3-axis robot with

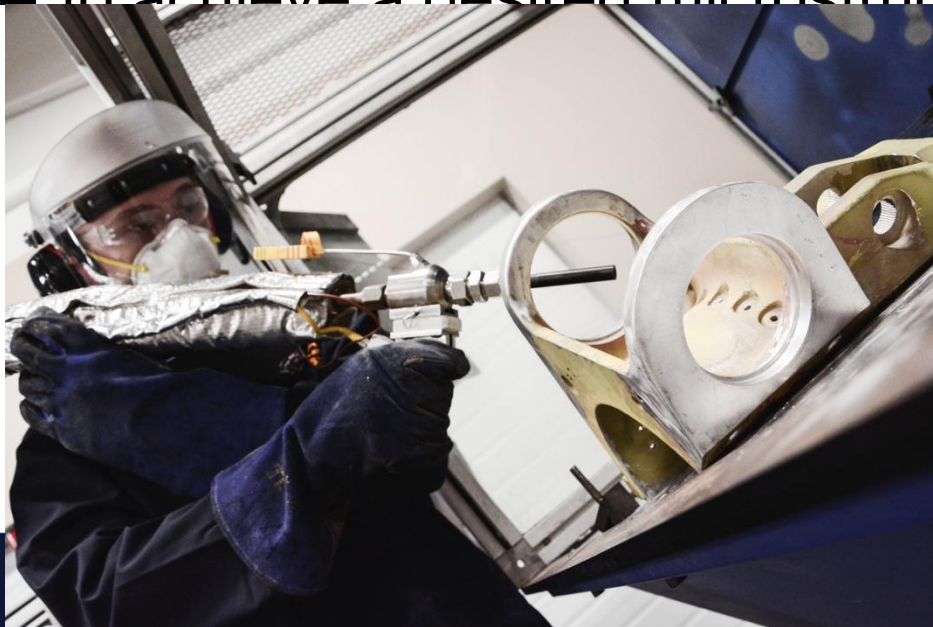
# Implications for Repair

- Ideal for parts that are heat sensitive
  - can avoid creating a heat-affected zone
- Powder microstructure is essentially preserved
- Some applications may require pre or post-heat treat
  - to achieve a desired microstructure in the deposited

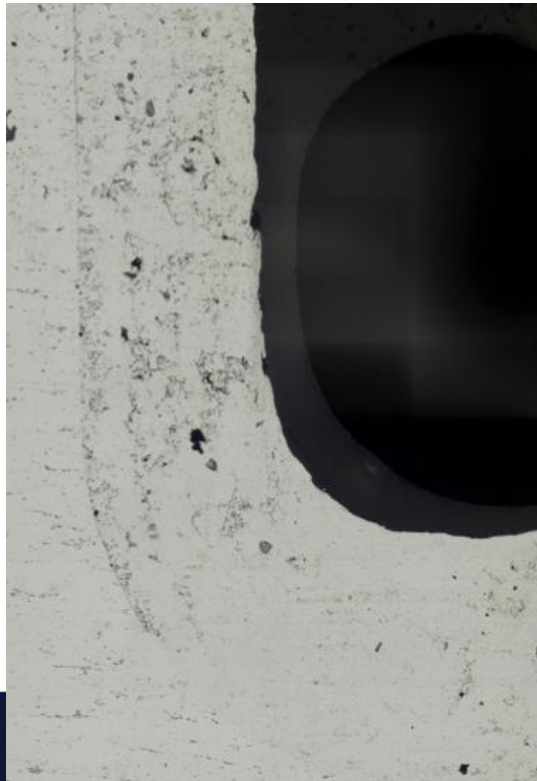
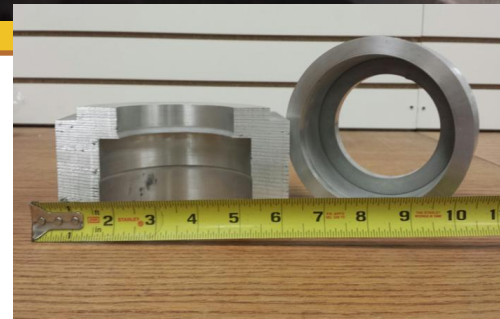
# Mechanical Testing

1. Min. 10 ksi adhesion
2. <5% Porosity
3. Machinable

Average  
Porosity =  
2.9%  $\pm$

2.10%

Critical  
Surface  
Porosity <  
1%

**ASTM C633 – Adhesive Bond Test**  
✓ Avg. >10 ksi (glue failures)

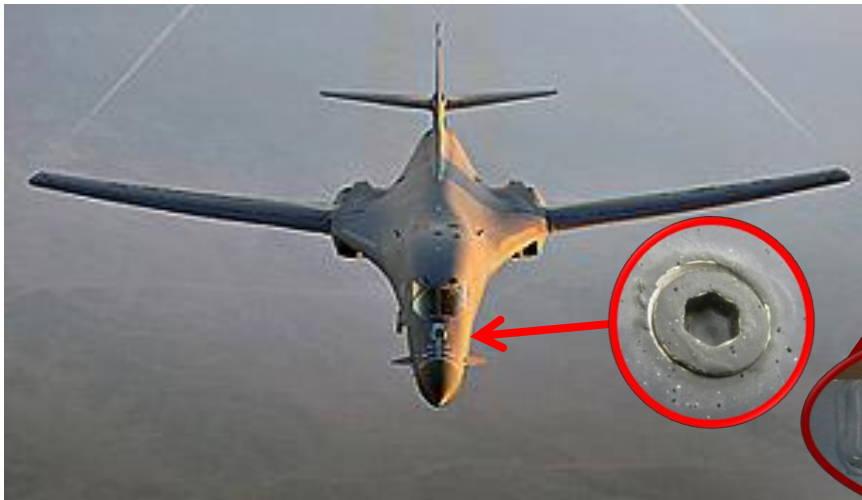
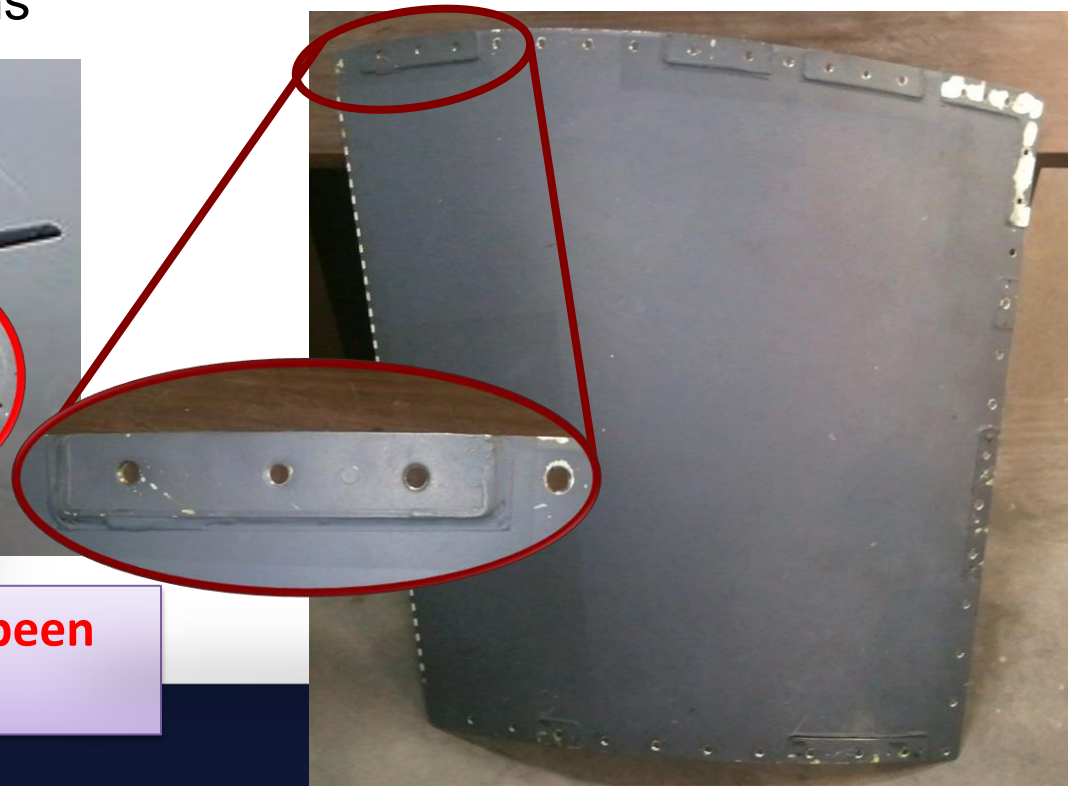
# Repair Application Example

- **B1 Bomber Skin Panel Repair**
  - Wear at fastener holes
  - Replacement Cost >\$200K each (Fleet liability: \$50M)
  - Access panel not designed to be load carrying
  - Part lead time > 18 months

**A cold spray repair solution has been developed... ROI > 10:1**

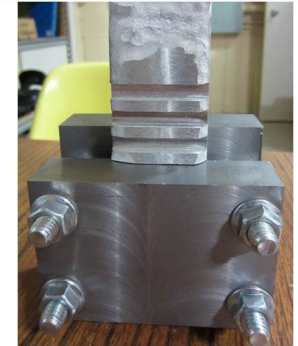
# Mechanical Testing

- Realistic requirements developed with Tinker AFB cognizant engineer
- Fatigue
  - 500K Cycles At 15 ksi
- Three lug shear testing
  - (Avg. 5681 psi  $\pm$  729)
- **Static Guided lap shear**
  - Carried full Mil-HDBK fastener bearing yield load of 3400lbs.
  - Tested up to failure at 5600 lbs – **no delamination at failure**

**No evidence of cold spray material failure observed up to full bearing**

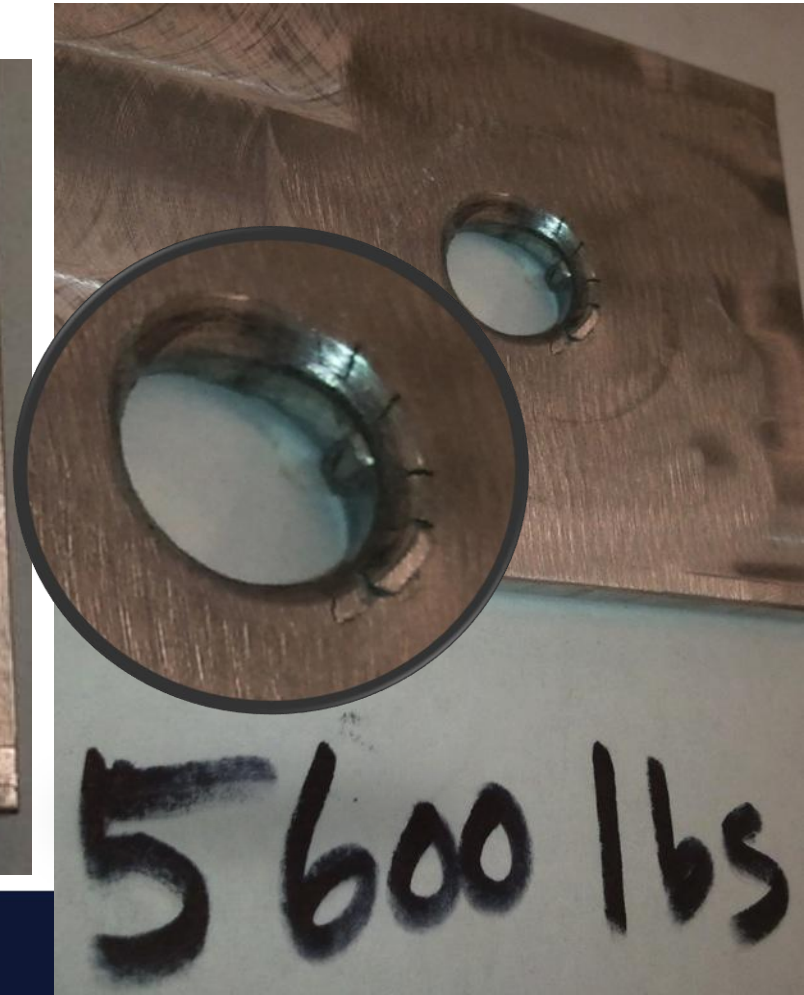
# Failure Load Testing

- Even tested up to failure at 5600lbs, the cold spray material did not separate from the coupon.

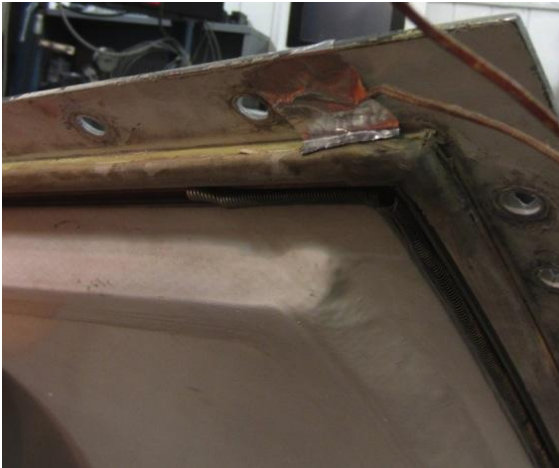
# Repaired Panel

Panel  
temperatures  
did not  
exceed 100°C.

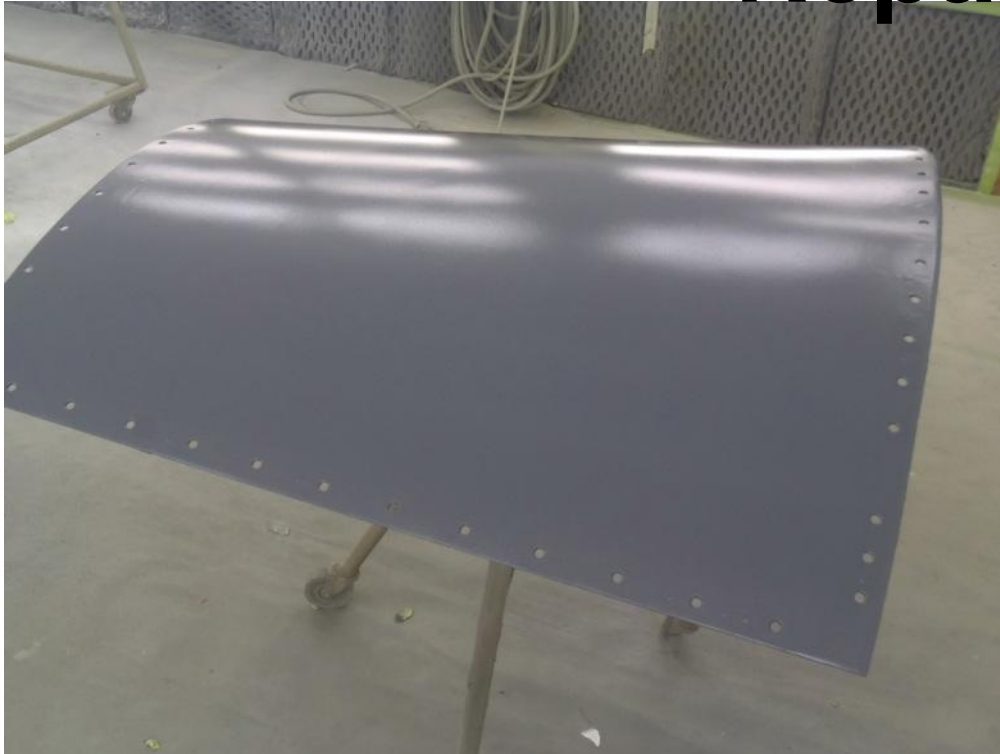
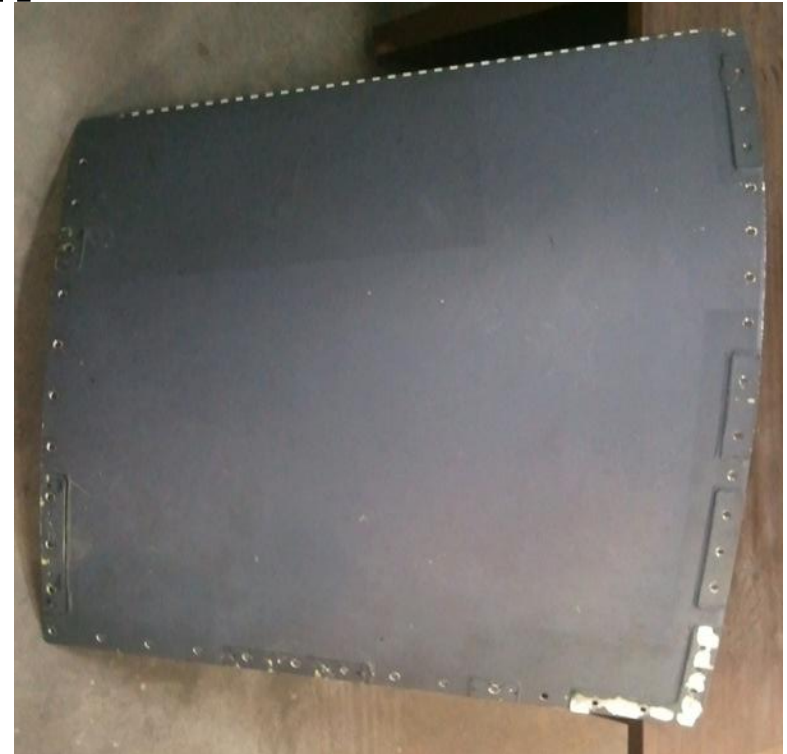
# Fully Restored Panel vs. Legacy Repair

- *The repair is currently flying on a B1 under an ETAR (August 2012)*
  - Still no sign of degradation or repair failure
- Total development time (with Tinker AFB support): 250 days
- Repair time: 2 weeks --- Savings >\$200K + Availability
