Repair and Refurbishment Lessons Learned Using Cold Spray

Dr. Christian Widener, Director Repair, Refurbish, and Return-to-Service Center South Dakota School of Mines and Technology

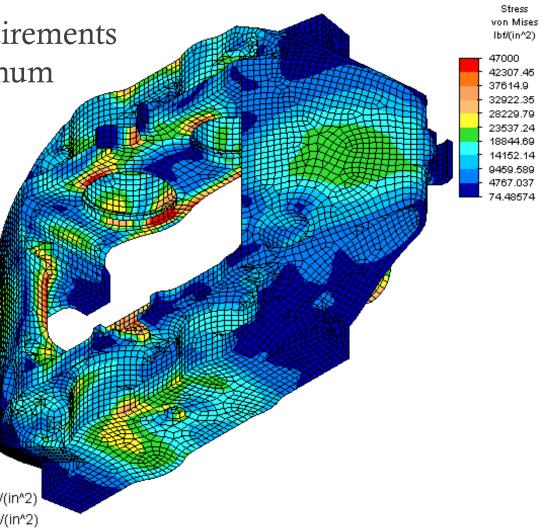
Material Load requirements are based on maximum stresses calculated to be present under design loading conditions...

Load Case: 1 of 1 Maximum Value: 103553 lbf/(in^2) Minimum Value: 74.4857 lbf/(in^2)

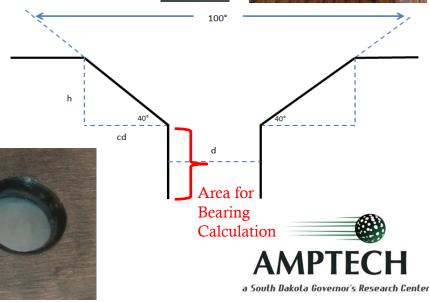
- Realistic requirements developed with Tinker
 AFB engineers
- Fatigue
 - 500K Cycles At 15 ksi
- Three lug shear testing
 - >5000 psi avg. adhesive shear strength
- Static Guided lap shear
 - Carried full Mil-HDBK fastener bearing yield load of 3400lbs.
 - Tested up to failure at 5600 lbs no delamination at failure

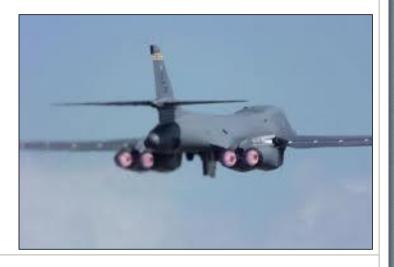
- The repair is currently flying on a B1 under an ETAR (since August 2012)
- Panels can be restored to their full form, fit, and function
- No sign of degradation or repair failure to date.
- Total development (with Tinker AFB support): 250 days
- Low risk and High return

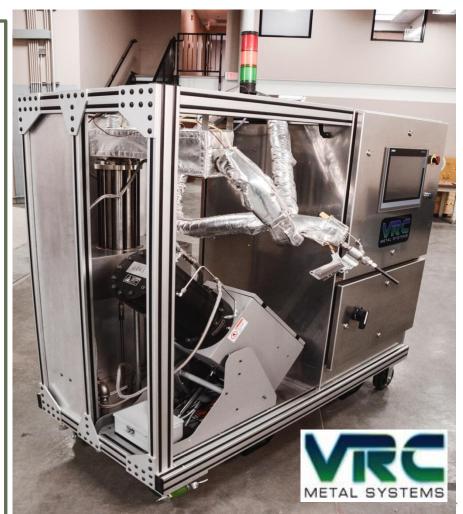
- VRC Gen III Cold Spray System
 - 1000 psi
 - 900°C
 - Lightweight articulatable nozzle and gun assembly.
- Developed for demanding repair applications for shop and portable in-field repair applications.
- With licensed patent-pending technology from ARL, SDSM&T and UTRC.
