Cold Spray Repair Technology at Honeywell

CSAT 2016

Honeywell

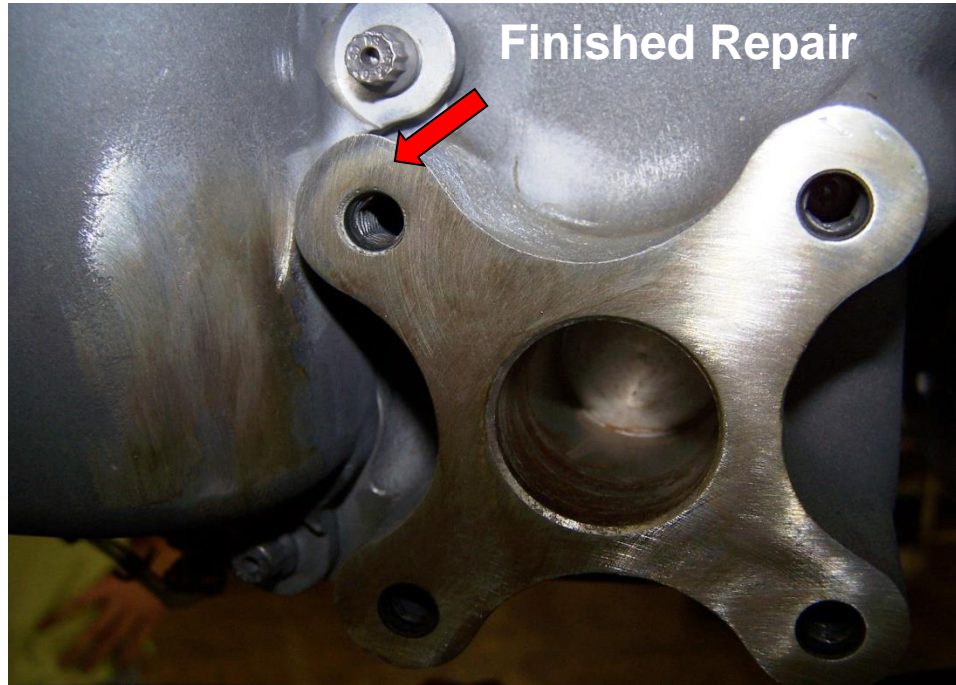
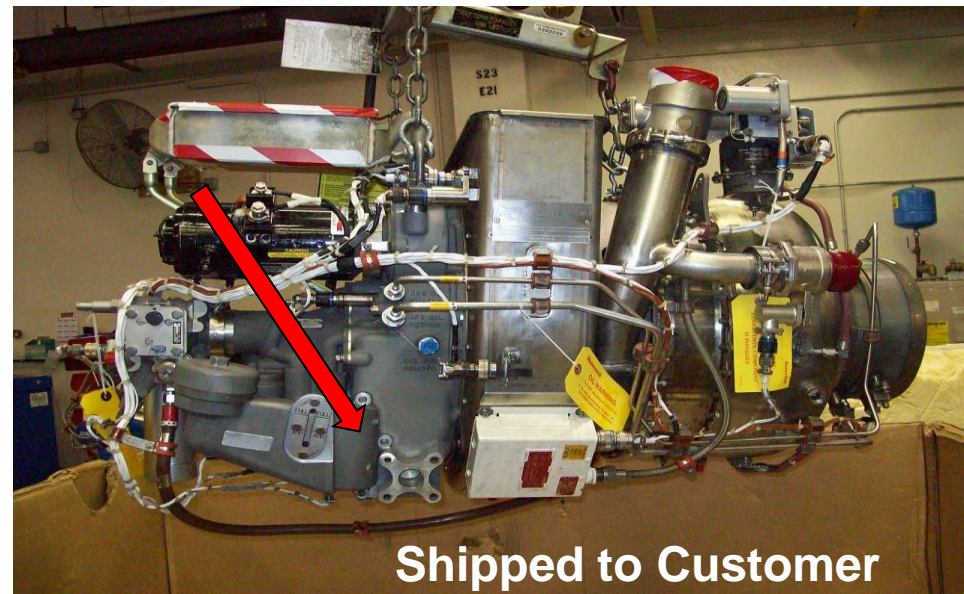
- Total repair time from start to finish 6 hours

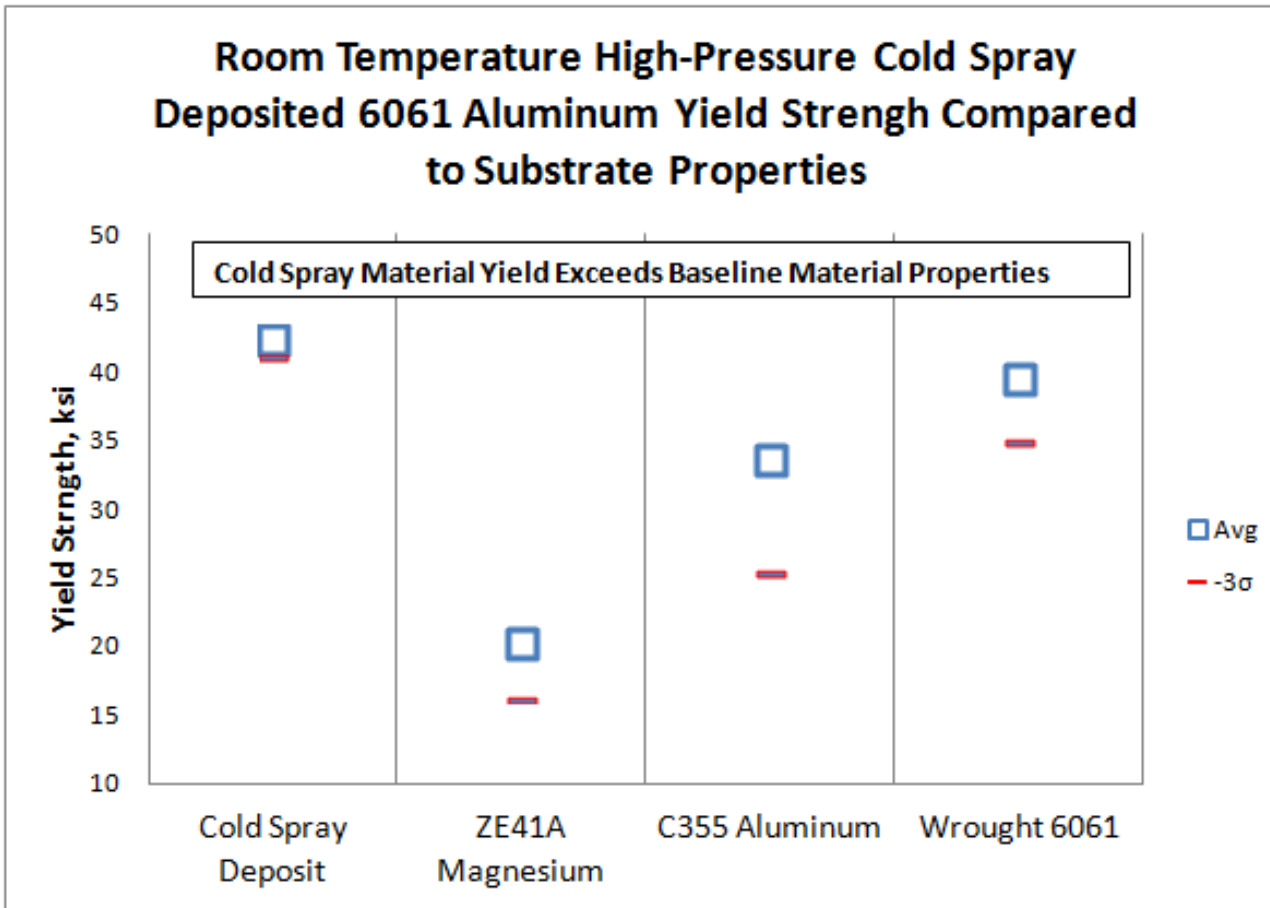
Preliminary Bulk Tensile Results

- Pooled data for aluminum and magnesium substrates
- Similar trends for ultimate and elongation values at room temperature and 300 °F

CS Bulk Material Tensile Exceeds Substrate Properties

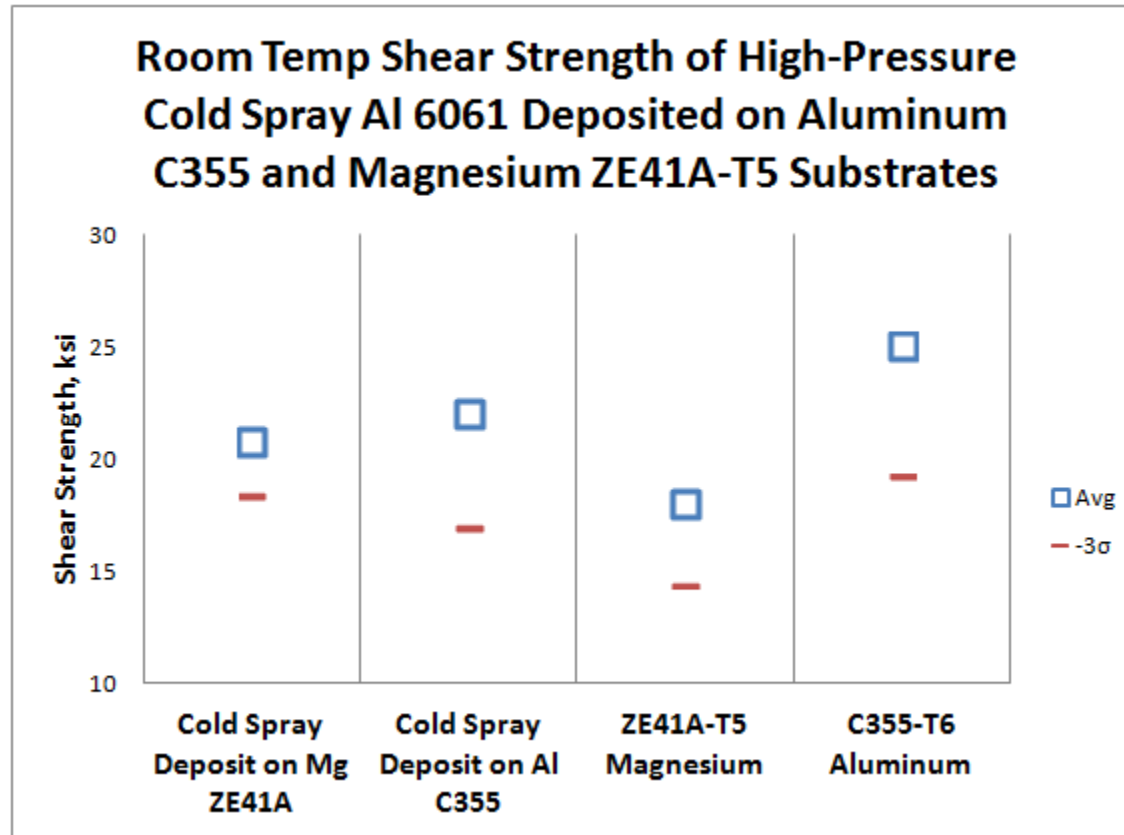
Preliminary Triple Lug Shear Strength Results

- Similar trends at 300 °F
- Cold spray shear strength results exceed the Mg ZE41A-T5 substrate properties
- Shear strength less than Al C355-T5 substrate

Shear Strength Results Sufficient for Majority of Proposed Repairs

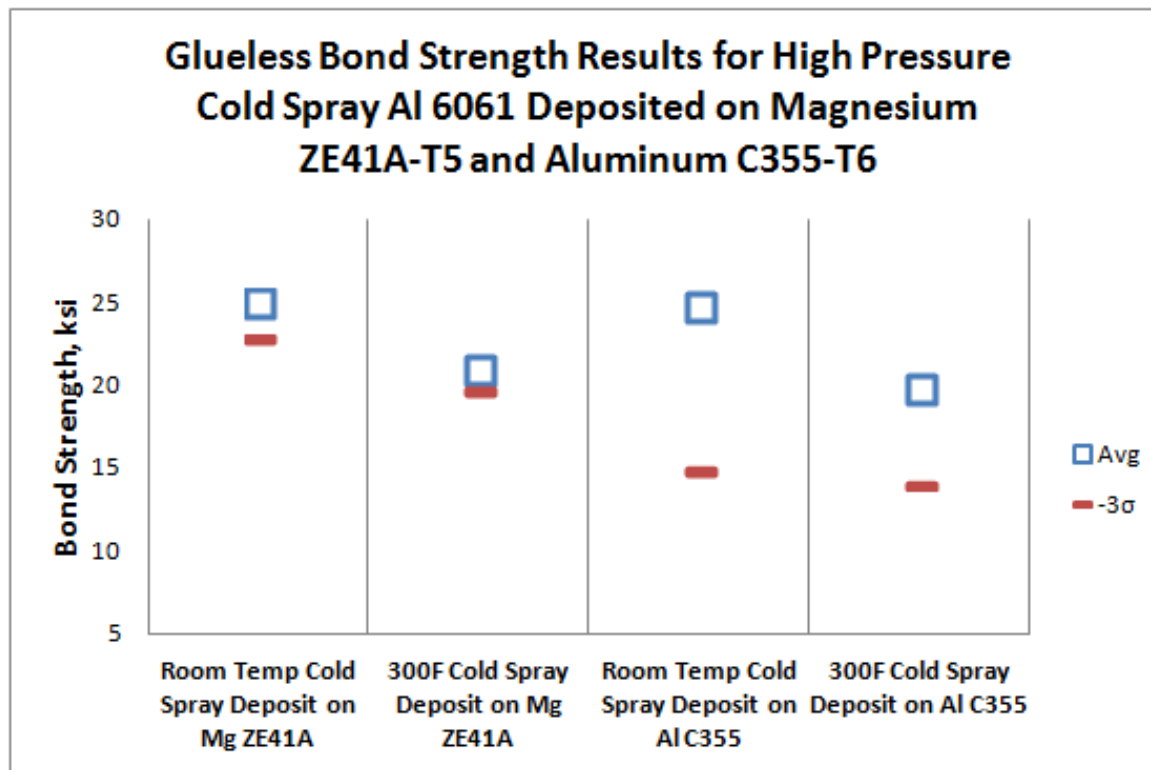
Preliminary Glueless Bond Strength Results

- Similar average performance relative to the two substrate materials
- Higher scatter with Al C355 substrate attributed to higher hardness of base alloy

Glueless Bond Strength Results Exceed Expectations
