Cold Spray Development for Apache Mast Support

Materials and Processes Technologies

- To develop a structural, cold-spray repair solution for corroded nickel plated main rotor support mast

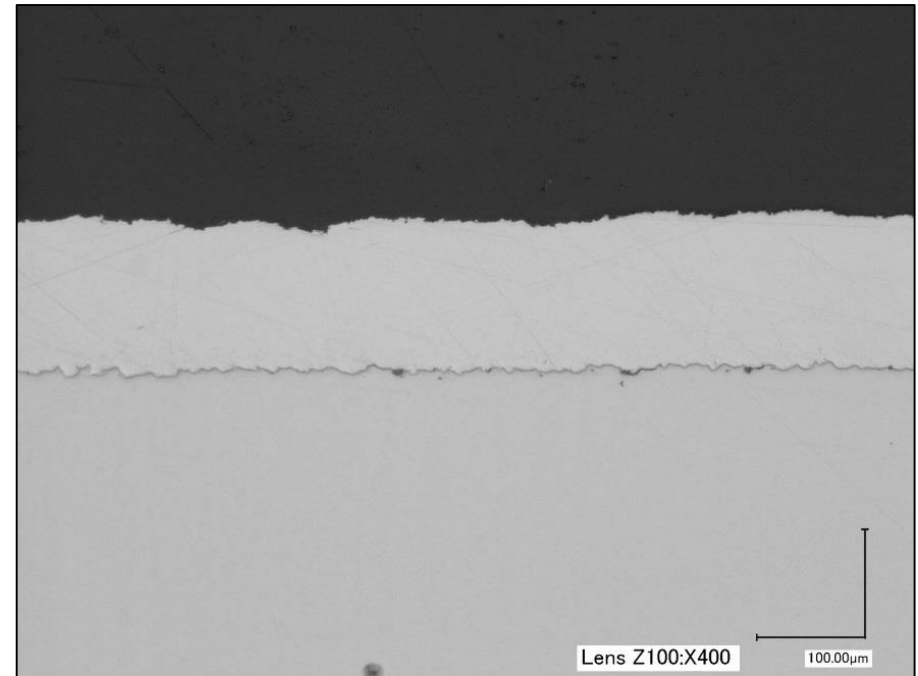
Cold Spray Equipment	CGT Kinetics 4000
Powder	AAE Ni-110, 99.9% (4-8 micron)
Carrier Gas	Helium
Sample #	B-13
Spray Date	10/1/15
Coating Thickness	0.008 inches
Interface contamination (particles greater than 0.002")	0 abrasive particles/inch
Porosity/Oxide Content Normal	Average value: 0.083 % Standard deviation: 0.039 % Minimum: 0.022% Maximum: 0.323 % Number of fields examined: 20
Cracks or interface zone separation	Non observed
Micro Hardness (10 sample average)	394 HV (0.2kg)

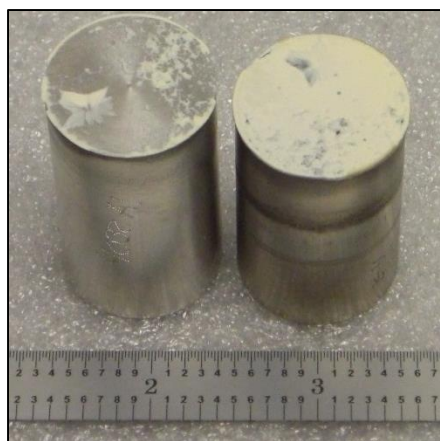
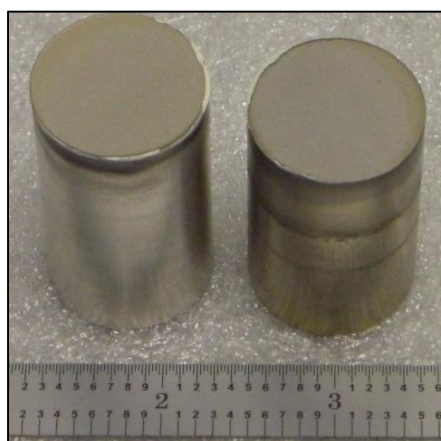
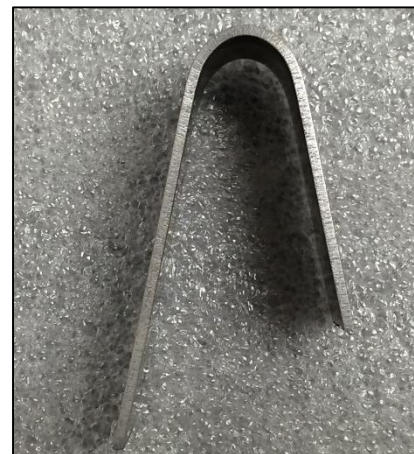
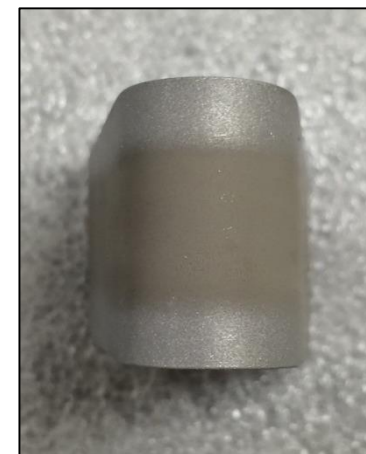
Specimen #	Spray Date	Coating Thickness (inches)	Test Result (psi)	Failure Mode
A-2	9/29/15	.010 to .011	11,906	Glue
A-3	9/29/15	.011 to .012	11,064	Coating Adhesion
A-4	9/29/15	.012	11,334	Coating Adhesion
A-5	9/29/15	.013	10,968	Glue
B-11	10/1/15	.009	11,484	Glue
B-12	10/1/15	.009	11,698	Glue
B-14	10/1/15	.009	12,048	Glue
B-15	10/1/15	.009	11,268	50% Glue/50%Coating

Requirement: 10,000 psi min.

Average: 11,471 psi

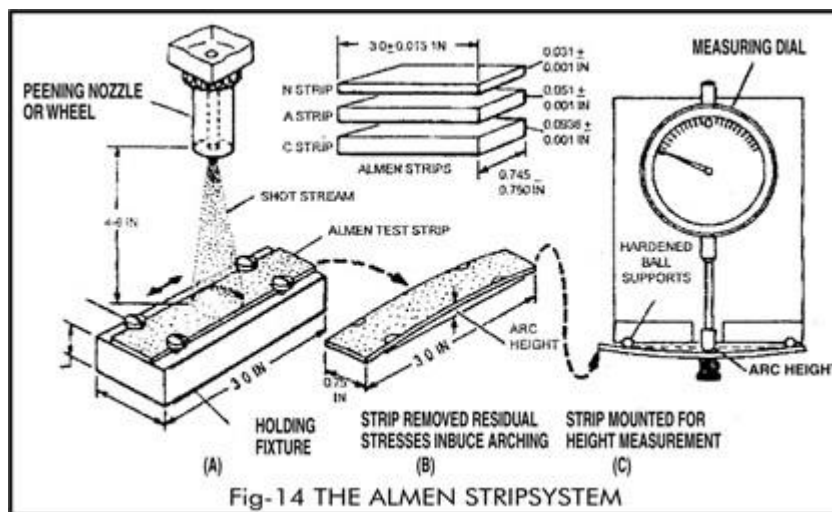
Specimen #	Cold Spray Thickness	As-Received Deflection	As-Grit Blasted Deflection	As-Coated Deflection	Deflection Difference	Residual Stress Type
1	0.004	-0.0004	-0.0003	+0.0024	+0.0027	compressive
2	0.004	+0.0001	0.0000	+0.0019	+0.0019	compressive
3	0.005	+0.0001	+0.0002	+0.0014	+0.0012	compressive
4	N/A	+0.0000	+0.0034	N/A	+0.0034	compressive
5	N/A	-0.0003	+0.0034	N/A	+0.0037	compressive

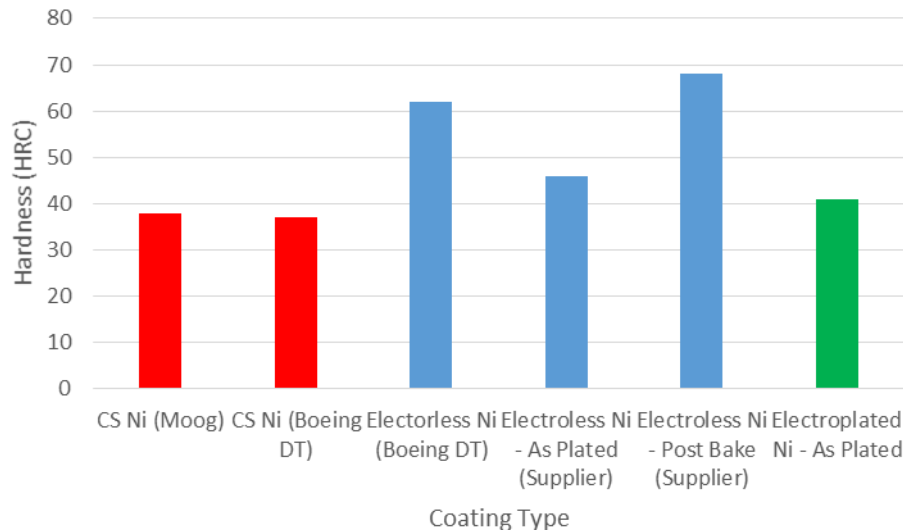
- Cold spray hardness lower than expected (38 HRC)
 - Hardness consistent through thickness
- Electroless Ni hardness increased due to hydrogen embrittlement bake
- Plan to simulate multiple installations prior to fatigue testing

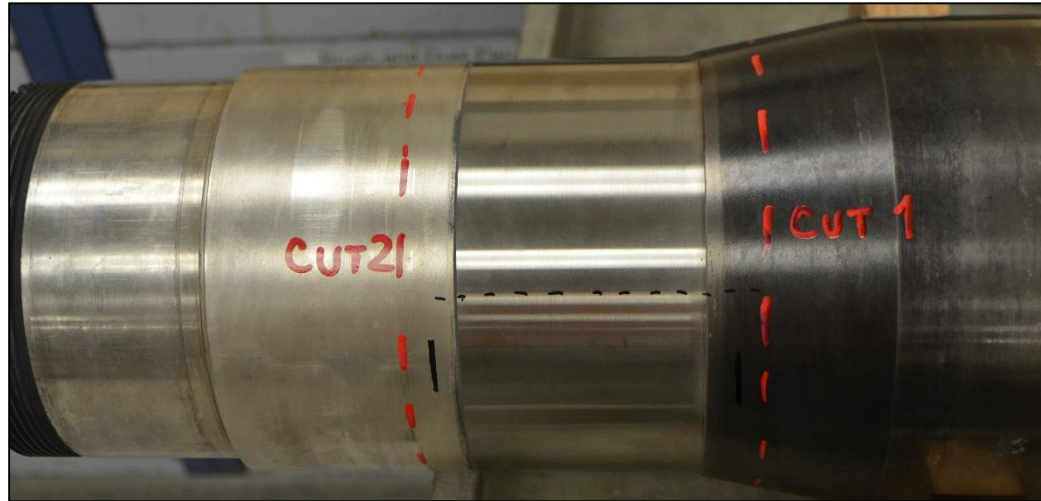
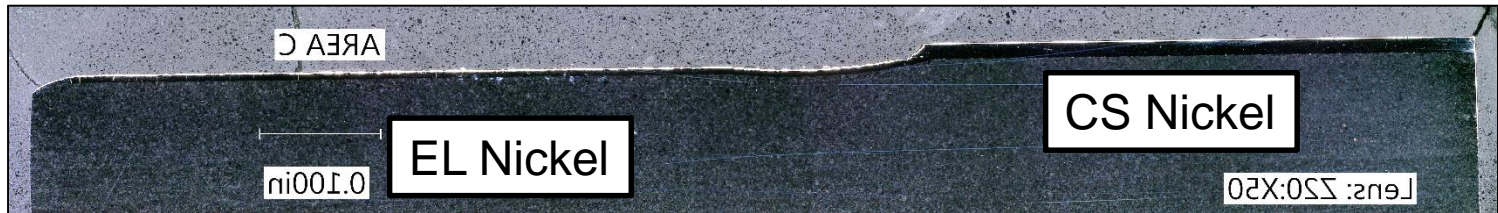
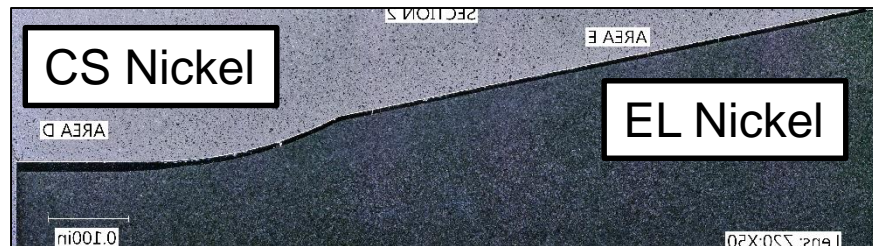
Cut 2

- **All test objectives were successfully completed**
 - Hardness of cold spray nickel was lower than anticipated
 - Fatigue test used to verify system performance
- **Destructive test article did not find any significant issues**
 - Lessons learned were incorporated into processing fatigue test articles
 - More consistent masking technique
 - Improved approach to machining
- **Two full scale fatigue test masts were successfully repaired**
- **Fatigue testing revealed no significant change in performance**
