Cold Spray Repair of Magnesium

ARL Center for Cold Spray
17 May 2011

UH-60 Sump Assembly Main Module-Main Gearbox Repair

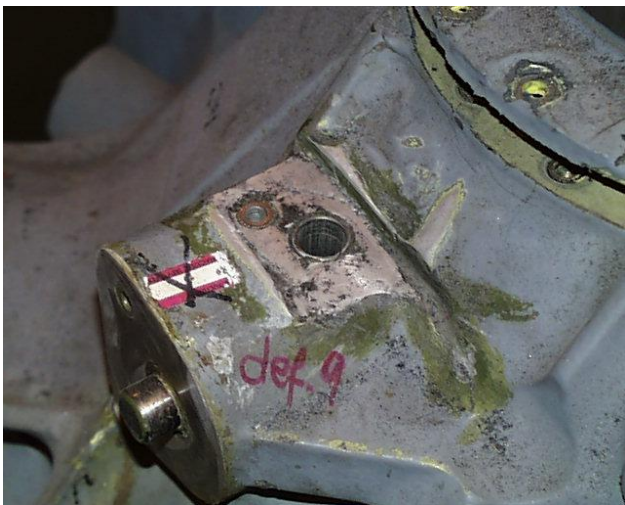
UH-60 Main Rotor Transmission

Examples of corrosion damage from service

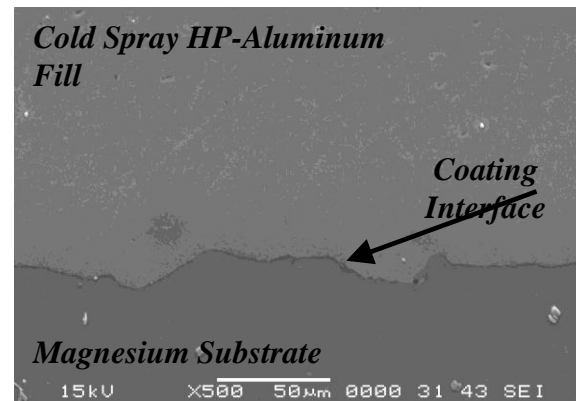
Microstructure of CS Repair

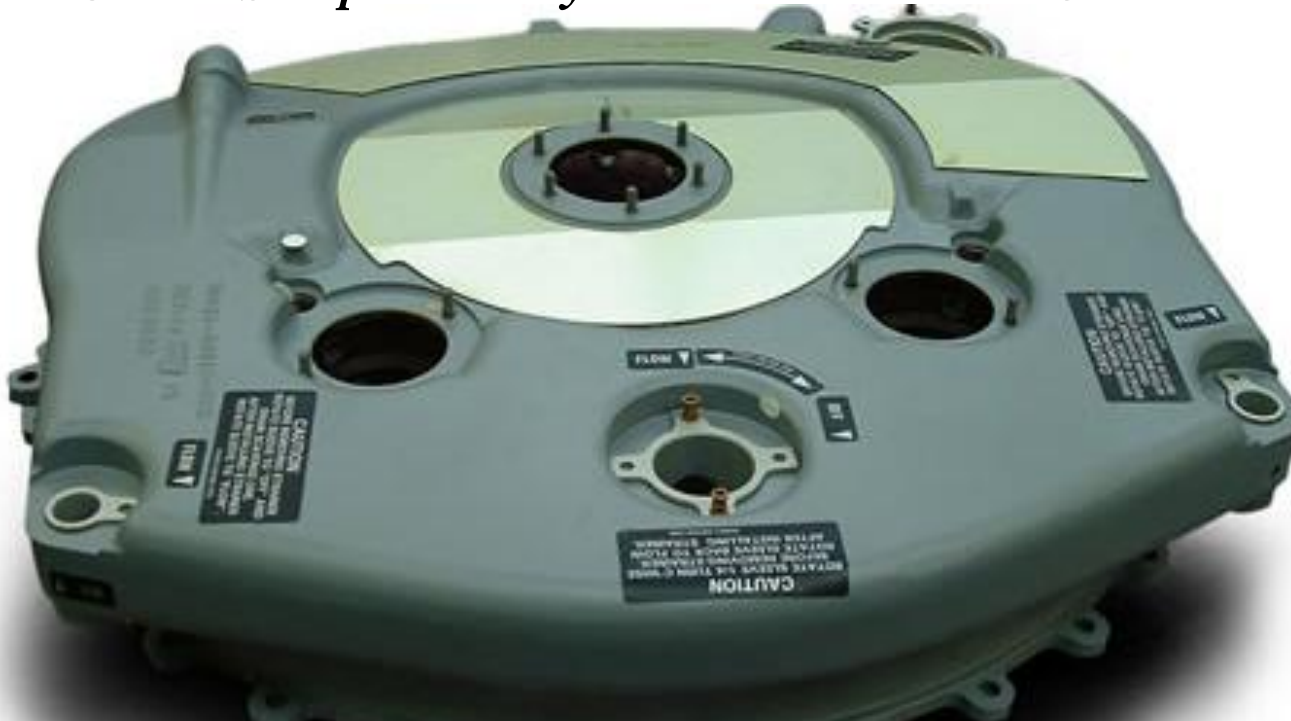
- *Cost of new component \$11,000.00 DLA (Defense Logistics Agency)*
- *85 sumps need repair per year based on a Sikorsky study over the last 3 years*
- *Total Replacement Cost Savings estimated to be **\$935,000.00/year***
- ***This costs savings is only for one magnesium part for the UH-60***

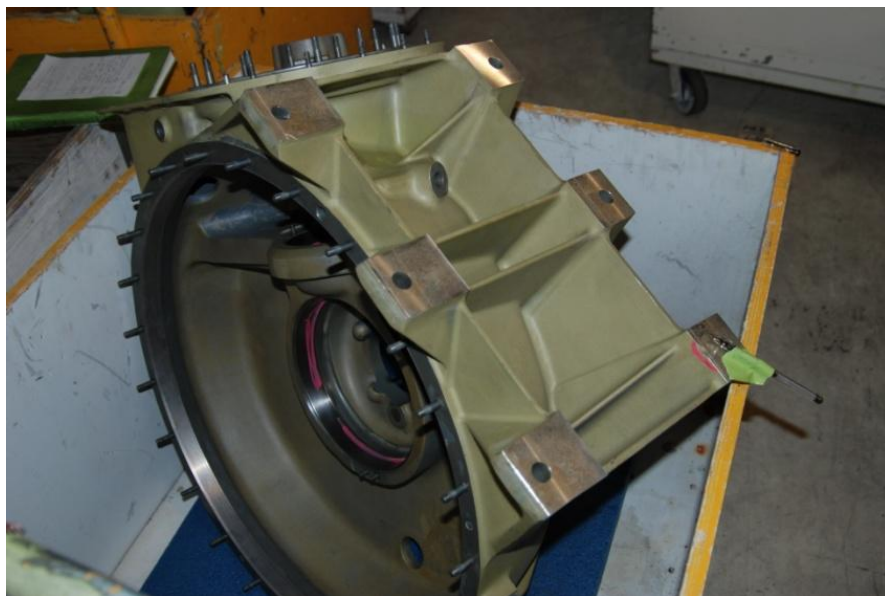
MOUNTING FEET LOCATION

Corrosion damage on the H-60 IGB is the leading cause of component removal

- Specifically, the corrosion occurs around the mounting pads. Inside areas as well as the bottom of the feet
- FY2009: Navy removed 23 corroded IGB from Service (82% of all removals)
- Component cost is \$45k
- 88 hours to remove, replace, and perform flight checks. Labor rate is \$36.95 hour

- The cold spray will provide better resistance to crevice corrosion on the bottom of the pads***
- 6061 aluminum alloy cold spray is harder than the ZE41A-T5 substrate and will provide better resistance to tool damage as well as better corrosion resistance on the inside of the bolting area***

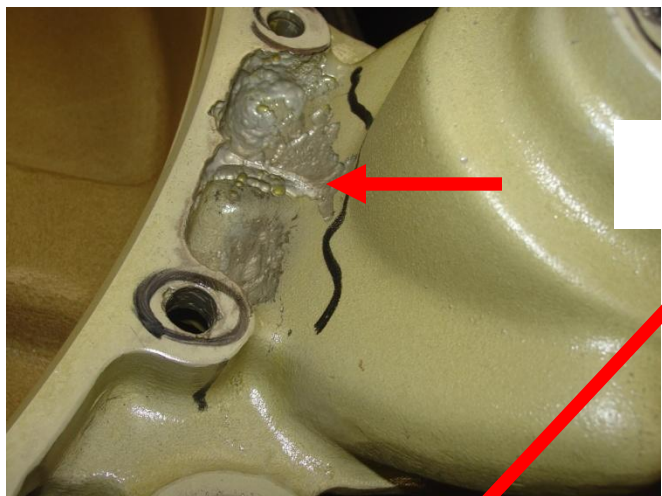
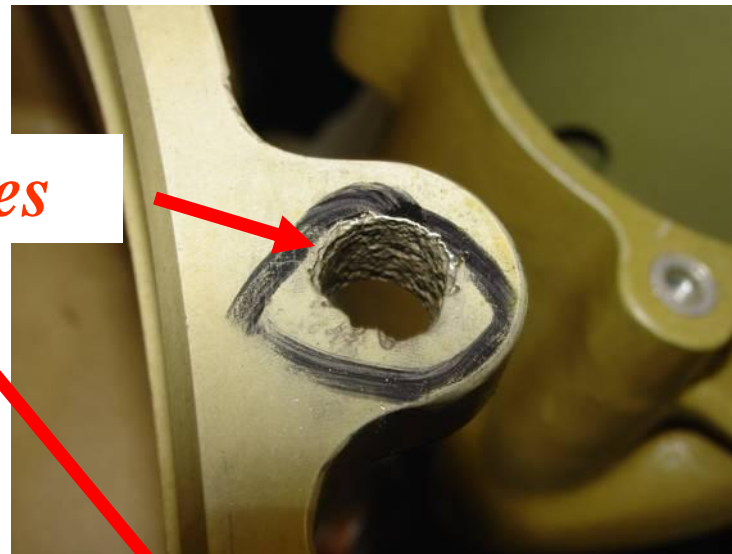
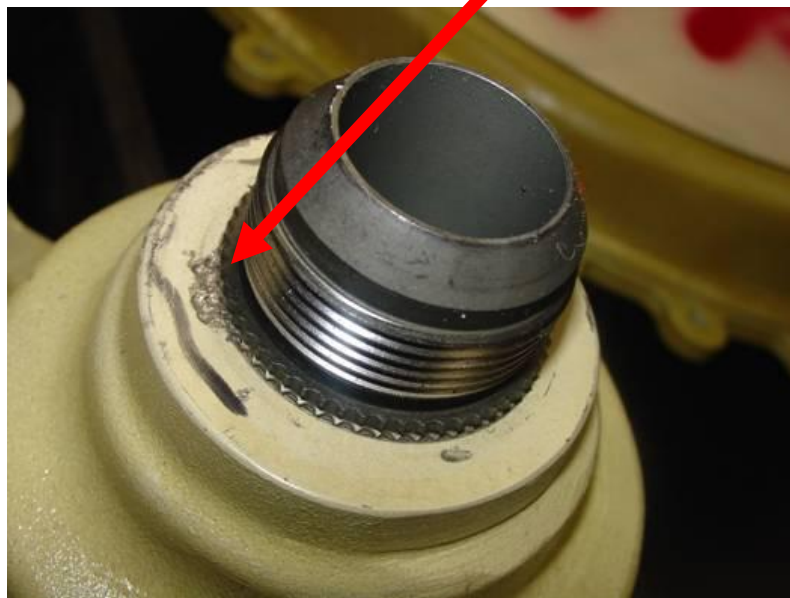
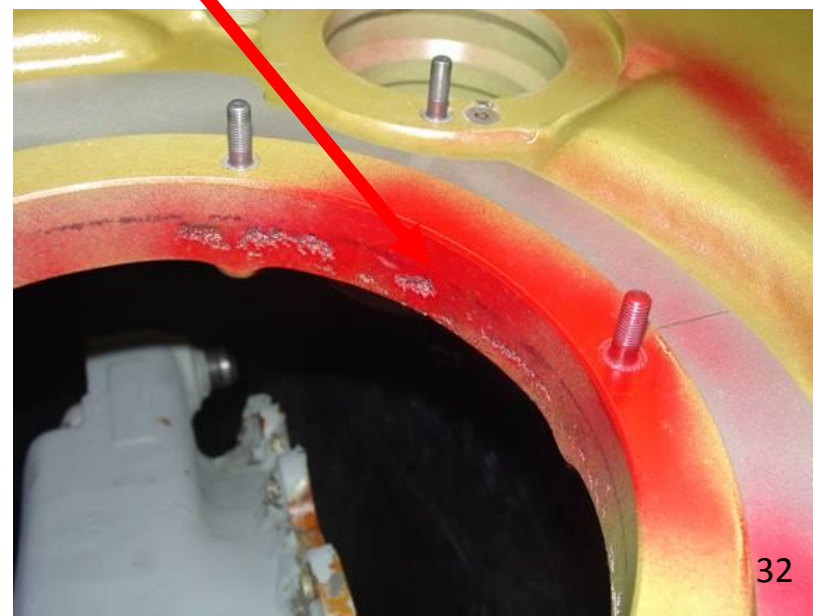
Repair Sites

UH-60 Sump Assembly Main Module -Main Gearbox Repair

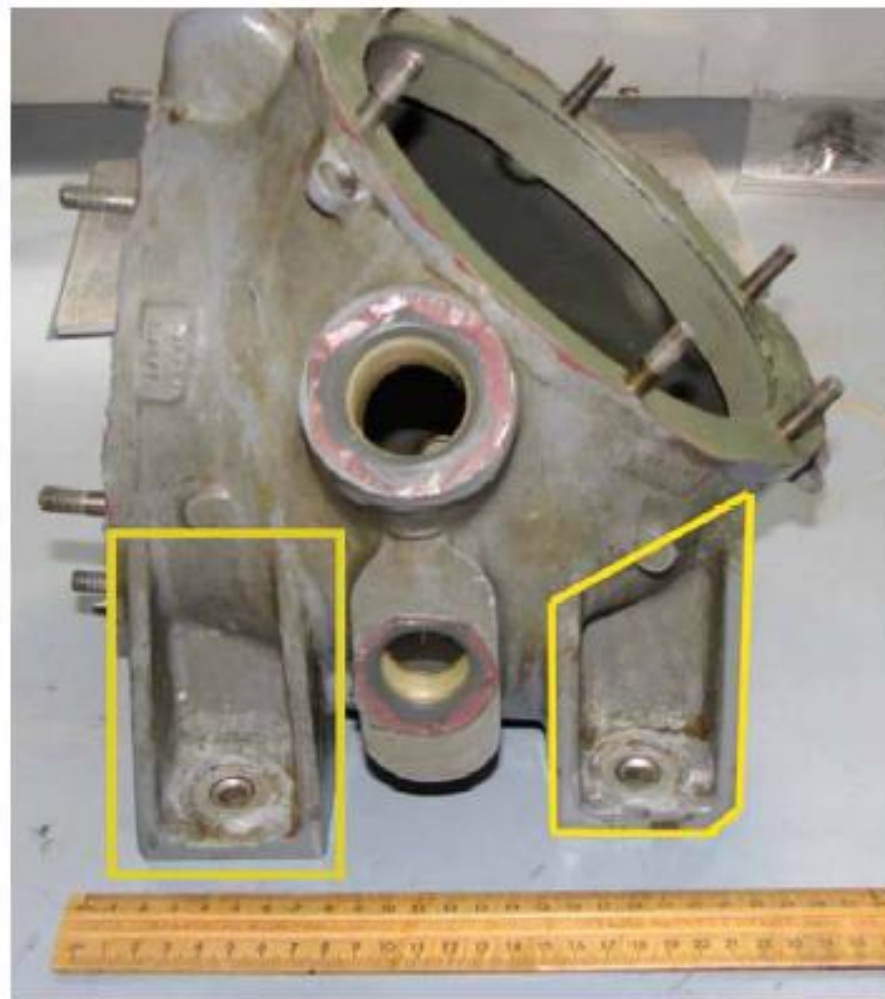
Navy spent approximately 1.1 million dollars on this issue in FY2009

Cold Spray a protective 6061 aluminum alloy coating onto the bottom of the mounting pads as well as the inside of the bolting area
