# Qualification of the UH-60 Main Gearbox Sump – Progress to Date

**Robert Guillemette, M&P Engineering**  
**Jason Wu, M&P Engineering**  
**Wayne Petroskey, O&R Engineering**

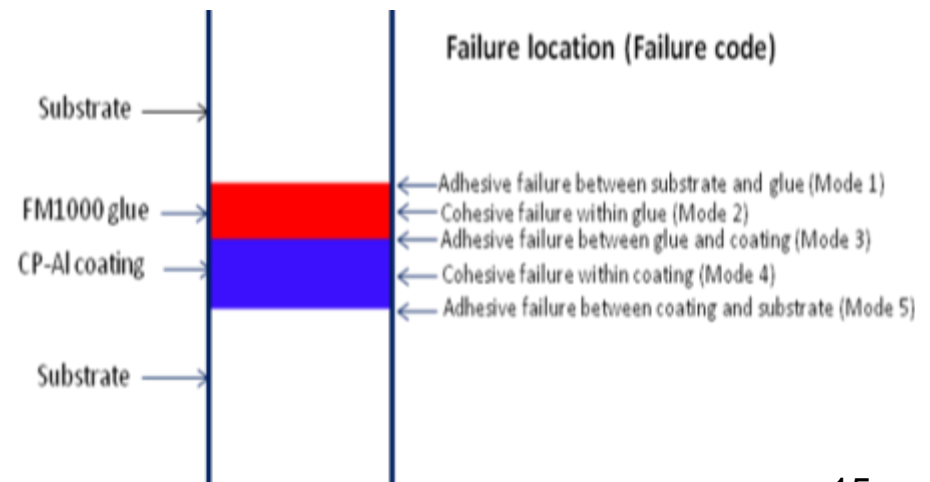
Specimen #	Diameter (in)	Max load(lbs)	Adhesion Strength (ksi)	Failure Mode
A1-B1	1	6908	8.8	Fixture thread failure. Coating intact
A2-B2	1	7299	10.1	Fixture thread failure. Coating intact
A3-B3	1	6288	8.01	Fixture thread failure. Coating intact
A4-B4	1	8293	10.56	Glue failure (85% mode 2+15% mode 1)
A5-B5	1	9306	11.85	Glue failure (75% mode 2+25% mode 1)
A6-B6	1	9118	11.61	Glue failure+ partially coating failure (30% mode 5+25% mode 1+45% mode 2)

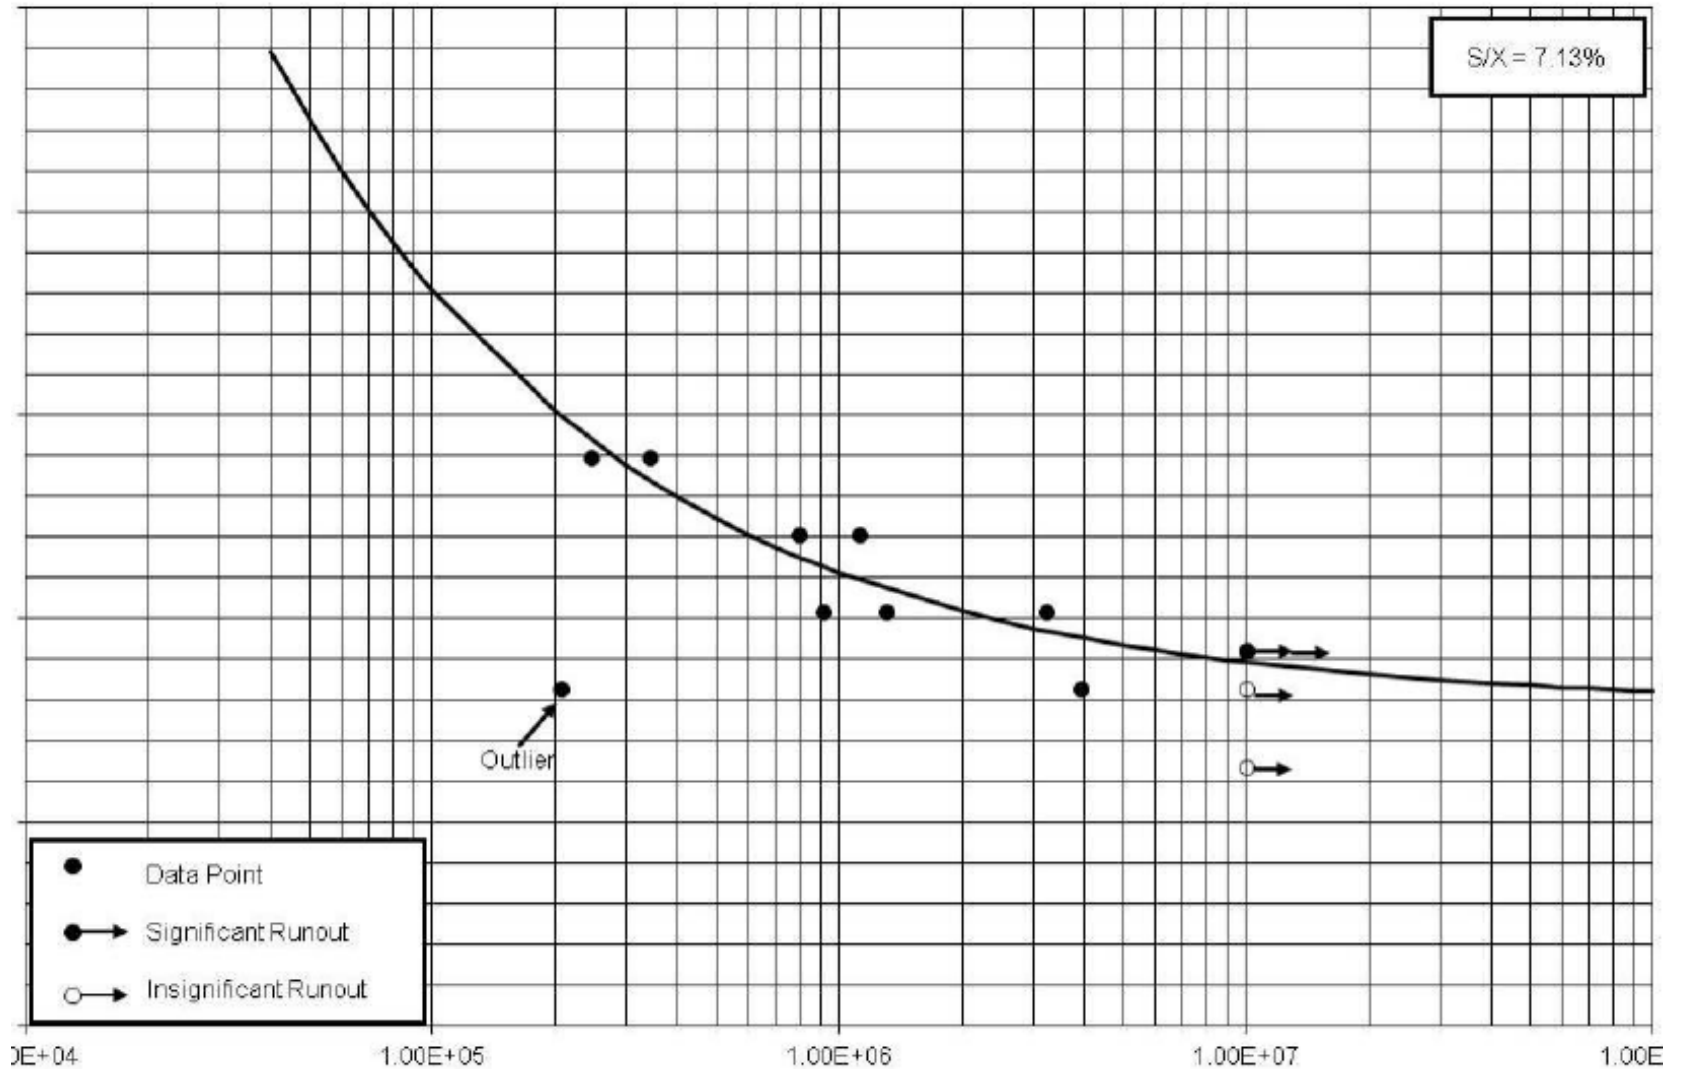
# Fatigue Data for CS CP AI

- Cold spray CP aluminum, under conditions tested herein, does not degrade fatigue strength of ZE41A magnesium. Fatigue strength of coating is similar to fatigue strength of magnesium ZE41A substrate.
- Fatigue strength equivalent to current HVOF Aluminum-Silicon coating
