CSAT 25 -26 June 2019

Quantifiable Structural Enhancement Outcomes using SPD (Cold Spray) Deposition

Neil Matthews

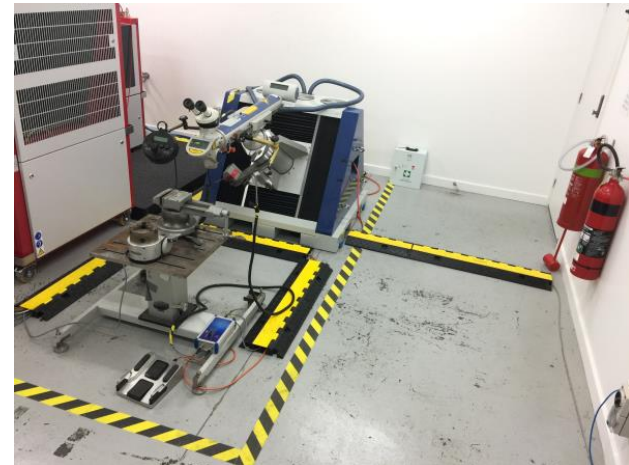
Laser Wire System

Acquired from RUAG Stanz

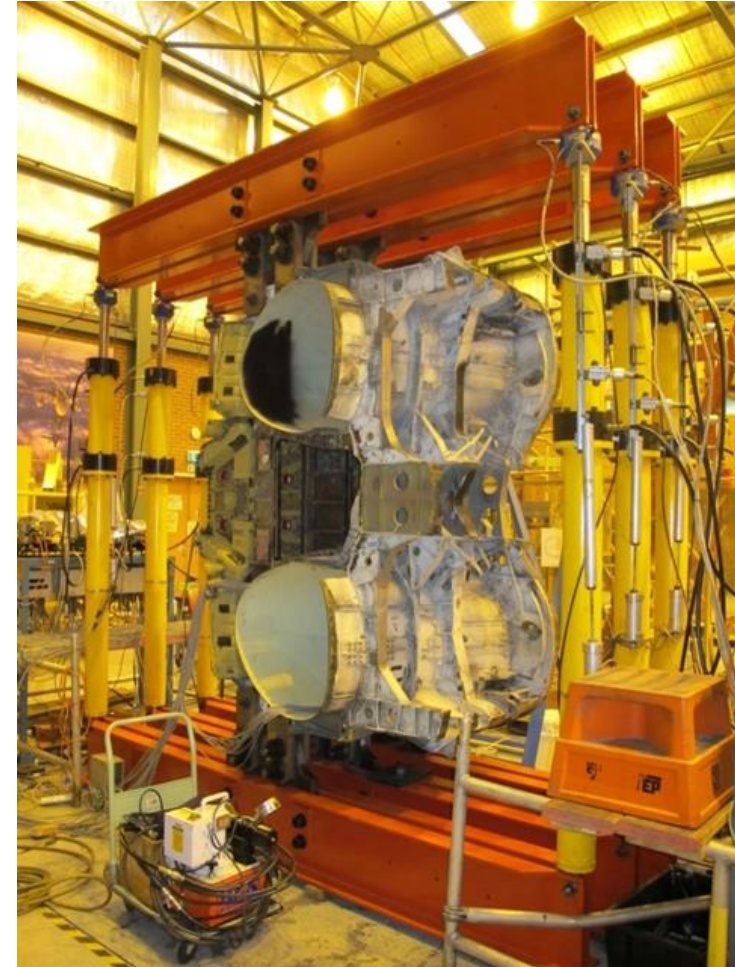
- As part of a RAAF/DSTO FLAW Identification Program 12 SPD doublers were applied to a centre barrel which was subjected to representative fighter wing root bending moment spectra until failure of at least one bulkhead. Failure of the bulkhead occurred at 18,000 test hours (3 aircraft lives). No SPD failures/disbonds. (peak stresses >200 MPa)

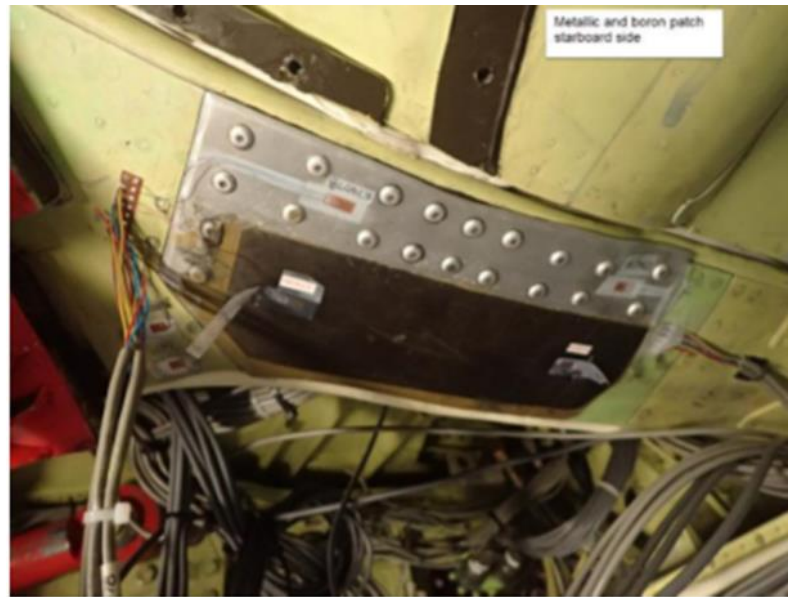
Lower wing skin suffers fatigue cracking emanating from corrosion pits and around fasteners. A number of current repair techniques have been employed to stop/ limit crack growth. Stop drilling/cold working, metal patch & composite patch.

SPD was evaluated as a possible solution to repair skin and stop crack propagation

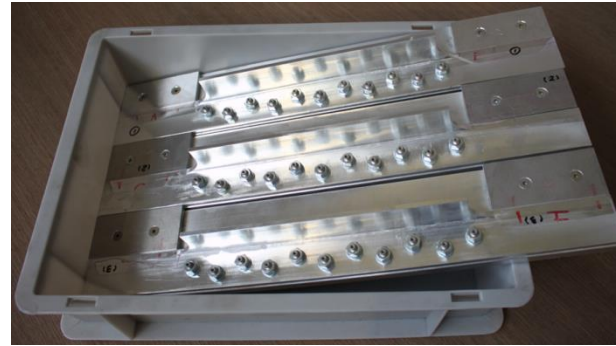
Specimen 1

At the same time a infra-red stress distribution images were taken.

The result obtained from the gauge reading were compared with both the FEM simulation and stress distribution imaging results to validate the strain gauge/thermography methods so as to apply them to predict stress/strain information at critical spot(s).

Using the above testing as base line, the specimen were cut at the skin to generate a crack into the fastener hole.

Further testing/FEM/Infra-red stress distribution were performed. The specimen then were SPD coated to form a patch over the cracked area. The average thickness of SPD for Specimens 1 to 3 was 2.72, 2.73 and 3.94 mm respectively.

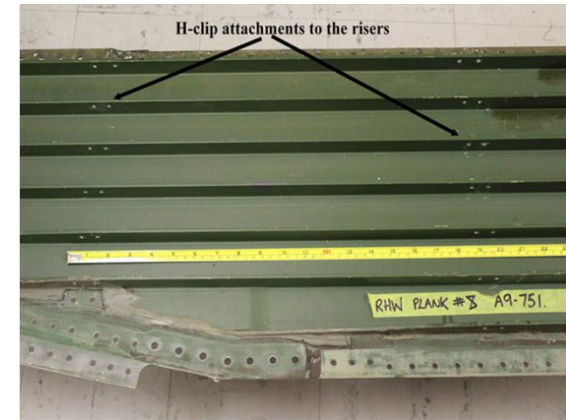
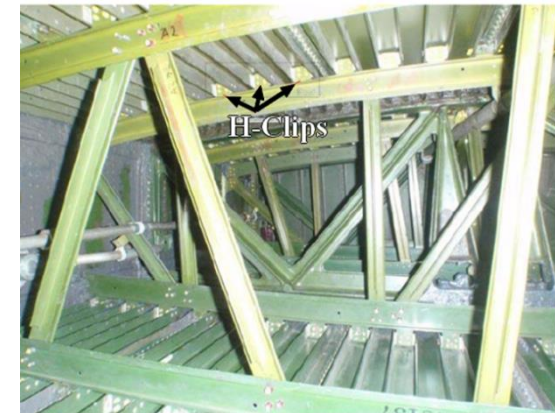
FE Baseline Model (*Provided by Monash University*)

- A 500 mm (long) by 250 mm (wide) rib stiffened 7075-T6 aluminium alloy panel where the skin and the risers were both 4.3 mm thick.
- The panel contained 5 ribs
- The length of the panel was taken so as to approximate the distance between the H-clips that are attached to the risers.
- The risers were 30 mm deep and 50 mm apart.
- The skin thickness analysed was 2.1 mm.
- The unloaded edges of the panel were assumed to be simply supported (other cases were analysed)

FE Model with Corrosion removal

- The corrosion was taken to be 40 mm in diameter with a depth of 1.05 mm. (50% of the total thickness of the skin)
- Centre of Panel for maximum Buckling stress

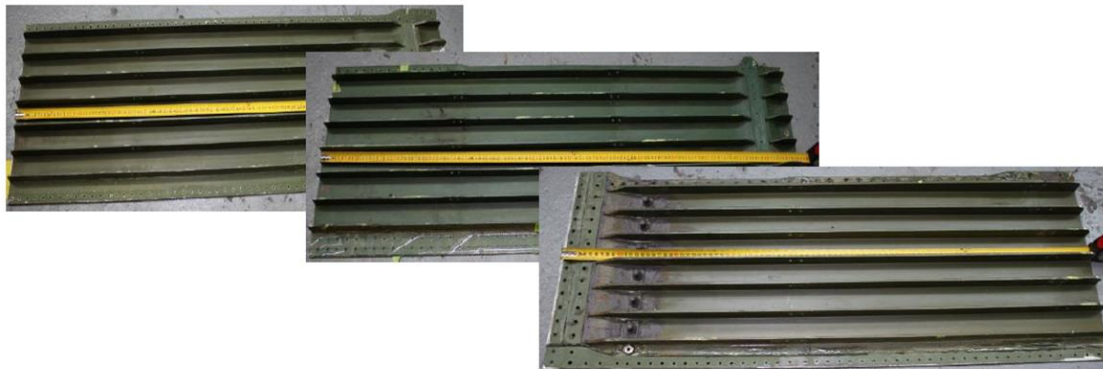
- ❖ SPD applications were evaluated by assessing Wing Integrity with Upper Surface Corrosion Subject to Compressive Loading
- ❖ Ex-service wing plank segments from retired P3-C Orion aircraft courtesy of the Royal Australian Air Force (RAAF) were able to be obtained along with. to the in-service load spectra. These wing segments are also typical of framed elements which exist in other aircraft.

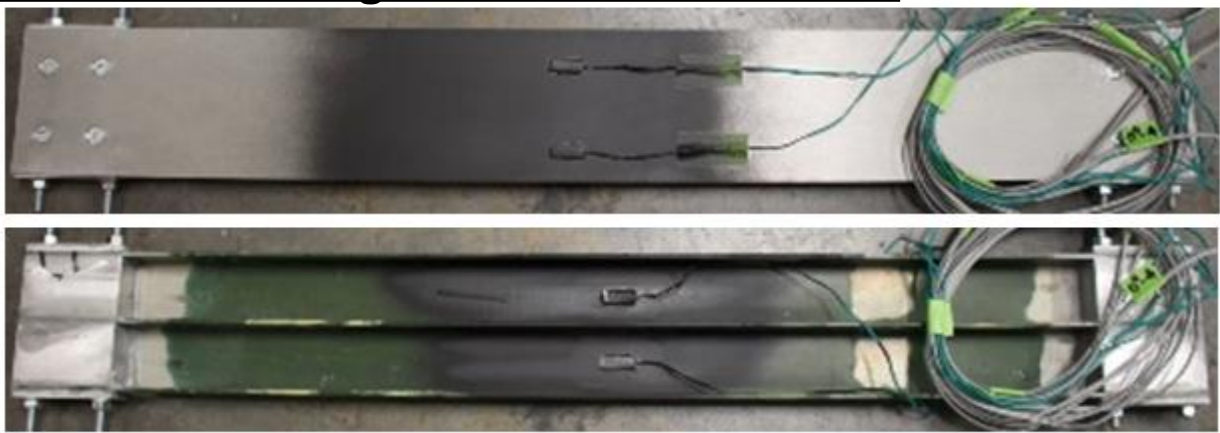
Locations of Strain Gauges – Baseline and SPD

Baseline Specimen 6

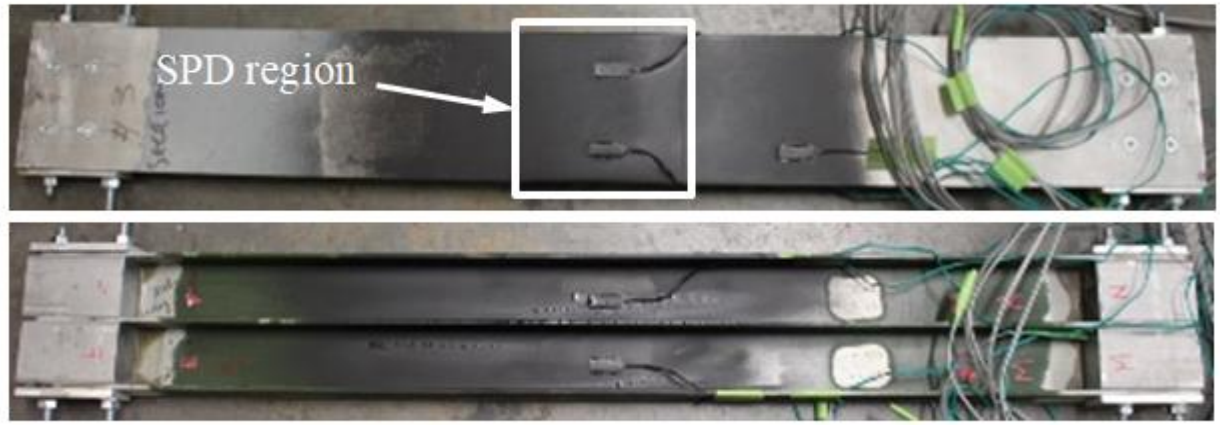
Specimen 3 (with SPD repair)

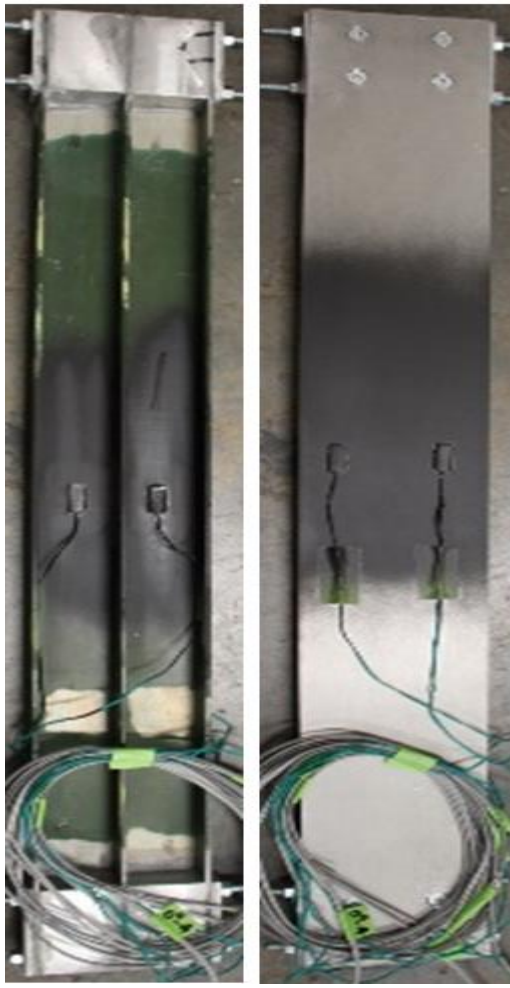
Strain Gauge Back & Front

- Prior to testing the SPD repaired specimens to failure both strain gauge measurements and infra-red thermography stress measurements were performed. Two test programs were performed, these being:
 - 1) *A static compression test with the loads varying from 0 to -50 kN.*
 - 2) *A cyclic load test with the loads varying from -5 kN to -55 kN at a frequency of 4Hz*

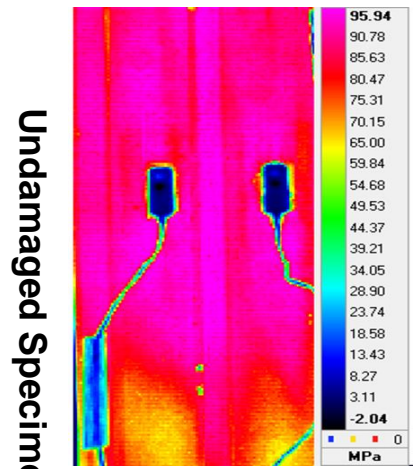
Undamaged Specimen

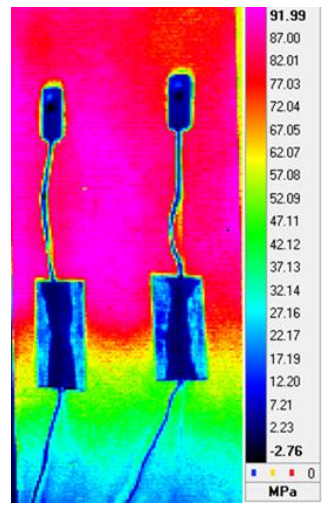
Thermography Back & Front

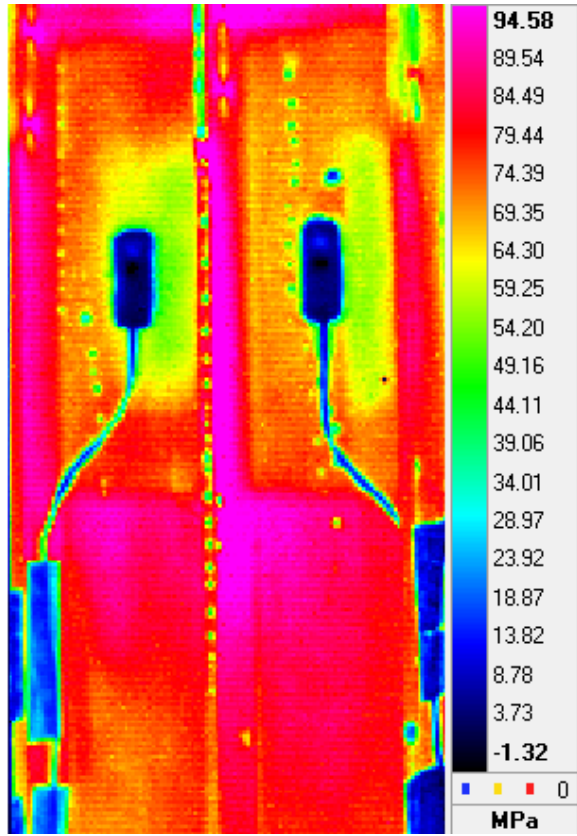
Reduced stress field due to the SPD repair sitting proud

Stress field on the upper and inner surfaces of the repaired P3C panel

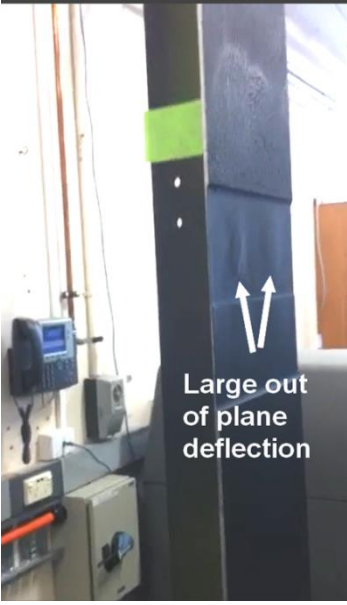
Simulated corrosion before SPD 3#

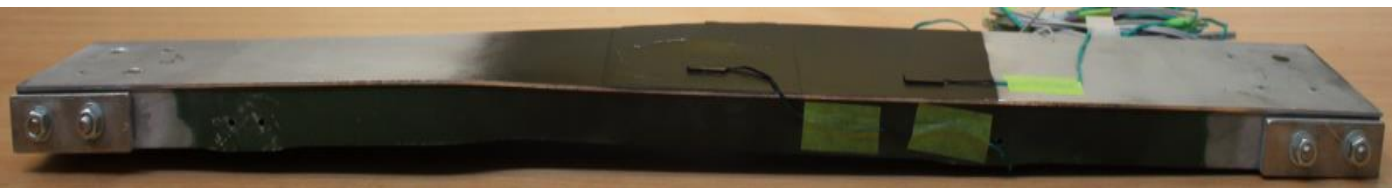
SPD repaired specimen (3#) after testing

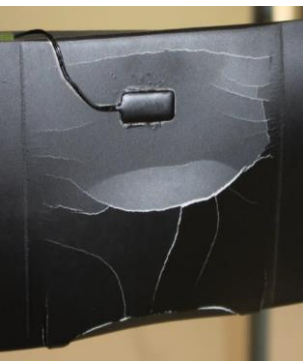
SPD repaired specimen (5#) after testing

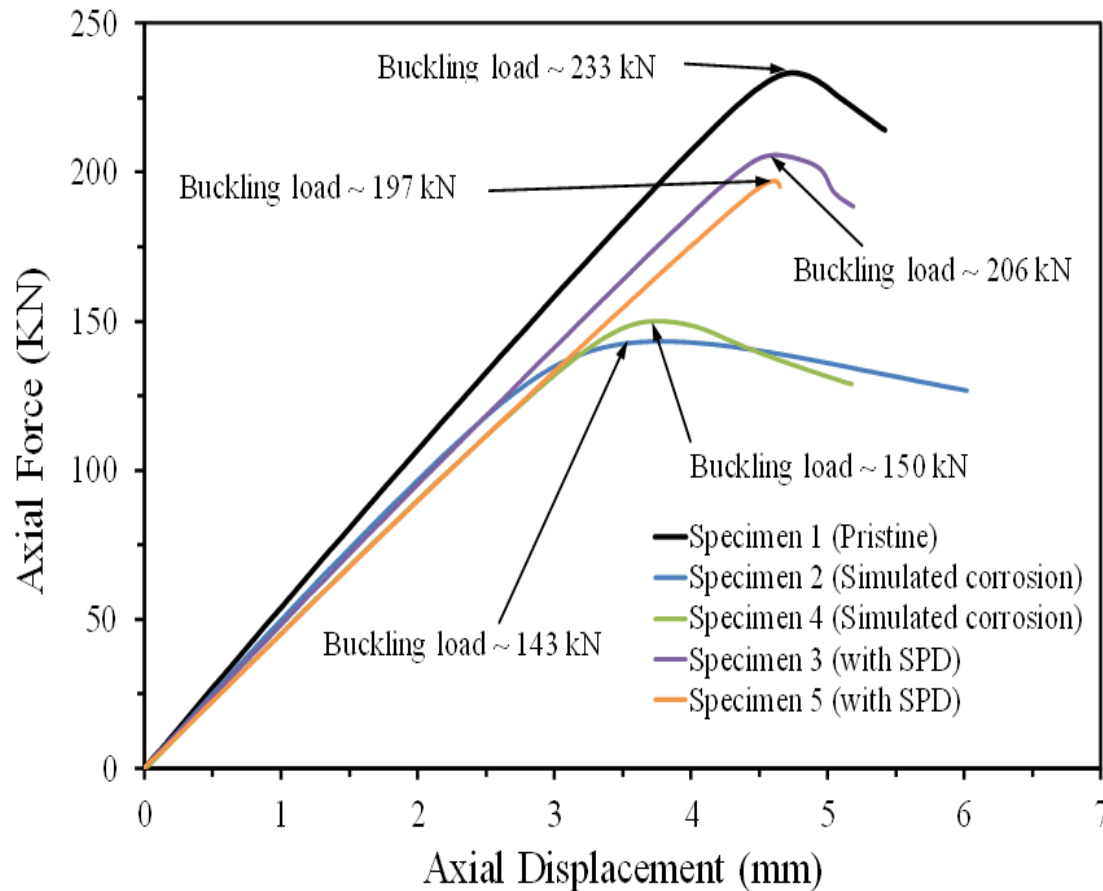
Effect of Skin Corrosion on Buckling Load

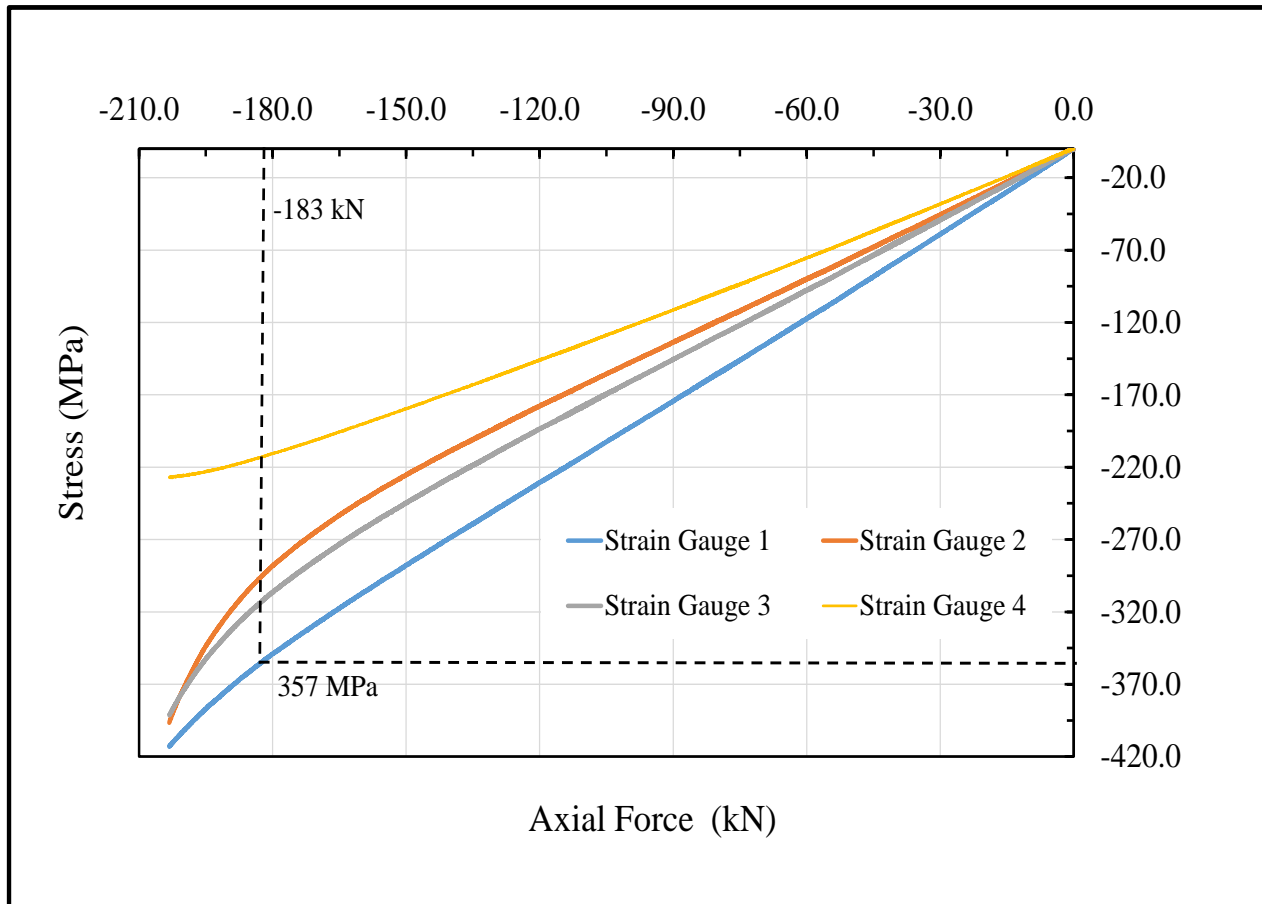
Effect of SPD on Skin Stresses

Panel stress at Limit load ~ 170 MPa.

SPD repaired panel can withstand proof load, with non linear behaviour at 115% DLL – A JSSG2006 requirement

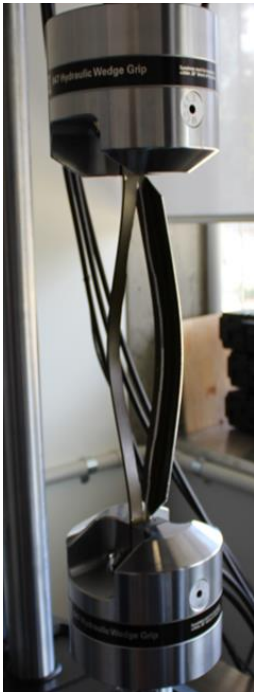
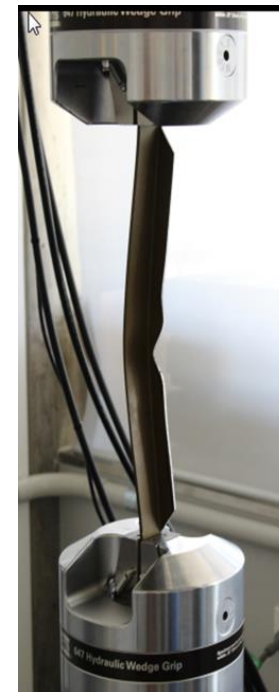
SPD Repairs on Compression Surfaces of a Wing Plank - Experimental Validation

- Nominally identical specimens were cut from a wing plank provided by MPSPO.
- Specimens with no SCC with 100 mm SCC and with both SCC and a SPD repair were tested.
